Kelmscott District Centre Precinct Plan

Place Audit Report (including Public Open Space Audit)

Taylor Burrell Barnett
Town Planning and Design

Revision	Reviewer	Date Issued
20/053	SB	13 May 2021

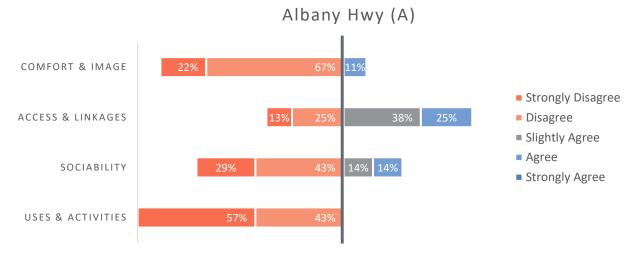
2.1 Albany Highway (A)

Albany Highway (A) consists of a high traffic volume main road with commercial and residential land uses on its eastern boundary and the railway line on its western boundary. This stretch of Albany Highway is well maintained with areas of landscaping.

Weaknesses	Strengths
Inadequate street trees/shading	Proximity to train/bus station and shared path
Footpath located "back of kerb" impacts real and perceived pedestrian safety	Train station highly visible from north approach
given vehicle speeds	Good mix of commercial uses
 Single storey buildings with large setbacks and wide road reserve create poor "sense of enclosure" 	Signalised pedestrian crossing
Limited pedestrian crossing opportunities	
 Car-orientated commercial uses limit pedestrian activity 	
Poor interface with Stargate "civic space"

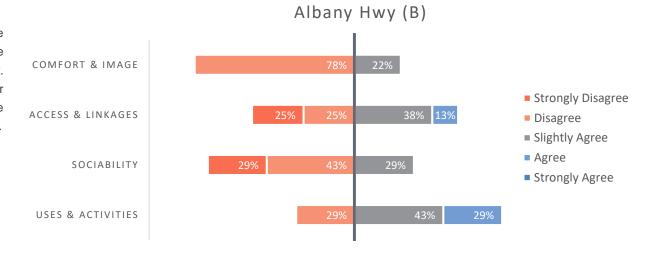
2.2 Albany Highway (B)

Albany Highway (B) consists of a high traffic volume main road with commercial land uses on the eastern side of the road and the Kelmscott train station on the west. There is a distinct lack of shading and areas for pedestrians to sit. There is a median strip in the middle of the road reserve that includes established street trees.

Weaknesses	Strengths
Inadequate street trees/shading	Proximity to train/bus station and shared path
 Footpath located "back of kerb" impacts real and perceived pedestrian safety given vehicle speeds 	Train station highly visible from north approach
 Single storey buildings with large setbacks and wide road reserve create poor "sense of enclosure" 	Good mix of commercial uses
Limited pedestrian crossing opportunities	Signalised pedestrian crossing
Car-orientated commercial uses limit pedestrian activity	
Poor interface with Stargate "civic space"

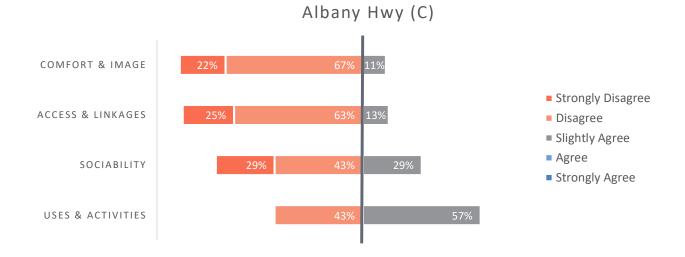
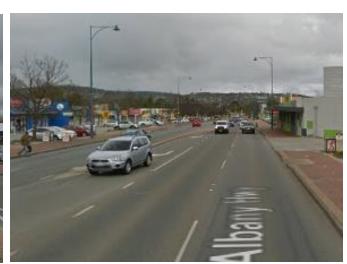
2.3 Albany Highway (C)

Albany Highway (C) consists of a high traffic volume main road with commercial land uses on both sides of the road. There are no street trees present and therefore no shaded areas to improve pedestrian amenity.

Weaknesses —————————————————————————————————	Strengths
Inadequate street trees/shading	Good mix of commercial uses
 Footpath located "back of kerb" impacts real and perceived pedestrian safety given vehicle speeds 	"Key stretch" through town centre – opportunity for unique street-scape and placemaking
 Single storey buildings with large setbacks and wide road reserve create poor "sense of enclosure" 	Prime location for potential future signalised pedestrian crossing
Limited pedestrian crossing opportunities	
Car-orientated commercial uses limit pedestrian activity	
Poor interface with Kelmscott Plaza	
Heavy traffic and fast vehicle speeds;	
Limited/no places to gather

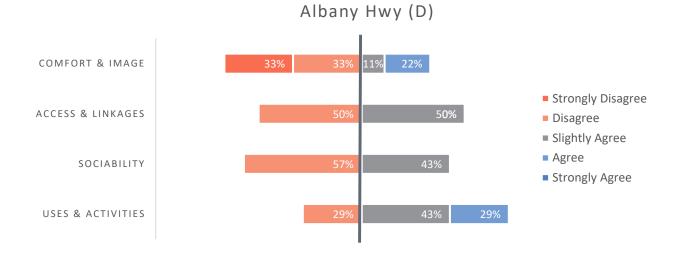
2.4 Albany Highway (D)

Albany Highway (D) consists of a high traffic volume highway with commercial uses, and petrol stations operating on both sides of the road. There are no street trees present and no places to sit.

- Automobile dependant commercial uses lack character and opportunities for pedestrian activation
- Lack of street trees/shading
- Lack of pedestrian crossing opportunity
- Car dominant street environment

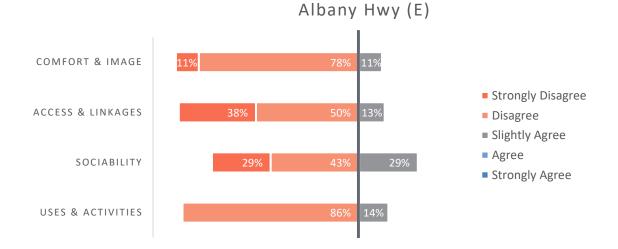
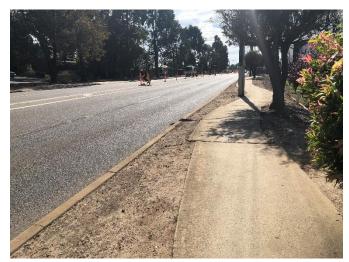
2.5 Albany Highway (E)

Albany Highway (E) consists of a high traffic volume highway with a mixture of commercial and residential land uses. There are street trees present and providing shaded areas, however there are no area to sit. The pedestrian side walk is located in very close proximity to the road, which creates an unsafe walking environment at some points.

Weaknesses	Strengths
Lack of distinct character – mixed building age, style and use	Heritage buildings improve character
 Narrow verge limits opportunities to improve pedestrian experience 	Some street trees
Lack of pedestrian crossing opportunity	Views to hills to south
 Deviations in footpath alignment and limited setback from road impact active transport opportunities 	
Car dominant street environment

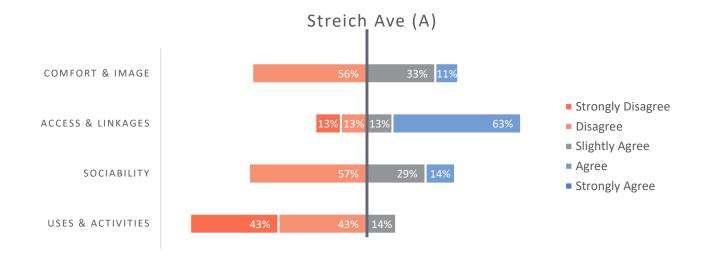
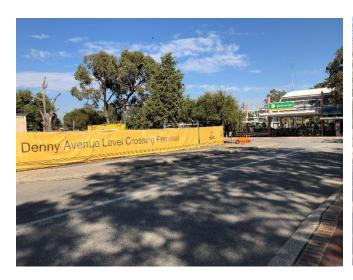
Streich Avenue (A) is a small section of road connecting Albany Highway through to the Kelmscott Train Station with no current land uses. There are no street trees providing shade, limited signage and limited lighting. This road is of particular importance to pedestrian connectivity to the train station and the town centre.

Weaknesses	Strengths
 Construction site to south and abandoned Station Master's cottage to north do not currently activate street 	Proximity to both train station and Albany Hwy
Underutilised "node" at station entrance	Good views to hills to west
Vista from station entry to Albany Hwy terminates in low quality "Jetts" building	Station master's quarters have character value
No street trees/shading	
Limited street lighting	
 Narrow road reserve makes pedestrian improvements challenging within current verge 	
Poor wayfinding and signage	
Lack of gathering spaces

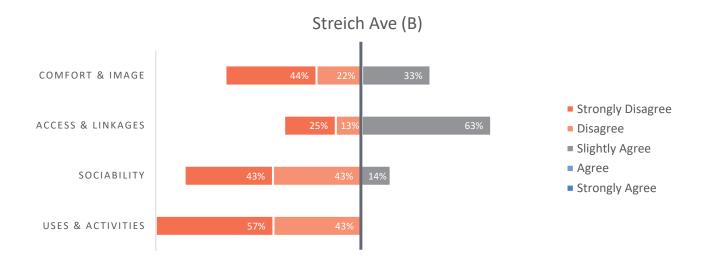
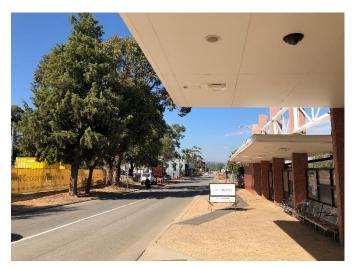
Streich Avenue (B) consists of a north south road running parallel with the train line and in close proximity to the Kelmscott Train Station. Commercial/retail uses occupy this portion of the road. There is excessive hard surface (road, footpath) present in this stretch of the road and there is a distinct lack of landscaping. It is noted that there are street trees present, however there is a lack of places to sit within the shaded areas provided.

Weaknesses	Strengths
Weanilesses	Sueliguis
 Lack of active commercial frontages limits vitality with poor pedestrian activity and passive surveillance 	Potential development site(s) adjacent station
Predominance of hard surface	Proximity to 'heart' of town centre
Limited street trees/shading and lighting	Key pedestrian and vehicle access route to train/bus station
Potential rail noise issues	
Physical barrier formed by railway	
Graffiti along blank walls and rubbish present in verge/road

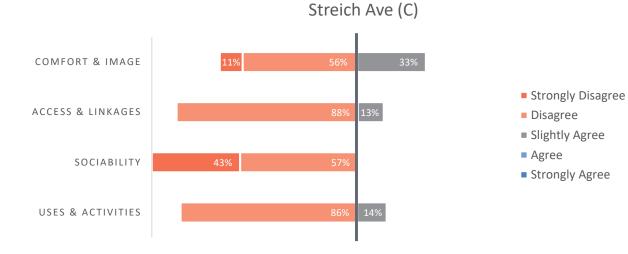
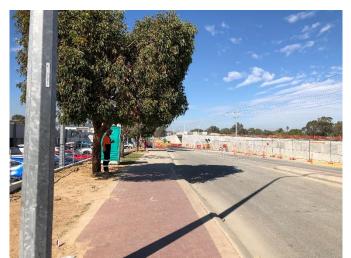
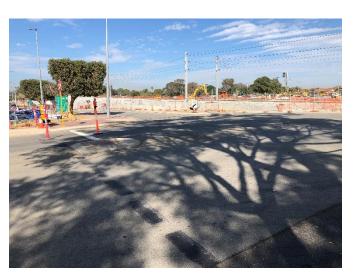
2.8 Streich Avenue (C)

Streich Avenue (C) consists of a north south road running parallel with the train line. Commercial/retail uses occupy this portion of the road. There is a lack of street trees and as a result there is limited shading provided, and limited areas to sit (with or without shade cover).

Weaknesses	Strengths
 Lack of active commercial frontages limits vitality with poor pedestrian activity and passive surveillance 	Good views to hills
Physical barrier formed by railway	Proximity to popular Kelmscott Plaza shopping centre
Visual impact of railway retaining	Key route to Davis Road underpass
Predominance of hard surfaces creates hostile pedestrian environment	
Limited street trees/shading and lighting	
Potential rail noise issues

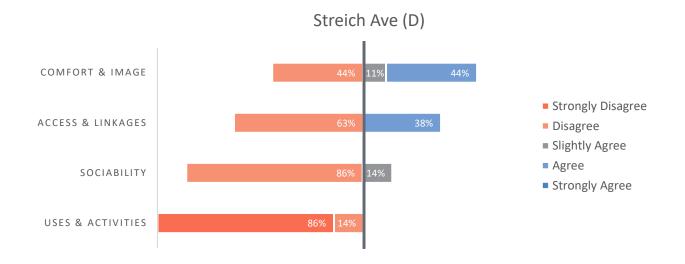
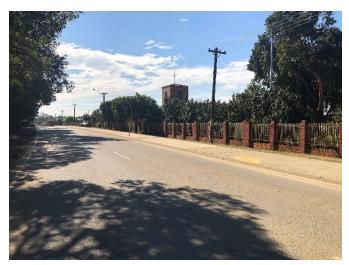
Streich Avenue (D) consists of a north south road running parallel with the train line. There is a large church that occupies the street's eastern boundary. There is a large presence of significant established trees bordering the road and the train line. There is limited street trees, shading and places to sit on the eastern side of the road, which is where the pedestrian access footpath exists. There is limited signage to the landscaped public access way (PAW) that is located on the southern end of the road.

Weaknesses	Strengths
Rail to west, and church as major landholding to east limits activity along street	 Established street trees along railway reserve provide visual amenity and opportunity for shaded pedestrian route
Limited street trees/shading to footpath	Landscaped PAW provides access to small POS
Footpath to one side of street only

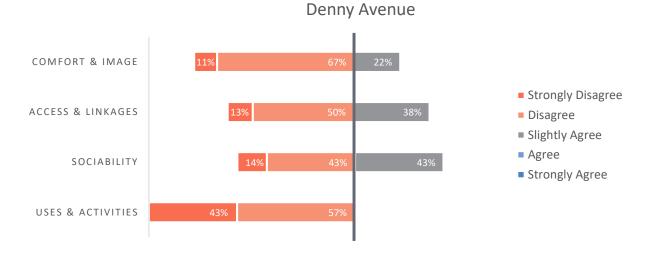
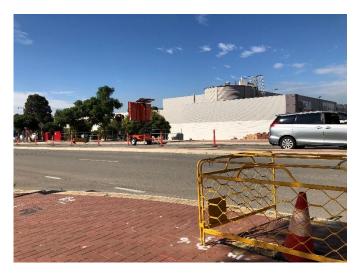
2.10 Denny Avenue

Denny Avenue is a small section of road connecting Streich Avenue to Albany Highway. This is a key connecting route with strong potential for redevelopment and street redesign. It is a quiet street with limited activity. There is a lack of street trees, landscaping and no land uses front the street. Further to this the road is lacking signage which would assist pedestrian direction to and from the Kelmscott Train Station. The view of the hills facing east is significant.

Weaknesses	Strengths
•	Open car park to north and blank building wall to south limits opportunities for passive surveillance	Key E-W route in proximity to station
•	Limited shade from street trees	Potential development site to north of street (Albany Hwy corner)
•	Level difference between street and car park to north creates challenges for any future interface	Views to hills provide visual amenity
•	Four lane road unnecessarily large now that Denny Ave level crossing has been removed.

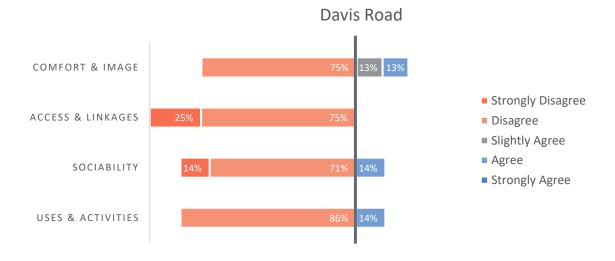
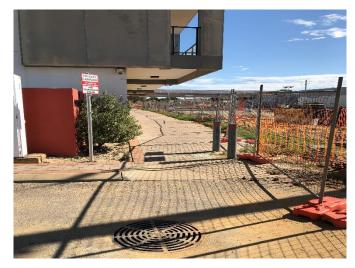
2.11 Davis Road

Davis Road consists of a road currently under construction of road works. Whilst a description is currently not pragmatic given the work that is currently being undertaken, the road may be of significant future importance as a high amenity pedestrian route given its linkage to the rail line and Albany Highway.

Weaknesses	Strengths
 Blank side of Kelmscott Plaza and large area of open carpark to north limit opportunity for street activation. 	Proximity to Kelmscott Plaza creates opportunity for land use intensification
No street trees (at time of audit)	Accessibility across rail line – potential key pedestrian route
Potential high traffic area due to new rail underpass connection	Ground floor commercial uses to south of street provide some street activation

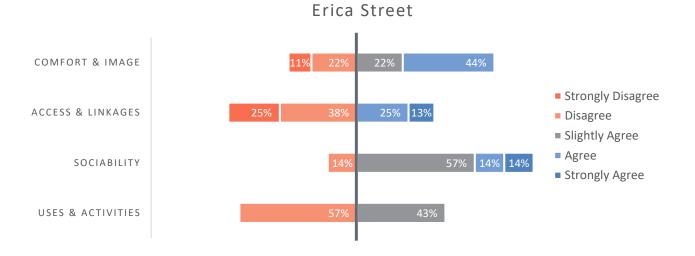
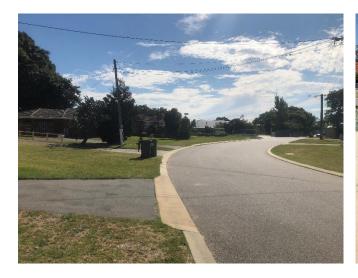
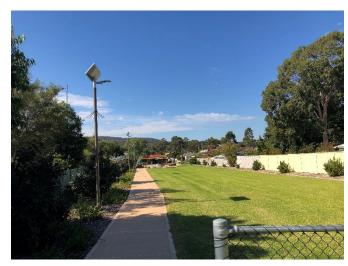
2.12 Erica Street

Erica Street consists of a quiet residential street which connects to a public access way park area at its northern end. The street lacks shade and pedestrian movement which is unsurprising given its quiet residential nature. Generous front setbacks are provided, and there is no footpath currently existing ensuring pedestrians are required to utilise the road for pedestrian thoroughfare to the public access way.

Weaknesses	Strengths
Lack of street trees/shading	Low-traffic environment
No footpaths	Wide street with ample verge and setbacks
	Borrowed amenity from landscaped PAW

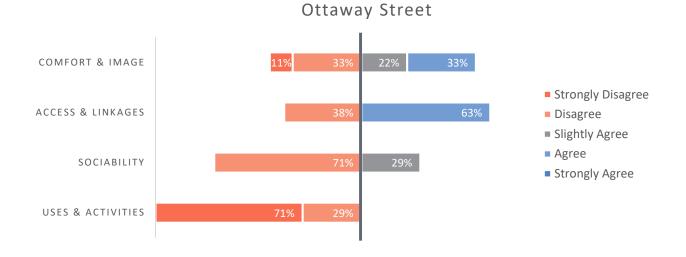
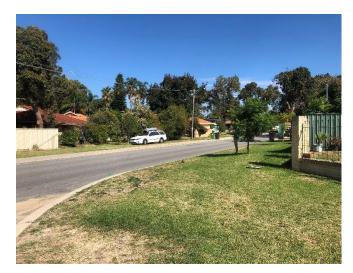
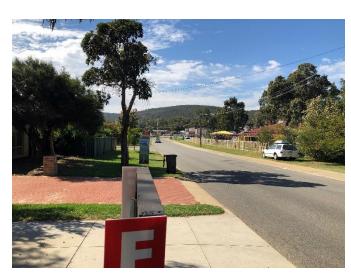
2.13 Ottaway Street

Ottaway Street consists predominately of low scale residential land use with generous front setbacks provided. The street includes views to the north east to the hills and south to the rail reserve trees. Ottaway Street is lacking in shade provision, places to sit and the street design encourages high vehicle speeds.

Weaknesses	Strengths
Street design encourages high vehicle speeds	 Good interface with child care centre on corner activates street during centre open hours
Lack of street trees/shading to North verge	Good views north east to hills, South to rail reserve trees
	 Lots of trees in road and private property (Southern half) provide good visual amenity

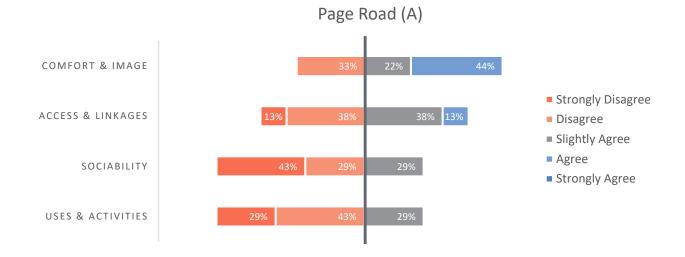
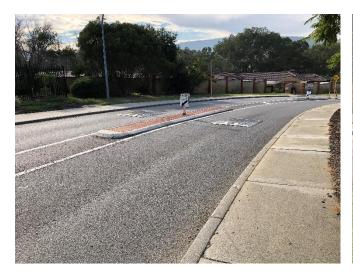
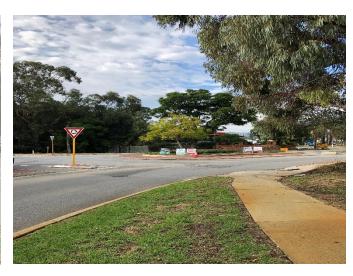
2.14 Page Road (A)

Page Road (A) comprises of a wide residential street with significant street trees. Fancote Park to the east provides significant streetscape character to this stretch of road, whilst the car park area and blank sheer wall to the west are a substantial detraction. There is a lack of street lighting and substantial vehicle traffic accessing the shopping centre car park, although this may be reduced when access from Albany Highway is reinstated.

Weaknesses	Strengths
Lack of active land use fronting street and extensive blank wall adjacent footpath limits pedestrian activity and amenity	Good established street trees, clean and well-maintained verge
Poor connectivity and route legibility to POS from Albany Highway	Reasonable shading to footpath
Limited seating and opportunities to gather	Proximity to park creates
Lack of street lighting	
Heavy local vehicle traffic	
 Footpaths one side only and of inadequate width – conflict with cycles and other users 	
Evidence of negative social issues (sharps disposal in POS)

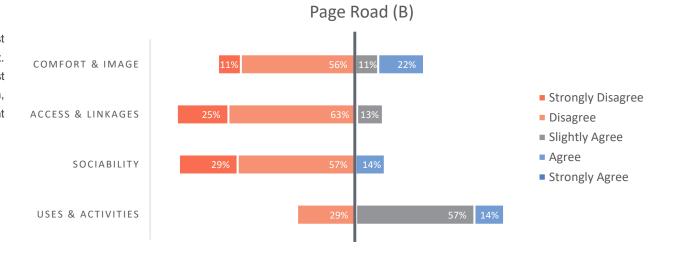
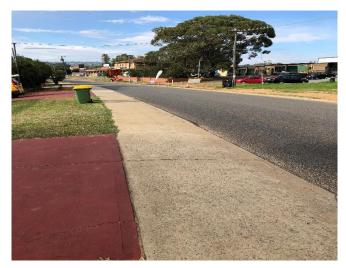
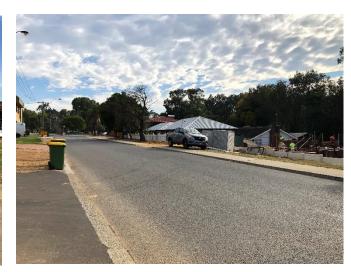
2.15 Page Road (B)

Page Road (B) includes residential land uses on the east side of the road, and commercial land uses to its west. The residential strip of housing is well maintained, whilst the commercial strip of shops are of mixed presentation, including poorly maintained frontages and vacant buildings.

Weaknesses	Strengths
 Vacant lots and inactive commercial frontages; commercial uses set back from road, behind parking - limits vitality 	 Reasonable mix of land uses Some pedestrian activity indicates potential key route
Poorly maintained front set-backs	Above average quality of housing, some new buildings
Limited street trees/shading	"Hidden" Café one of the few signs of gentrification of the area
No footpath on side adjacent commercial uses	Established trees along river visible and provides good amenity
Poor accessibility to/from Albany Hwy	
Vehicle speeds limit cycling opportunity	
Lack of opportunities for gathering

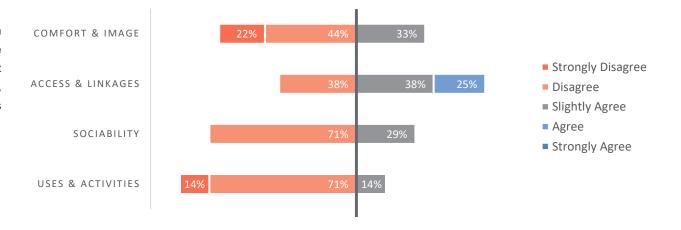
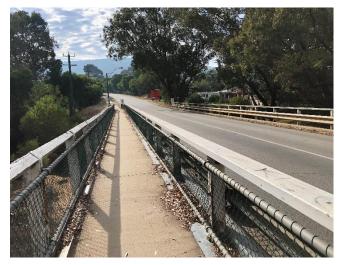
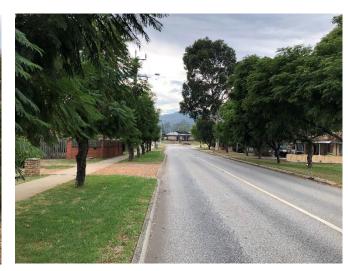
Gilwell Ave

Gilwell Avenue consists of residential land uses on both sides of the street and a heritage bridge over the Canning River. Generous setbacks and significant street trees characterise the area to the east of the bridge, however there are poorly maintained verges in places and rubbish present within the river reserve area.

Weaknesses	Strengths
Visible rubbish in river reserve	 Abundance of trees in river reserve and established street trees provide visual amenity
Poorly maintained verge (adjacent river)	Good views west to hills
Footpath one side of street only	 Key pedestrian and vehicle connection across river, linking town centre with residents and recreational uses to the east
 Single narrow footpath on bridge, potential conflict between pedestrians and cyclists on footpath 	Good accessibility and visibility of Frye Park Pavilion

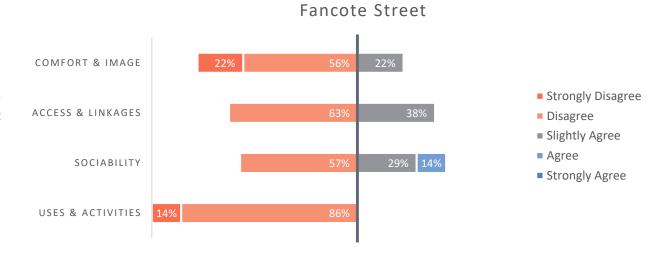
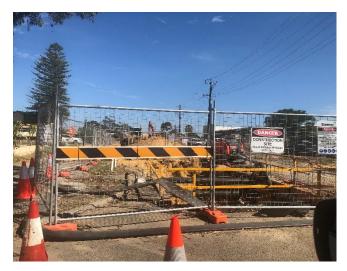
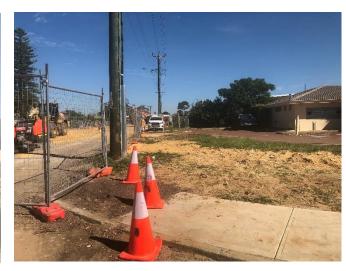
2.17 Fancote Street

Fancote Street provides a potential connection between Page Road and Albany Highway. Fancote Street was undergoing substantial roadwork construction at the time of the audit. The commercial land uses to the north of the street present a poor interface. There is limited street trees and landscaping present.

Weaknesses	Strengths
Poor built form interface to north side	Key link connecting Davis Ave underpass to river reserve
No street trees/shading	Open space at East end of street provides potential amenity

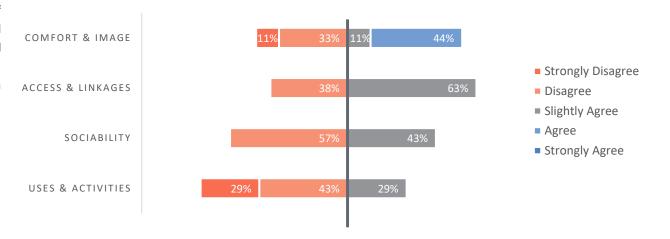
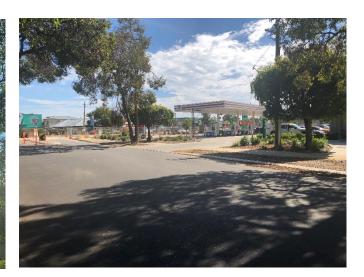
The Church Street area comprises a mix of commercial uses adjoining Albany Highway and residential properties to the east. There is a good presence of street trees and generous setbacks. There is however no presence of places to sit within shaded areas.

Weaknesses	Strengths
Poor interface with Water Corporation Kelmscott Depot	Wide verge
Poor condition of verge landscaping in some areas	Great street trees create good visual amenity
Footpath to one side of verge only	 Key route between town centre and Kelmscott Primary School, Rushton Park and church (Anglican Parish of Kelmscott)
Low intensity residential land-use

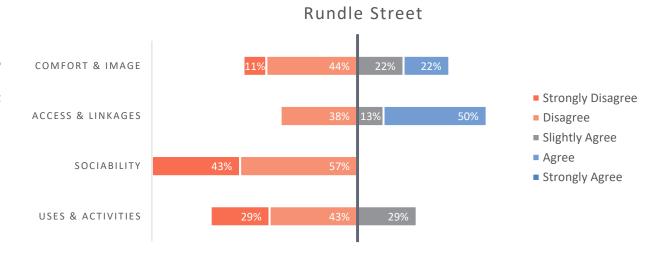
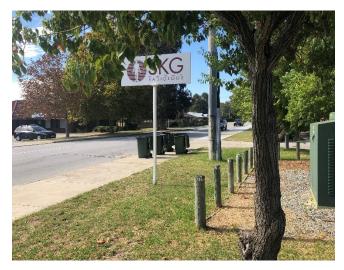
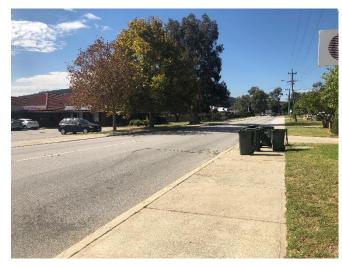
2.19 Rundle Street

Rundle Street consists of commercial uses on each of its corner with Albany Highway, with the balance of the street consisting of predominantly low-scale residential to the east. As is a consistent feature of the area, there are significant views to east (hills, trees within Kelmscott Caravan Park), with some established street trees. The Street is lacking in the provision of shade and encounters large volumes of traffic for a residential street, due to its connection to Albany Highway.

Weaknesses	Strengths
Street design encourages high vehicle speeds	Good views to east (hills, trees at Kelmscott Caravan Park)
Limited street trees/shade	Some corner activation at Albany Highway
	Some established street trees

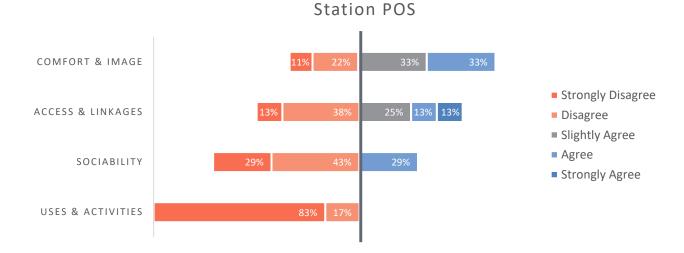
The Station POS has potential to create a soft interface respite location from the rail to Albany Highway. The Station Masters cottage provide instant character and the existing trees provide immediate shade and refuge opportunities. As it is currently fenced, it provides little public amenity in its current status.

Weaknesses	Strengths
High level of traffic noise.	 Prime access from the rail station through to Albany Highway so optimal location for POS
 Is located adjacent Albany Highway so design needs to consider pedestrian & vehicle interface 	Heavily shaded so instant appeal
Limited wayfinding	 Interesting building (Station Masters Cottage) in situ which looks as a conversion opportunity (for example a café)
 Allocated pedestrian crossing across Albany Highway is from the east on the opposite verge (south) or further north along Albany Highway from the shopping complex 	 High level of passive surveillance and ready traffic use nearby makes this location feel safe
	 Existing building with potential for heritage retrofit (similar to Goods Shed café in Claremont).
	 Key pedestrian access from each boundary and in close proximity to the train station.

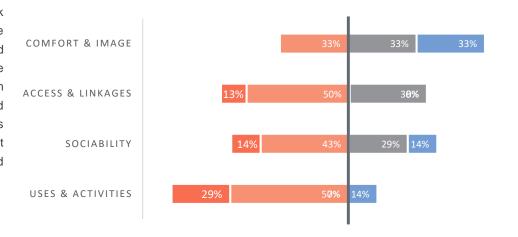
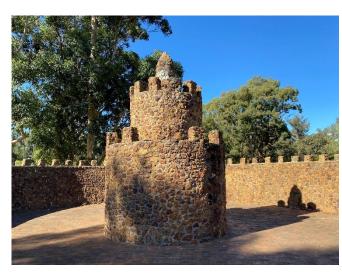
The arrival to Fancote Park along Page Rd is book ended with carparking each end on the opposite lots. Whilst there is great tree canopy, shade, and amenity appeal, the park faces the back of house of the adjacent shops with no evident path connections from outside of the park. Whilst the park is well maintained and shady, it is without a large range of activities available and the elements within the POS are not organised. There is no connection to the river and currently there is evidence of anti-social behaviour.

- The whole length of the park along Page Rd to the south faces the back of house of the shopping centre and side house fencing. There is no visual connection to Albany Highway or the activity in the town centre. Where it isn't back of house, there is low walling in need of maintenance.

- The park lacks a focus/heart. There is a confusing central stone structure with no apparent purpose. By the nature of it, it is inward facing and not connected to the broader park.

- Having the river near by without any connection is a rare but missed opportunity.
- There is no passive surveillance.
- There are 14 pole top lights throughout the park without any seeming order. Some light poles are in the middle of grass areas and not near anything in particular in some cases.

- Evidence of anti-social uses within the park. This is not a reassuring aspect to encourage use.
- Dated large play structure. Functional but aging.
- There is no pram ramp connecting from this path link to the park.

- There is a 'qateway' to the park, but no connecting pedestrian path to this from anywhere adjacent.
- Basic picnic settings and seating peppered around the park. No apparent organisation of facilitates.

- You can walk to the park from Albany Hwy but only by crossing carparking.
- Fitness equipment layout not aligned to changing 'outdoor fitness design'. Locations have no shelter or water. They are located where self-consciousness and close proximity to road doesn't appeal for use.

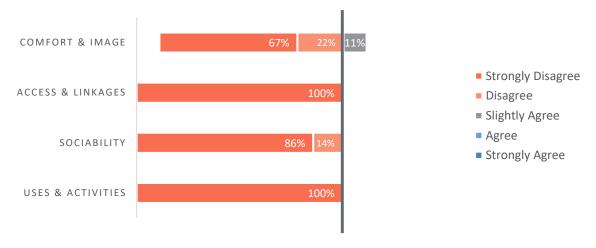
Bush Forever Site 246

The Bush forever site is situated to the rear of residential properties with the north extent bounded by Gilwell Road. The river flows through the site with the majority of vegetation is located adjacent its banks. It is denser here than in other locations where there is no vegetation at all. There is no formal infrastructure provided and pedestrian use feels discouraged.

- No amenity. Located back of house
- Rubbish evident and detracting from general sense of maintenance investment.
- Not fully vegetated.
- No passive surveillance and feels unsafe.
- No infrastructure
- There is access off Gilwell Ave however the majority of the Bush Forever site is beyond housing with no public access.

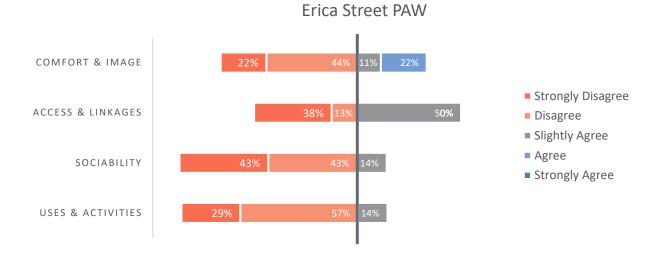
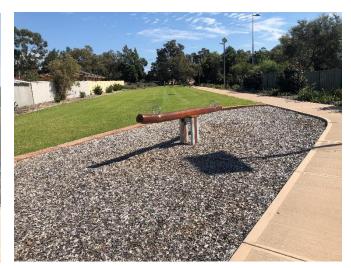
3.4 Erica Street PAW

Erica Street PAW has been elevated in use by the play elements clustered at the eastern end of the PAW. It is tidy and well maintained but only provides a true connection to a quiet residential street. There are no connecting paths beyond the one located in the POS. The lack of shade would detract from use.

Weaknesses	Strengths
Limited shade	There is clear visibility within this PAW
 Limited traffic at entry points No connection of footpath to adjacent paths PAW doesn't lead to anywhere in particular 	 Primarily the elements (low key play & basketball half court) encourage use within the PAW beyond pedestrian thoroughfare
	Limited passive surveillance but doesn't feel unsafe
	 Whilst still basic, it is a positive attempt to be more engaging with any public park provision
	Clear access from Streich Ave to Erica Street
