## Appendix E: Tree Retention Strategy

# APPENDIX A - ARBORICULTURAL SURVEY

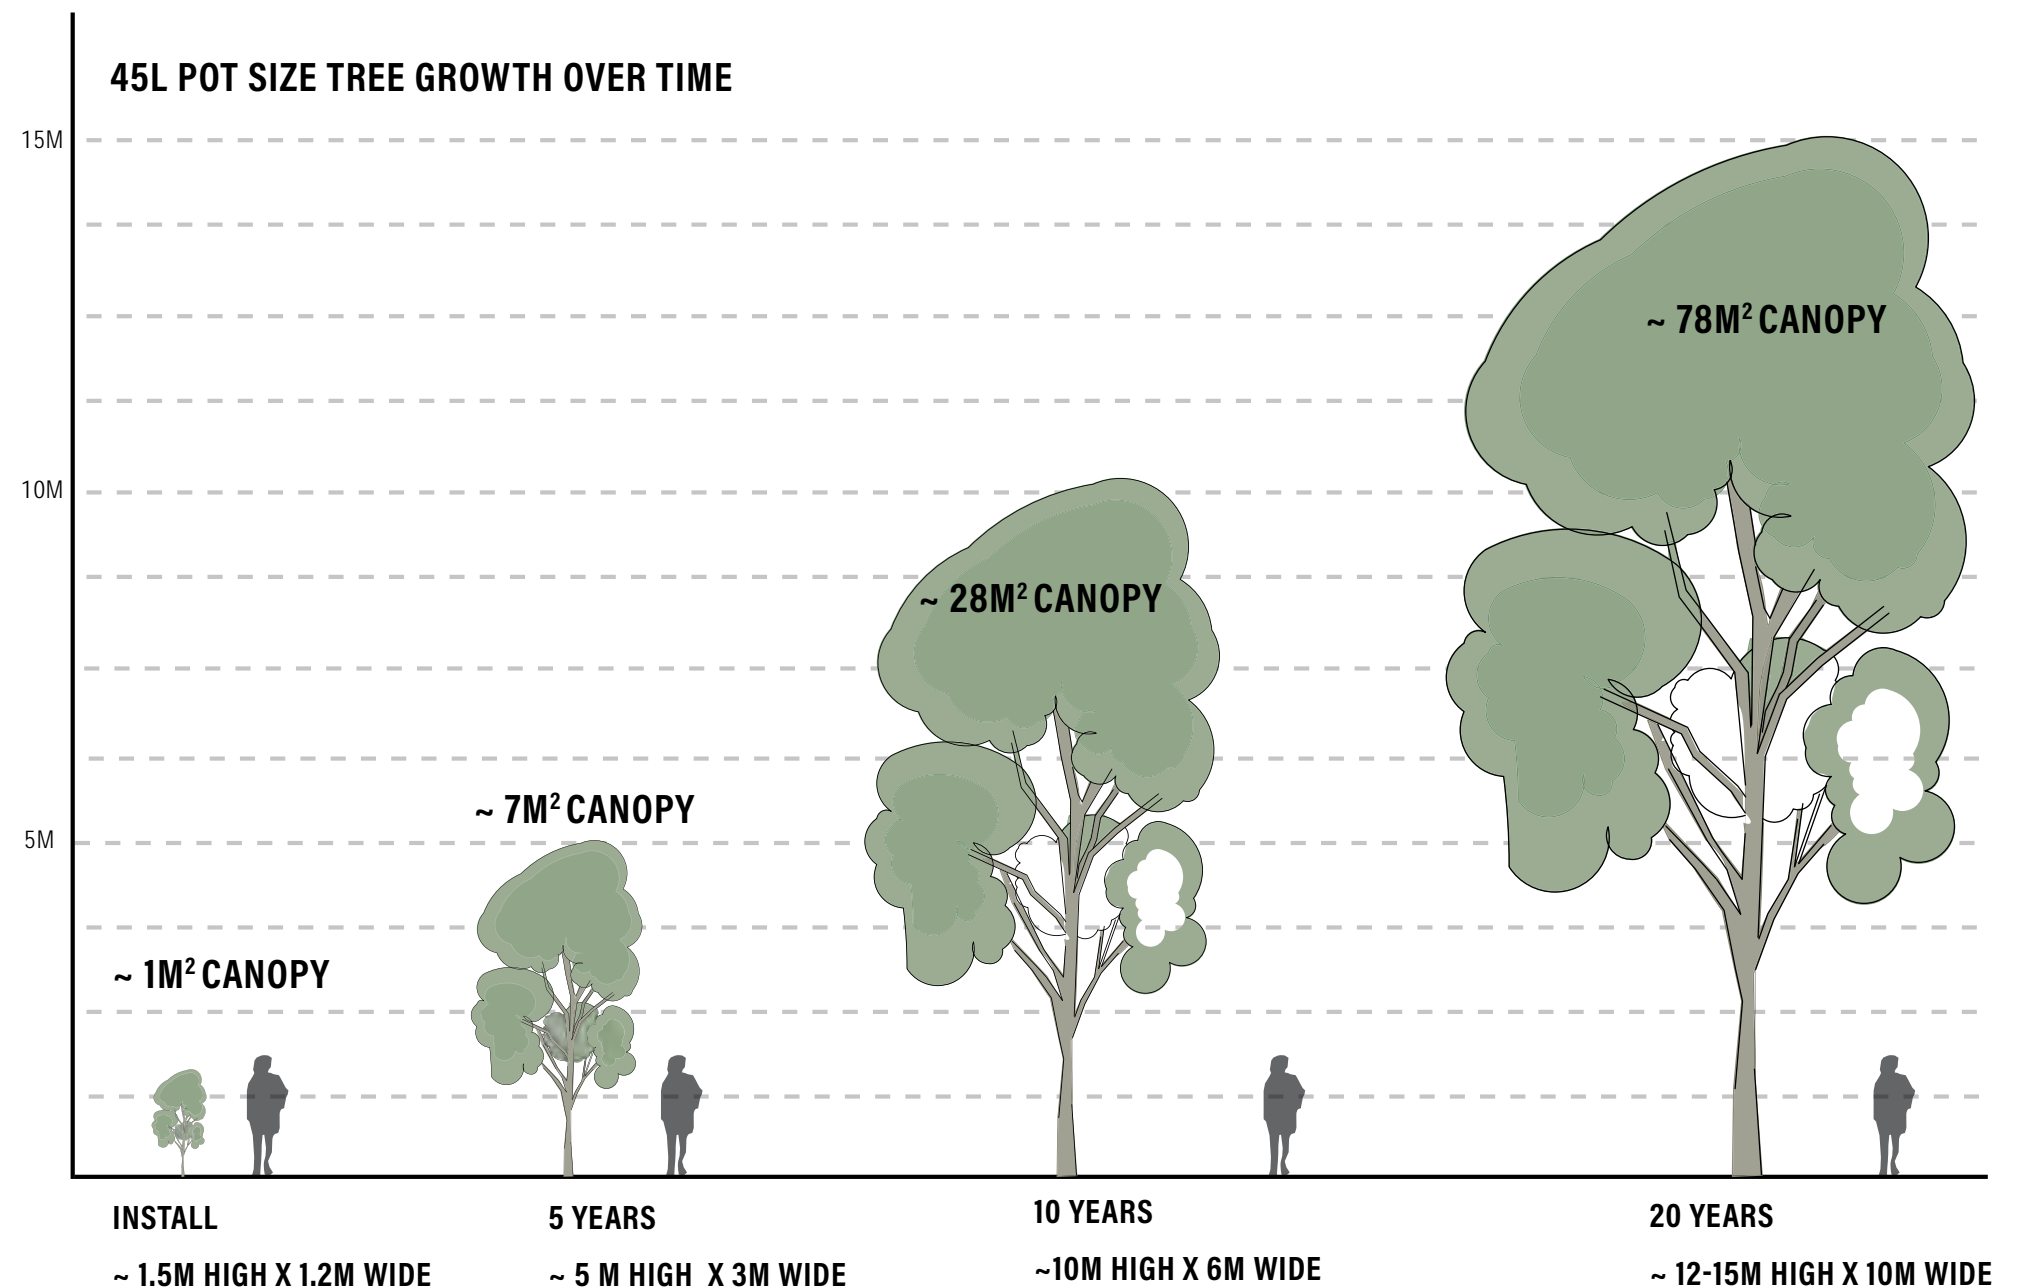
FIGURE 6. 45L TREE PROJECTED GROWTH OVER TIME FOR USE IN CANOPY MODELLING. SIZES DETERMINED BY PERSONAL OBSERVATIONS BY PROJECT ARBORIST AND LANDSCAPE ARCHITECT.

Canopy modelling calculations were developed based upon the projected average growth of the proposed tree species and sizes projected sizes at different times by the Project Arborist and Landscape Architect based upon personal observations of tree growth of various species in similar conditions (refer to Figure 8 as example for 45L).

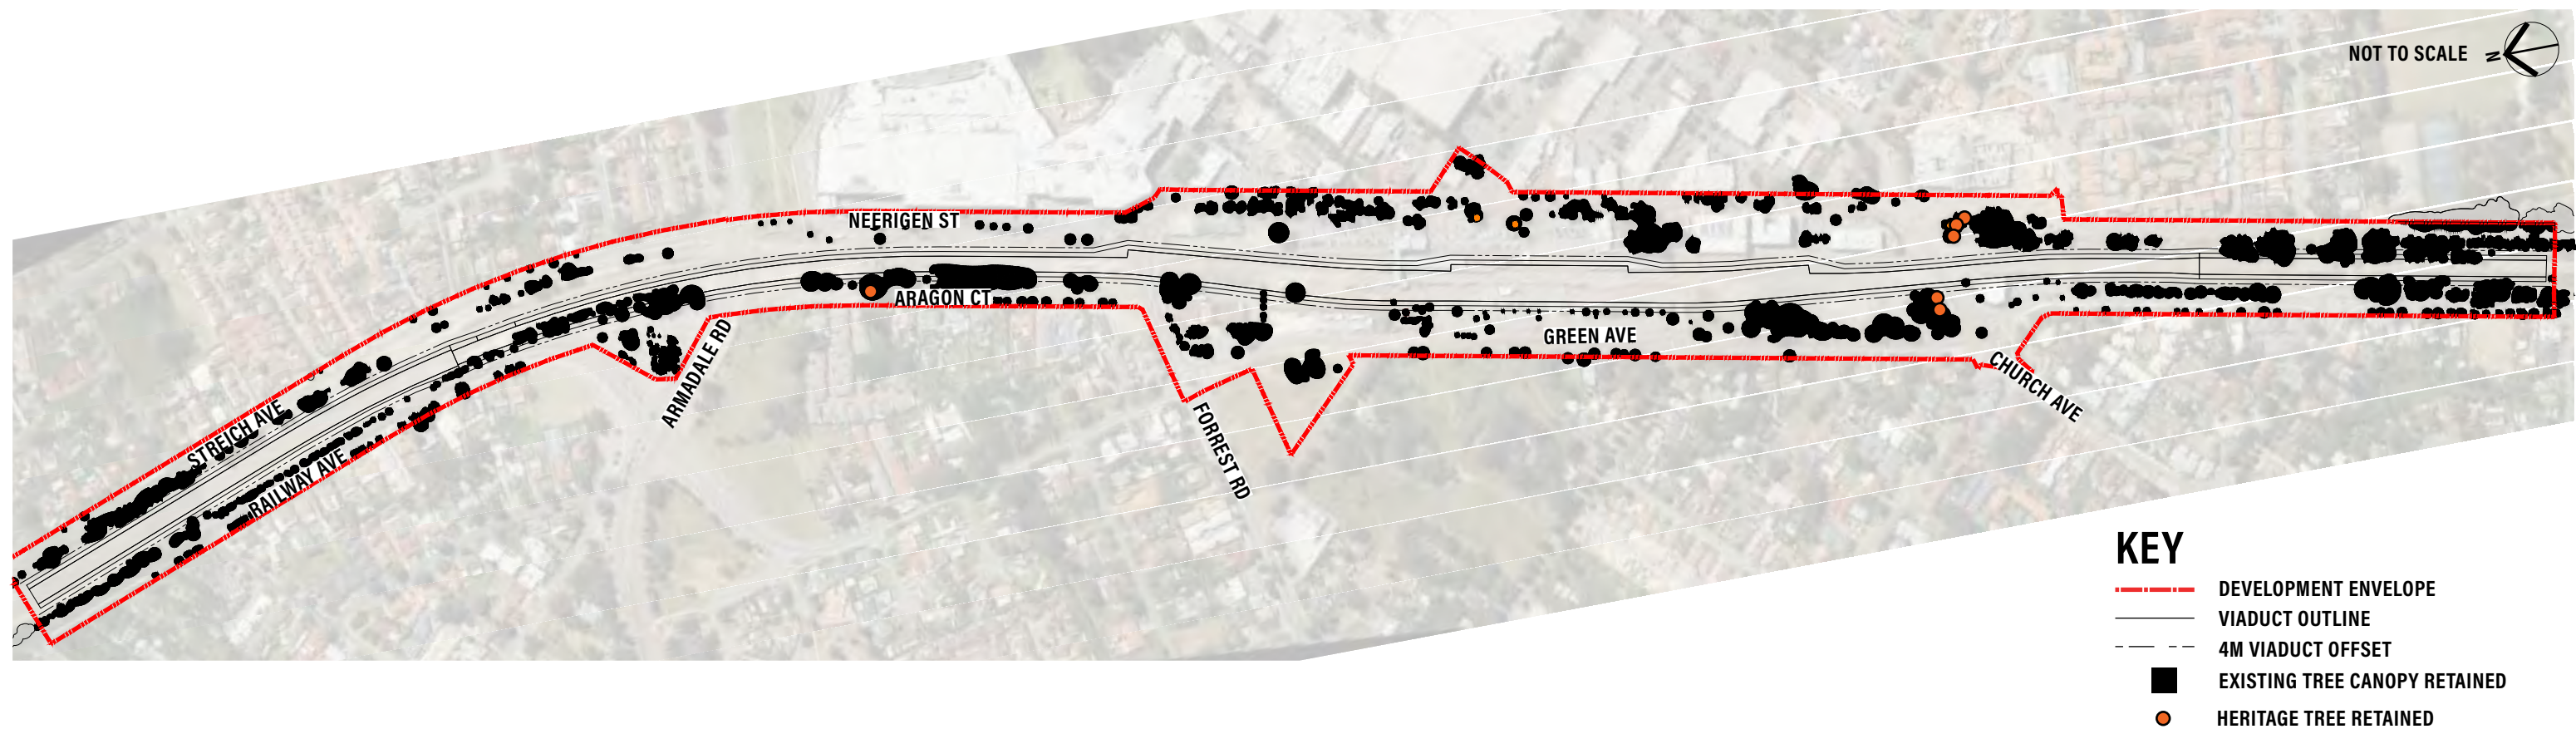
**~18.78% CANOPY COVERAGE WITHIN DEVELOPMENT ENVELOPE**

FIGURE 7. EXISTING BASELINE CANOPY WITHIN THE DEVELOPMENT ENVELOPE

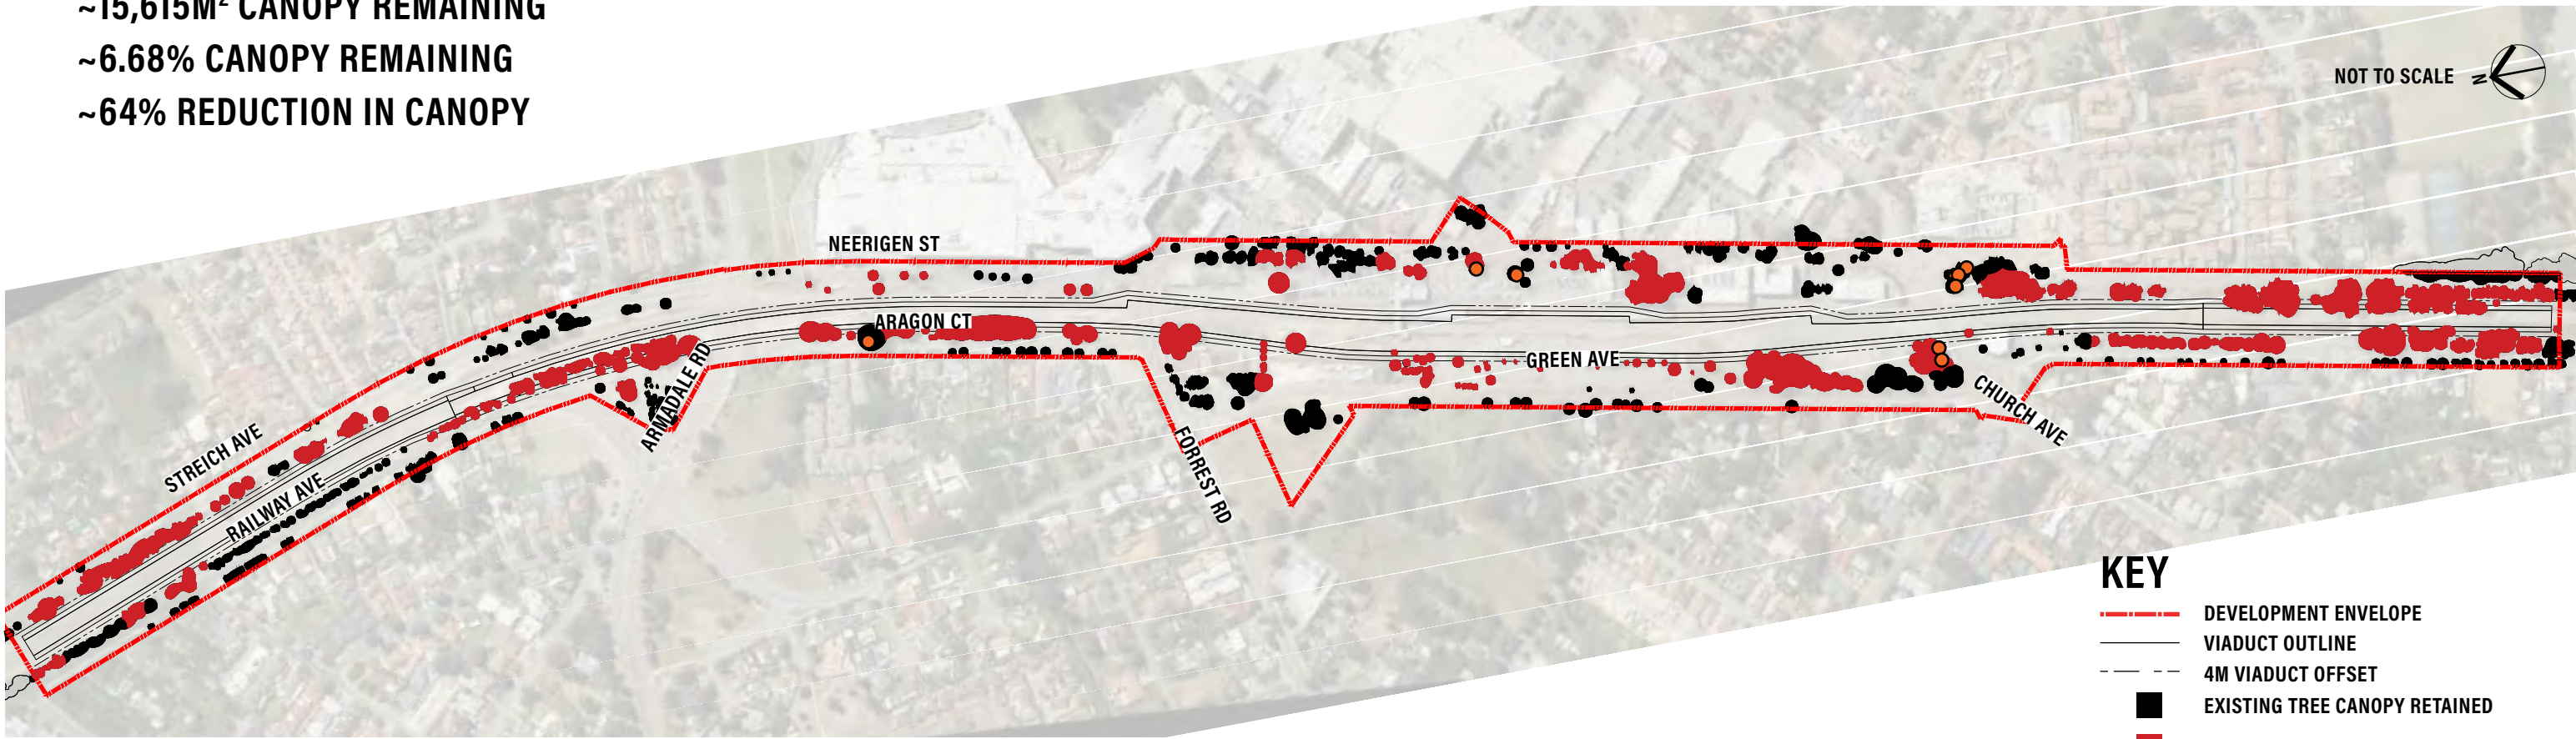
~15,615M<sup>2</sup> CANOPY REMAINING  
~6.68% CANOPY REMAINING  
~64% REDUCTION IN CANOPY

FIGURE 8. ORIGINAL PROPOSED CANOPY REMOVAL PRIOR TO

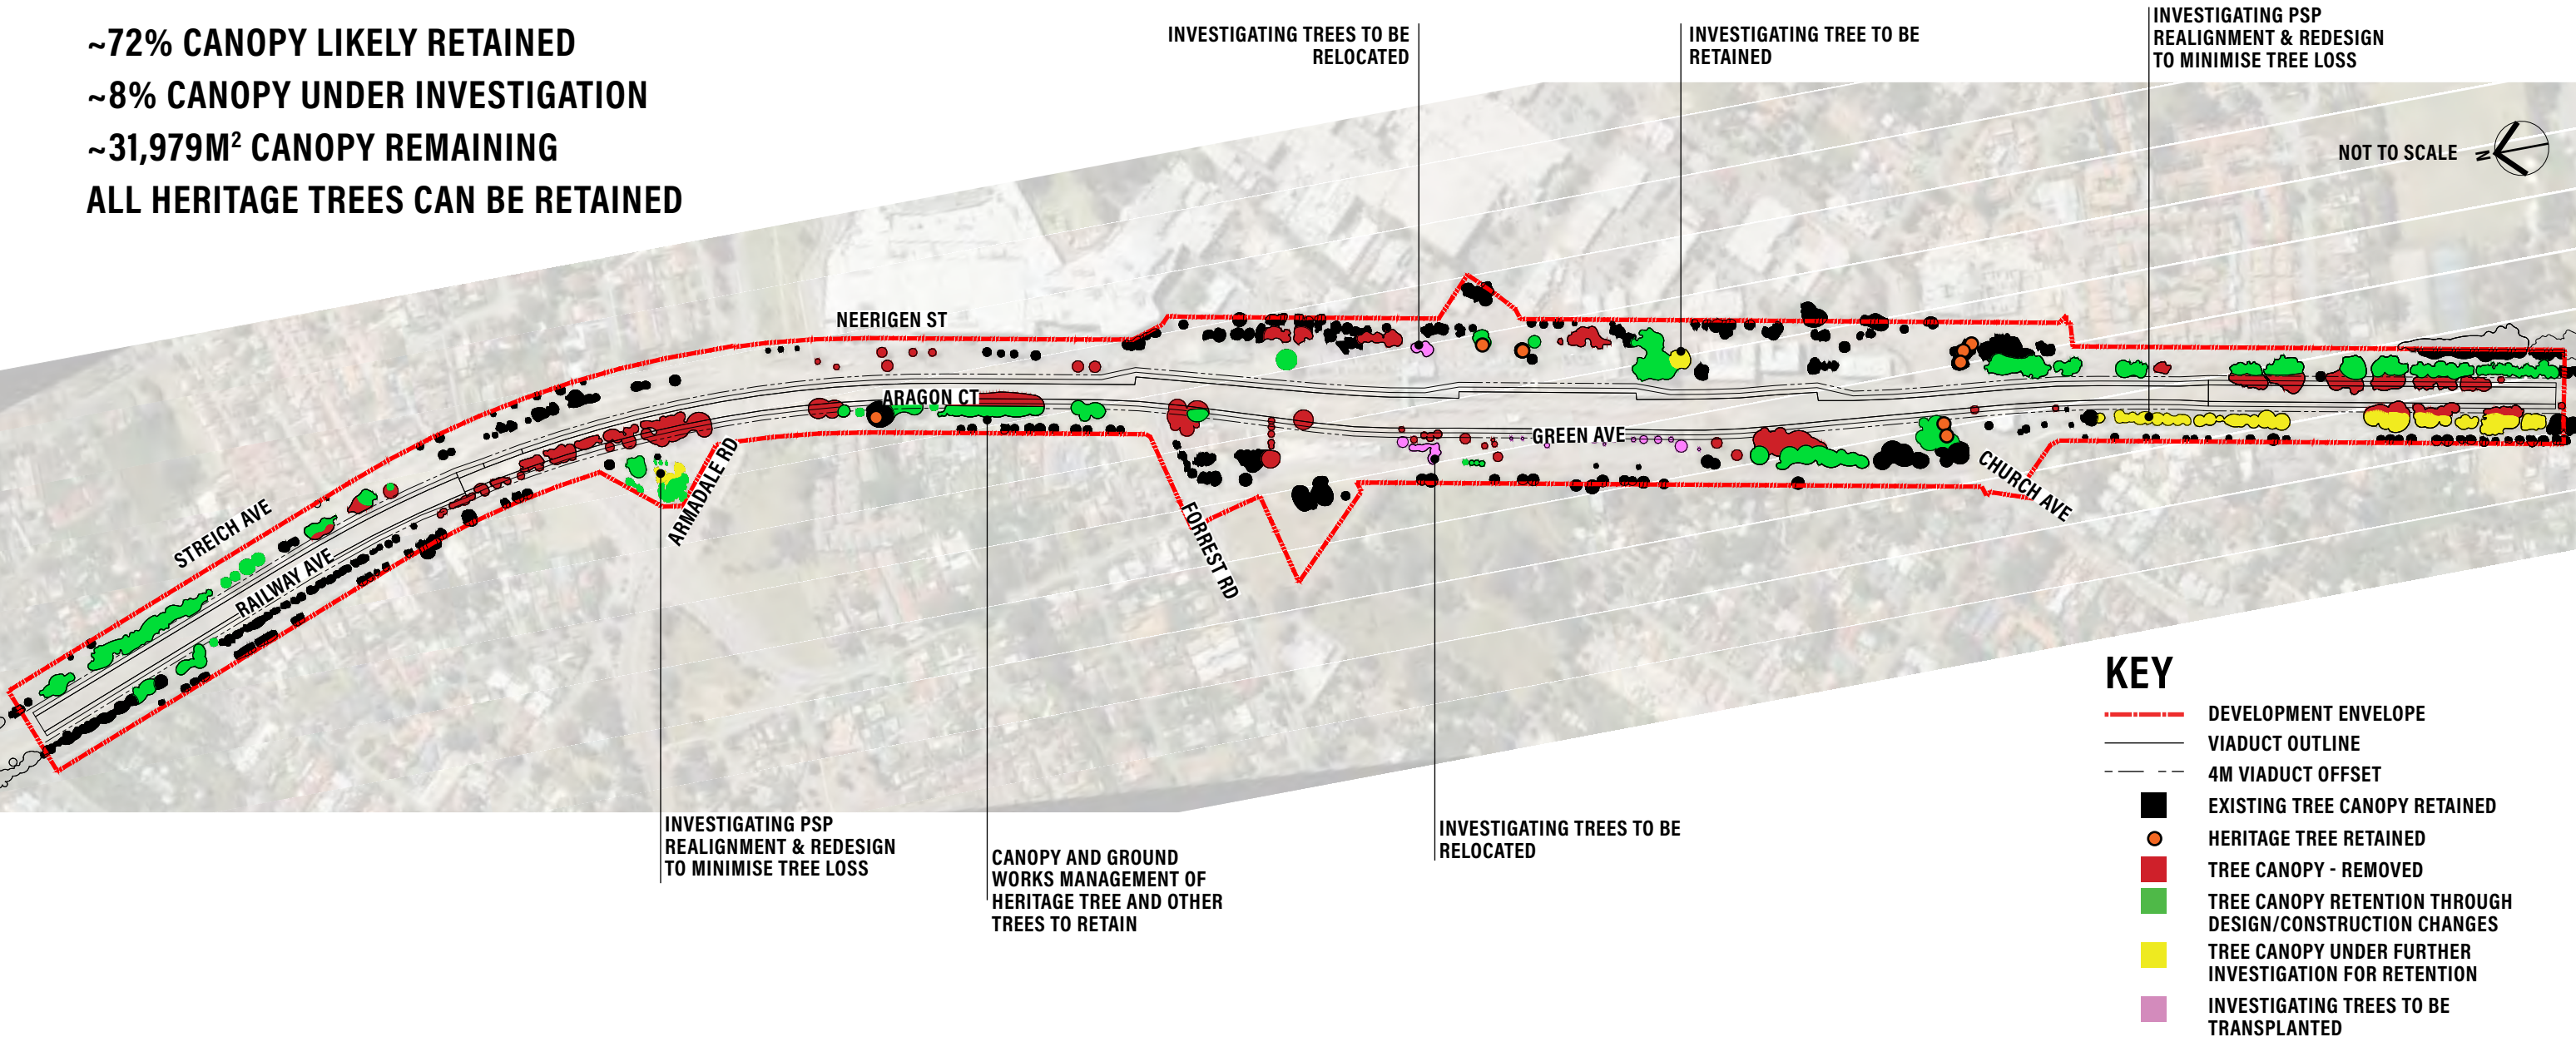
- ~72% CANOPY LIKELY RETAINED
- ~8% CANOPY UNDER INVESTIGATION
- ~31,979M<sup>2</sup> CANOPY REMAINING
- ALL HERITAGE TREES CAN BE RETAINED

FIGURE 9. IMPROVEMENTS TO CANOPY RETENTION

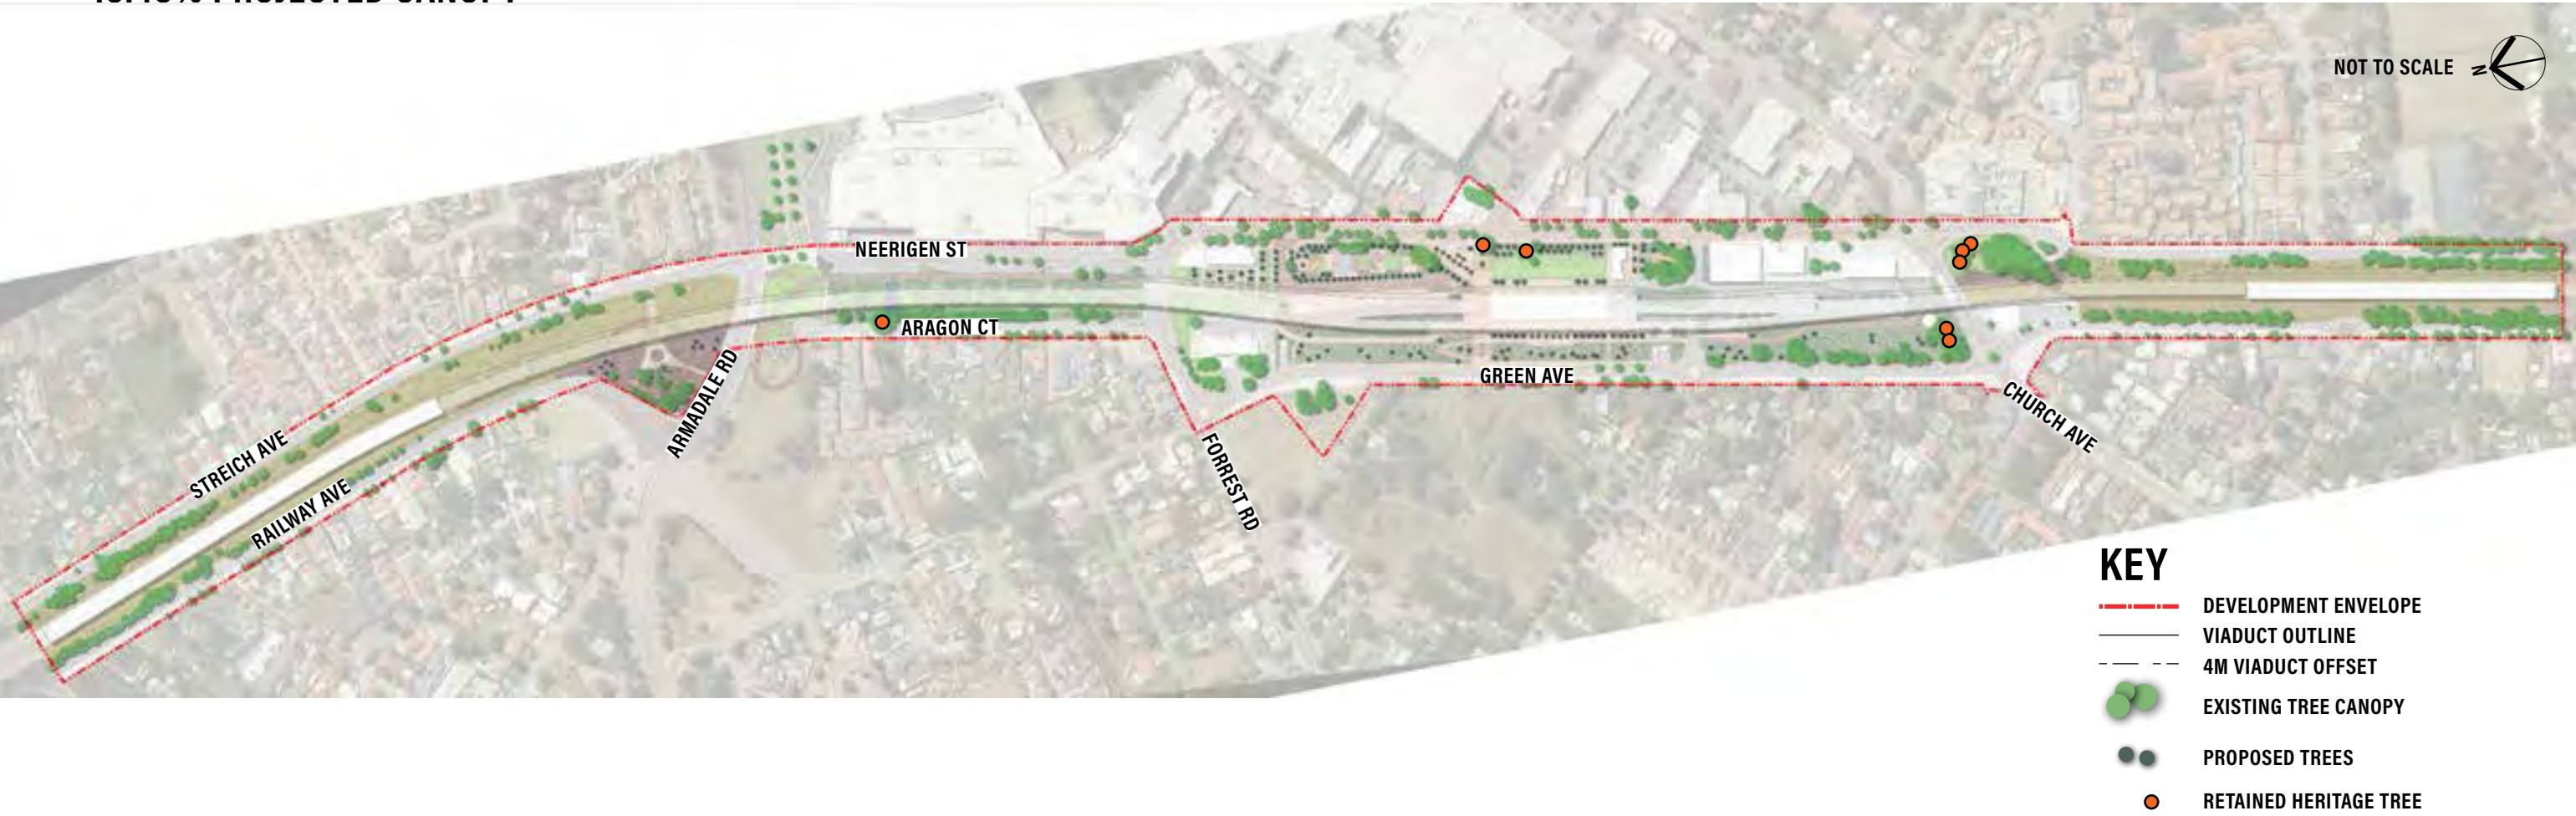
**~36,6579M<sup>2</sup> PROJECTED CANOPY**  
**~15.48% PROJECTED CANOPY**

FIGURE 10. LIKELY CANOPY PROJECTION AT DAY 1

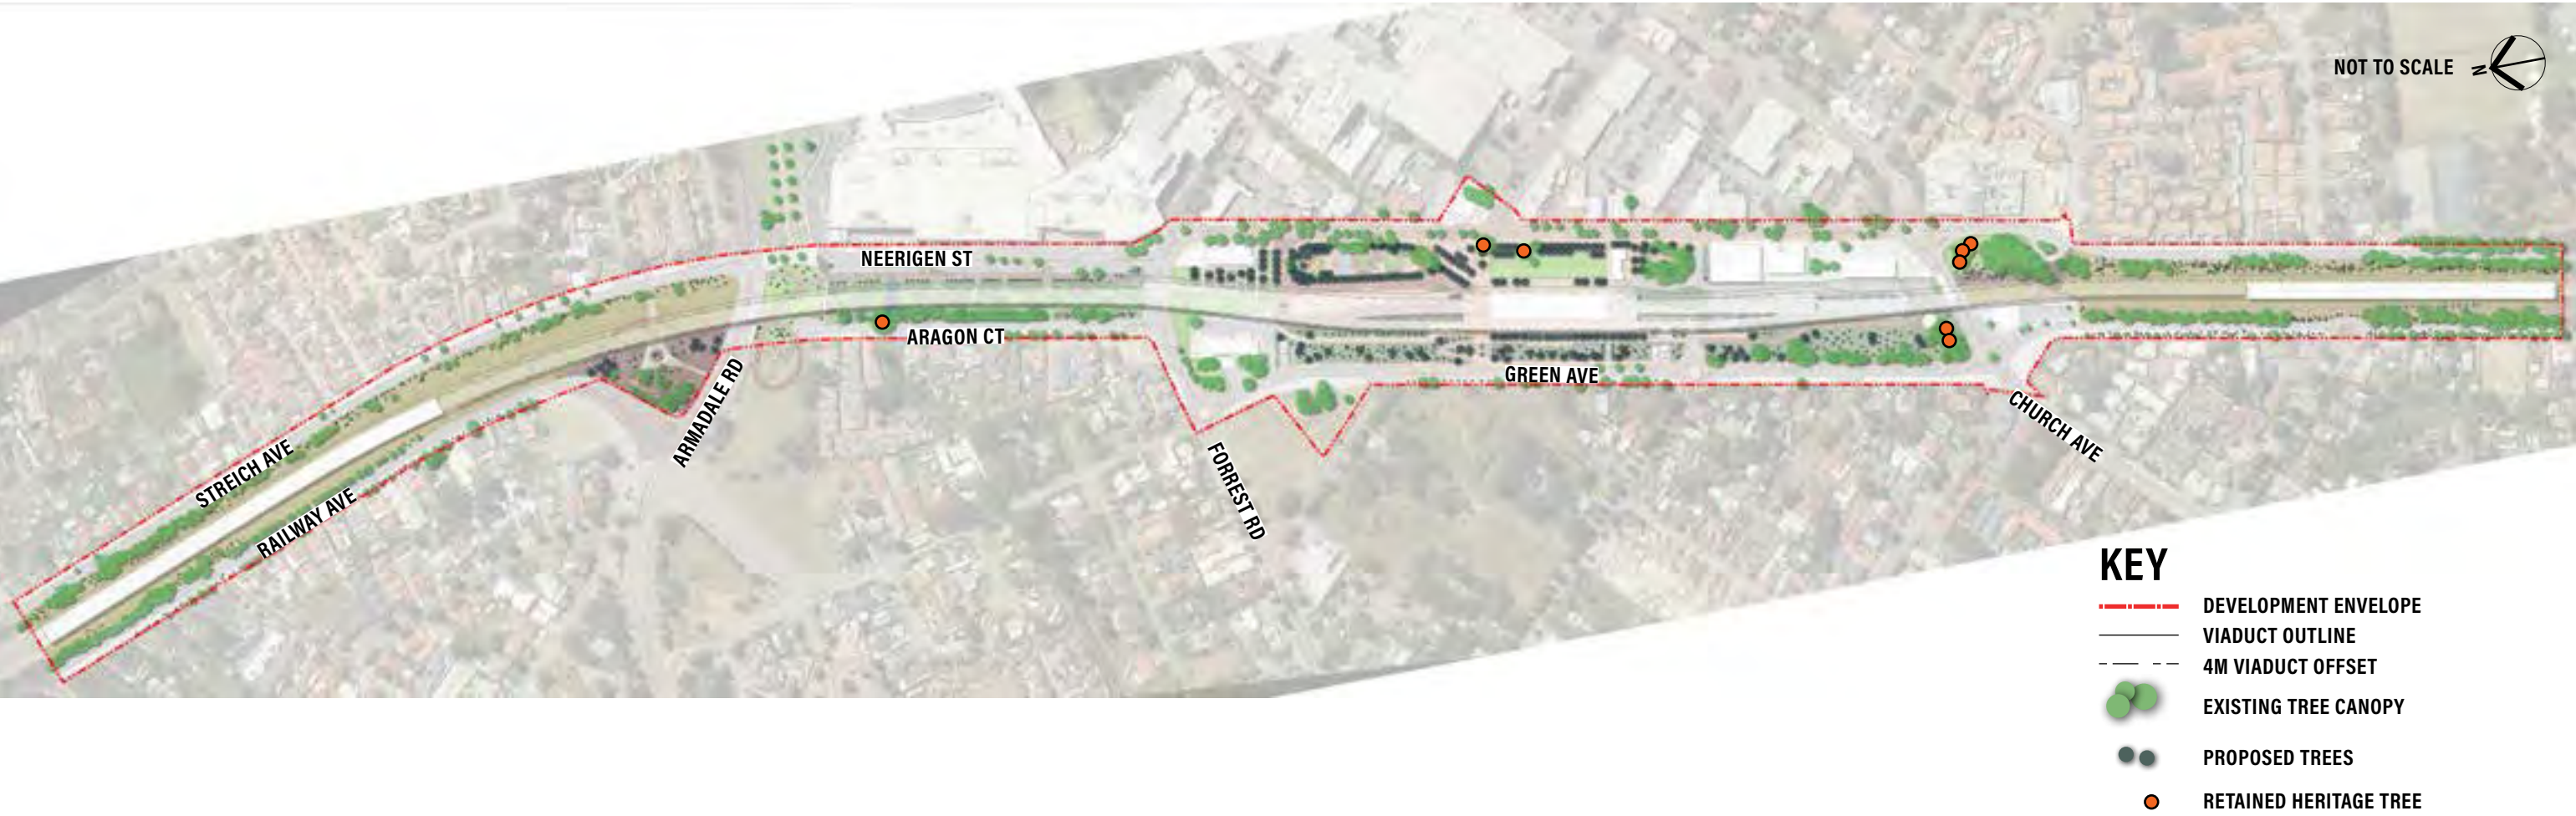
~ 47,578M<sup>2</sup> PROJECTED CANOPY  
~ 20.14% PROJECTED CANOPY

FIGURE 11. LIKELY CANOPY PROJECTION YEAR 5

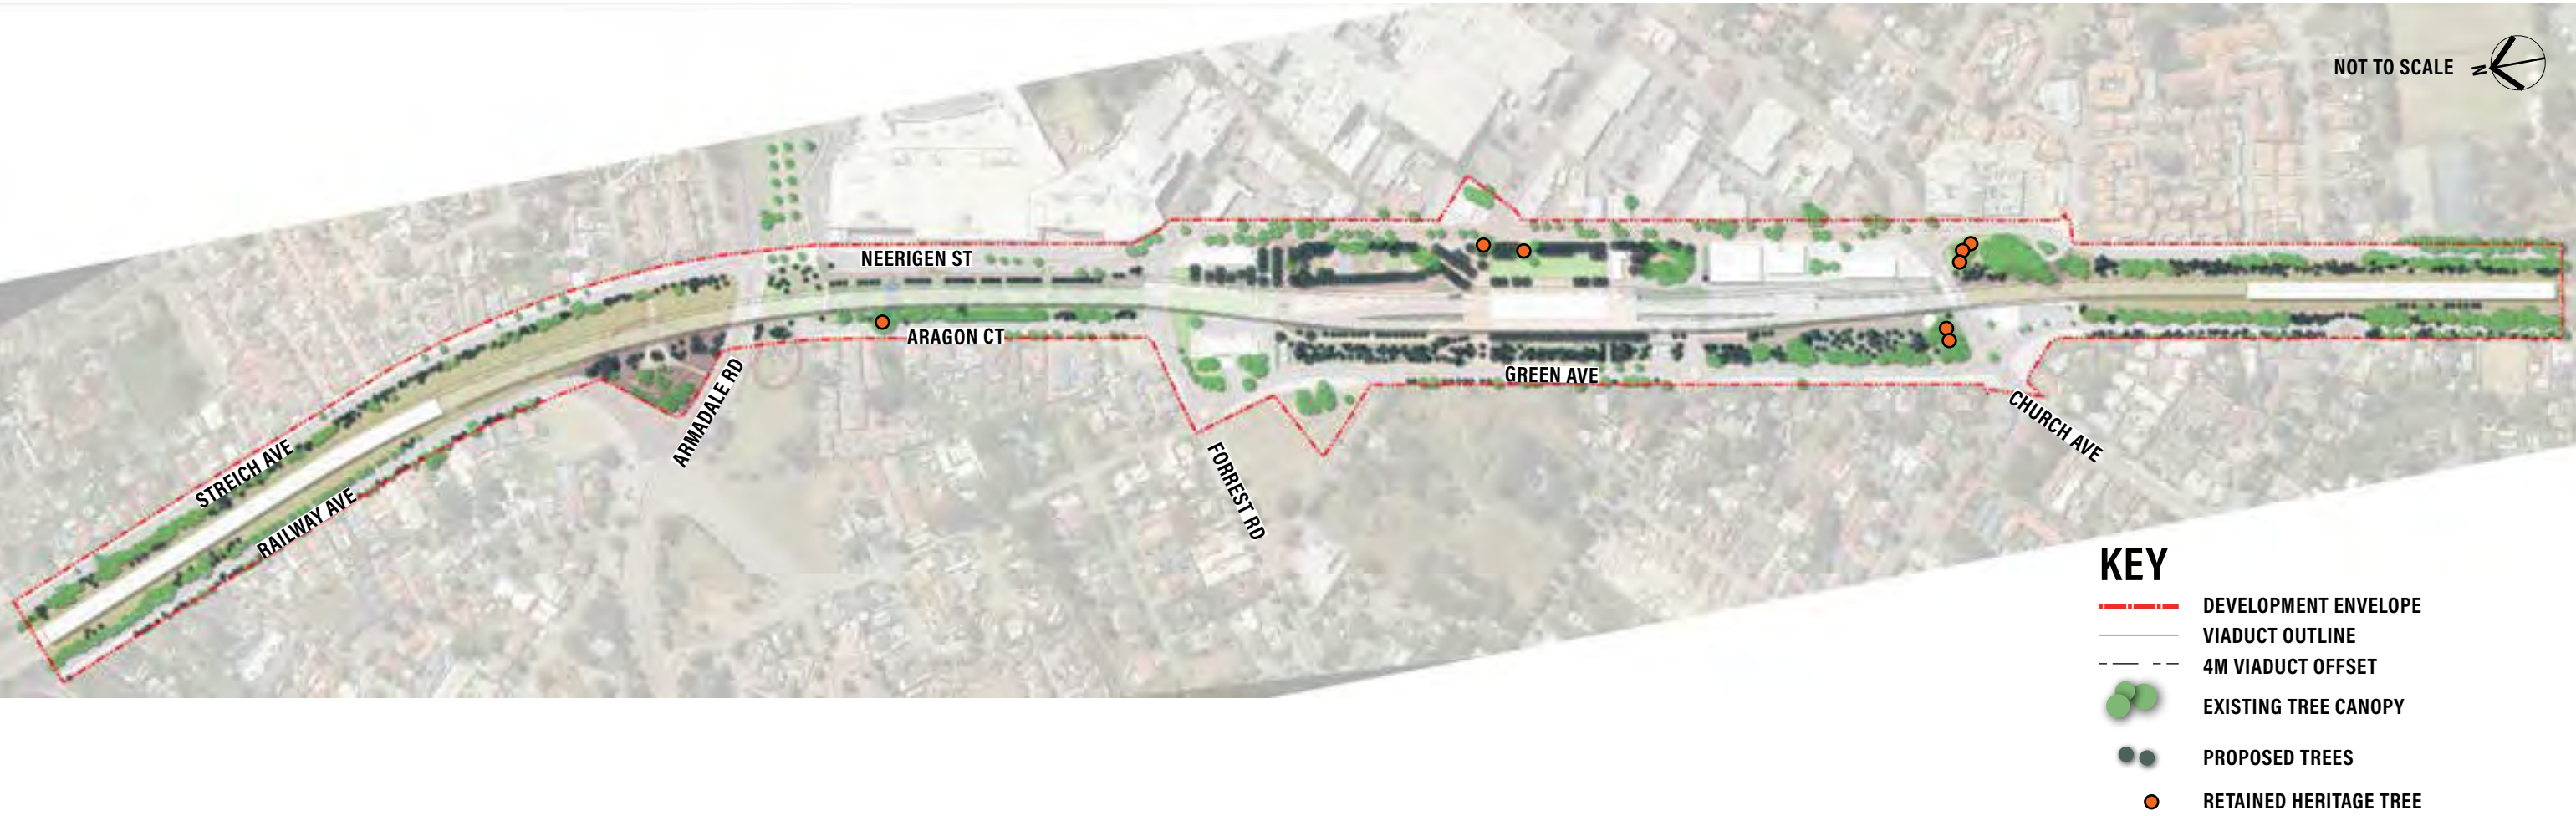
~ 69,979M<sup>2</sup> PROJECTED CANOPY  
~ 29.62% PROJECTED CANOPY

FIGURE 12. LIKELY CANOPY PROJECTION YEAR 10

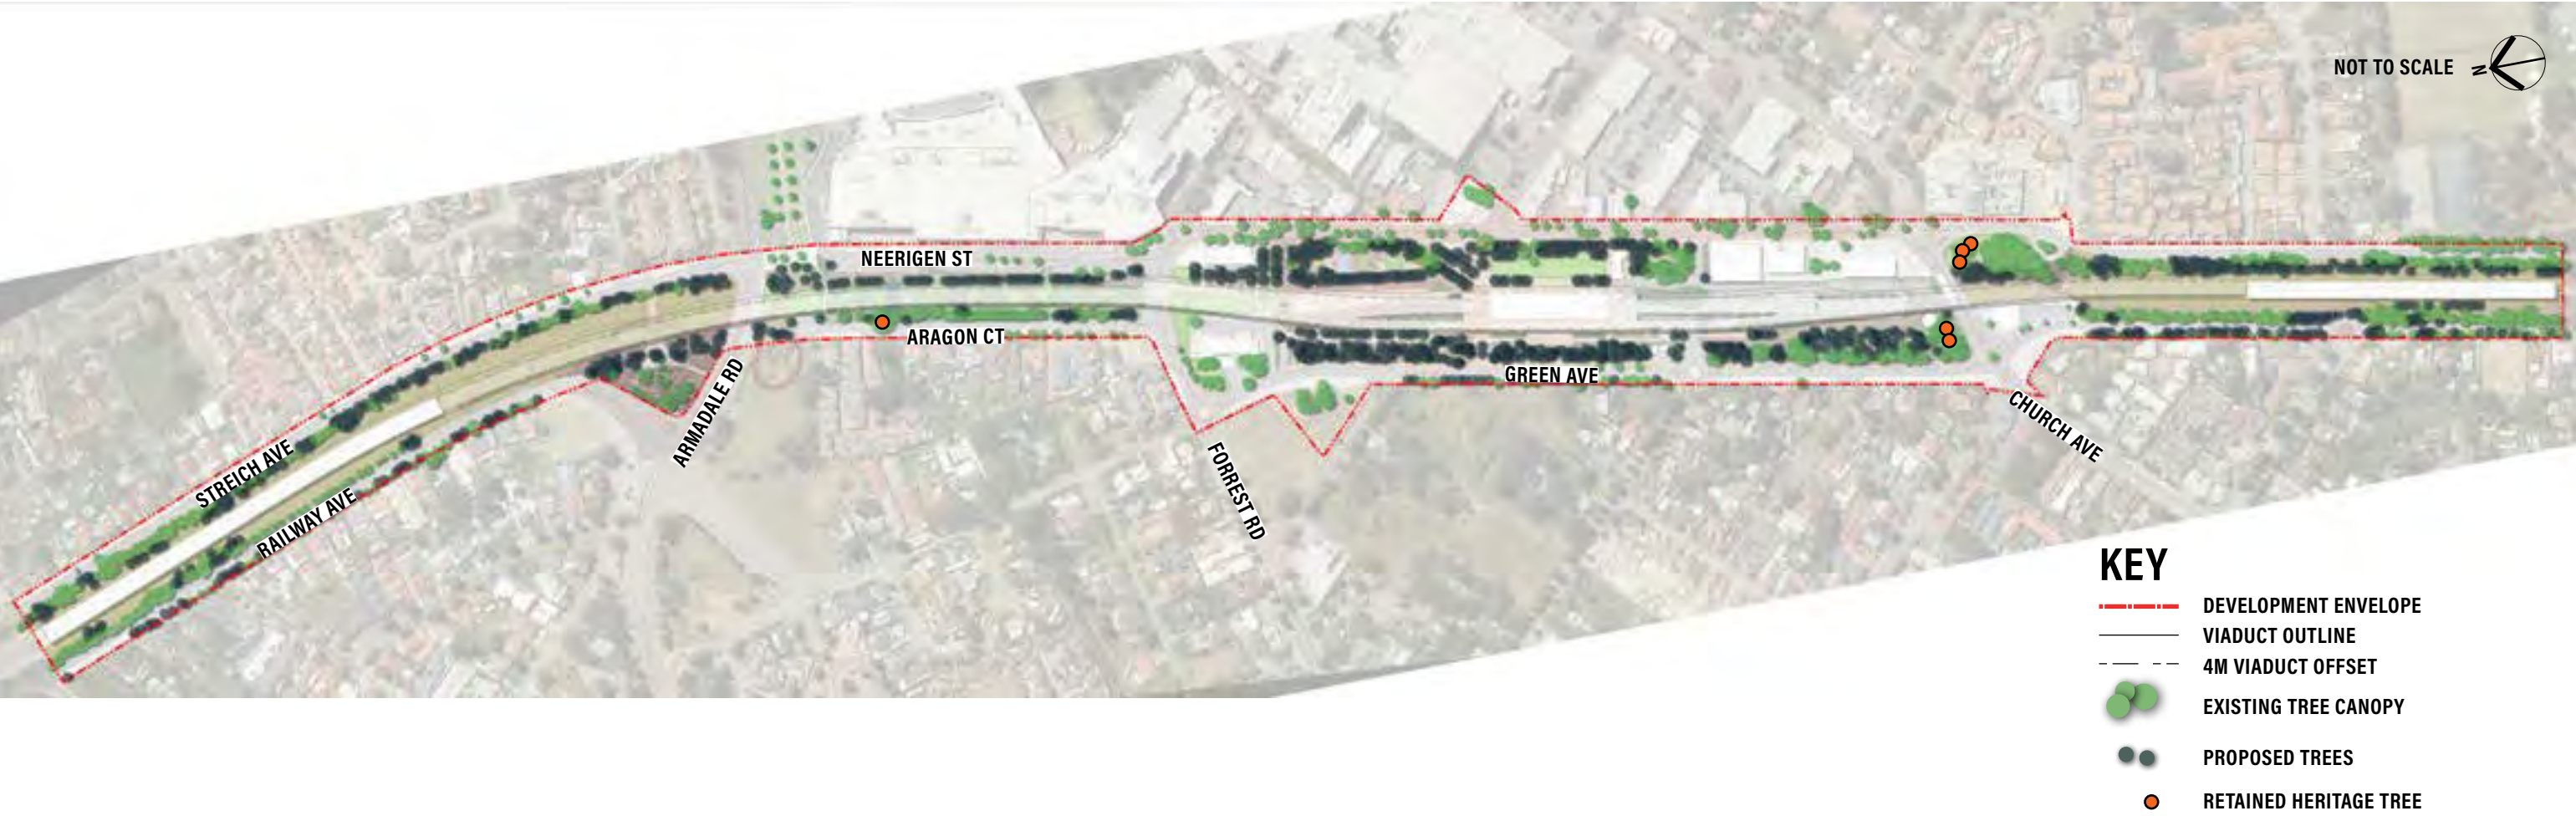
~ 76,036M<sup>2</sup> PROJECTED CANOPY  
~ 32.18% PROJECTED CANOPY

FIGURE 13. LIKELY CANOPY PROJECTION YEAR 20

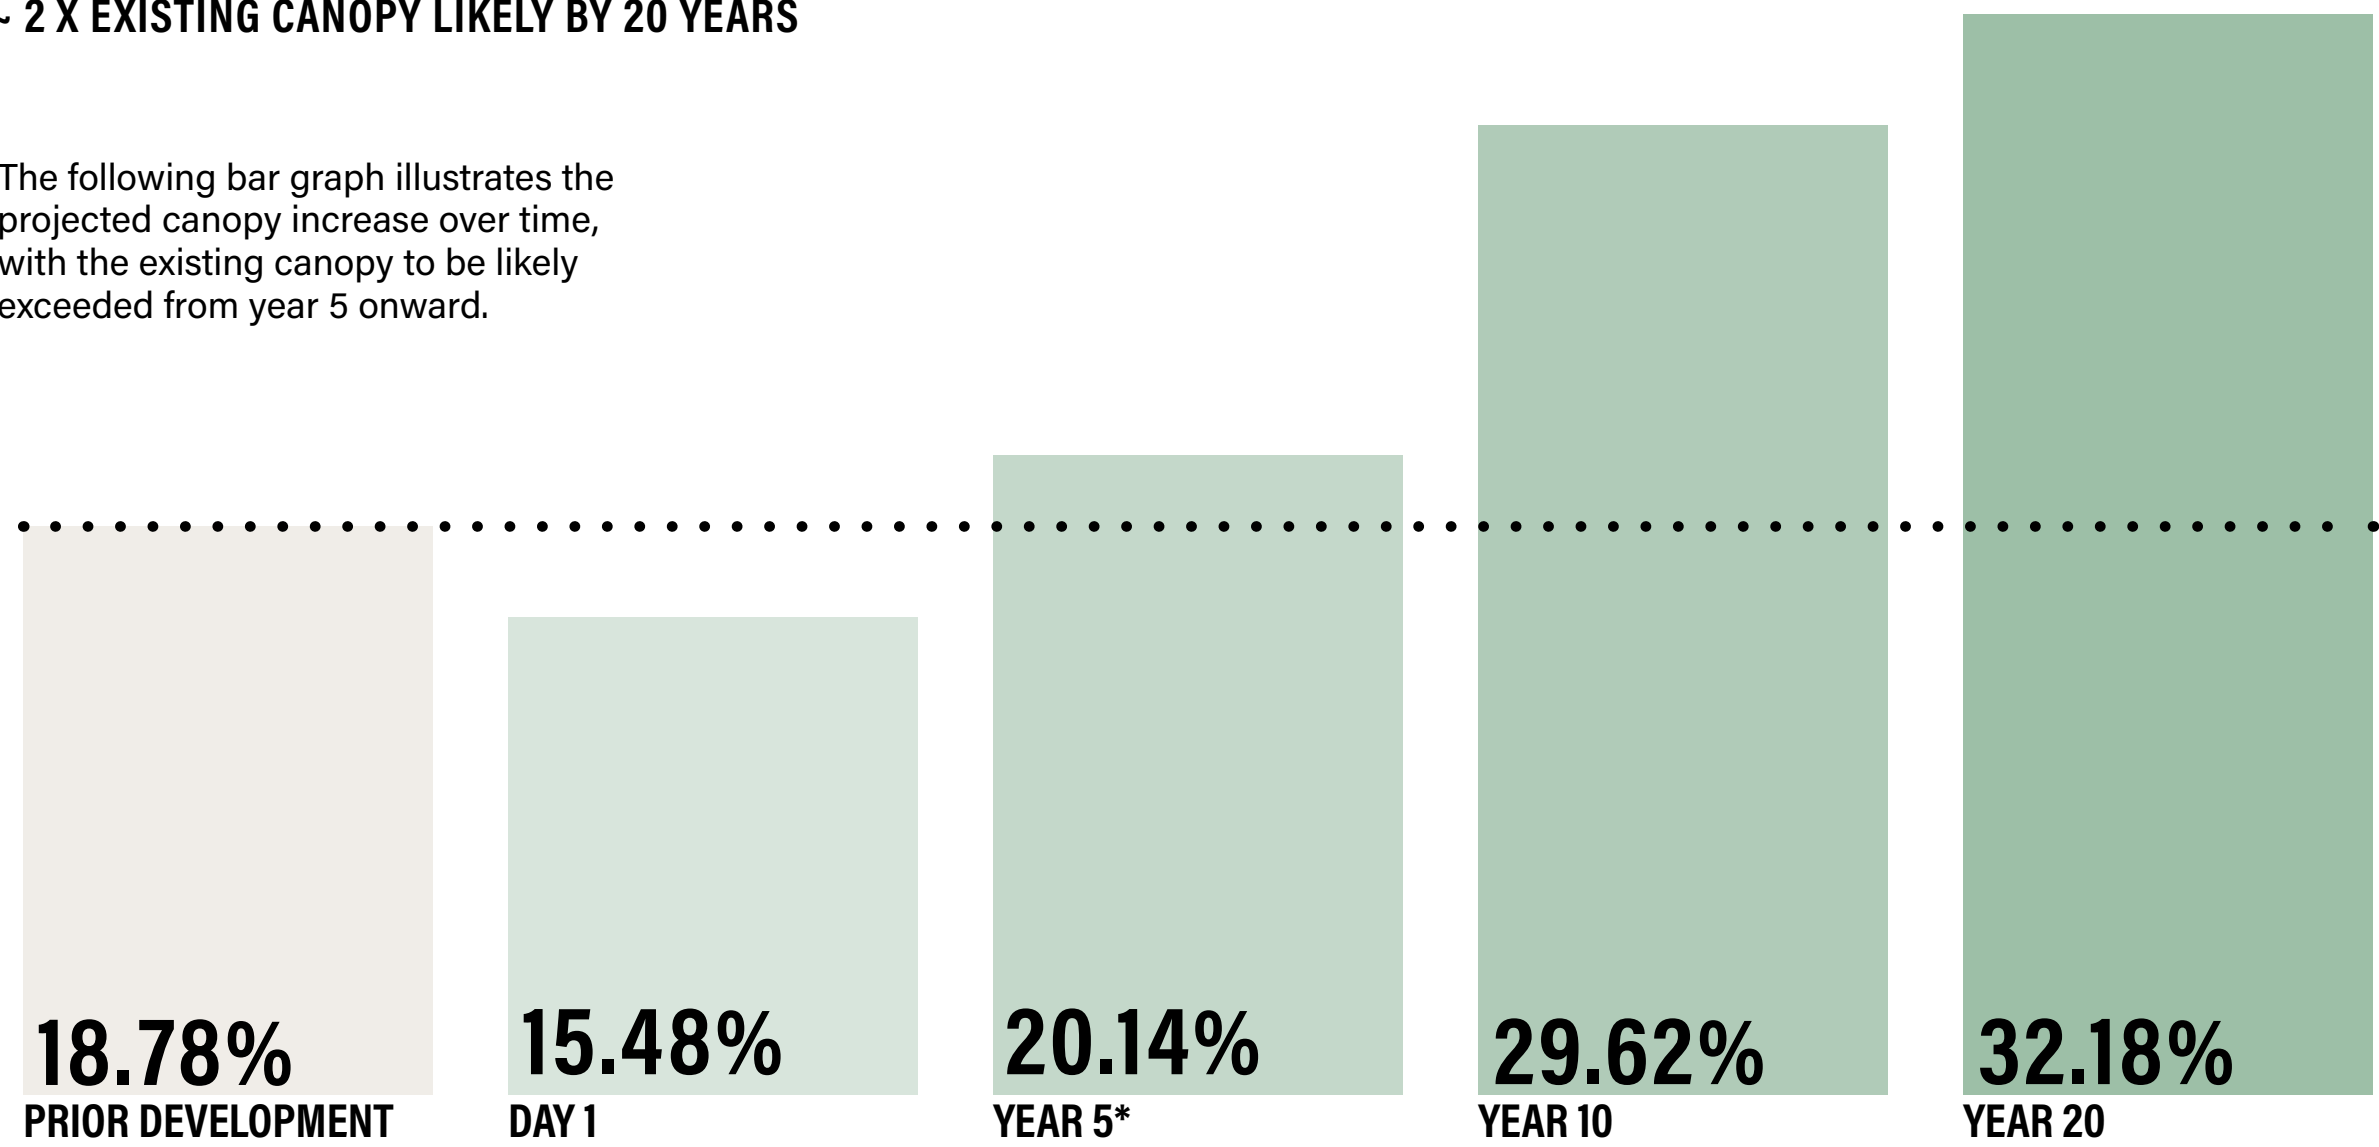
The following bar graph illustrates the projected canopy increase over time, with the existing canopy to be likely exceeded from year 5 onward.

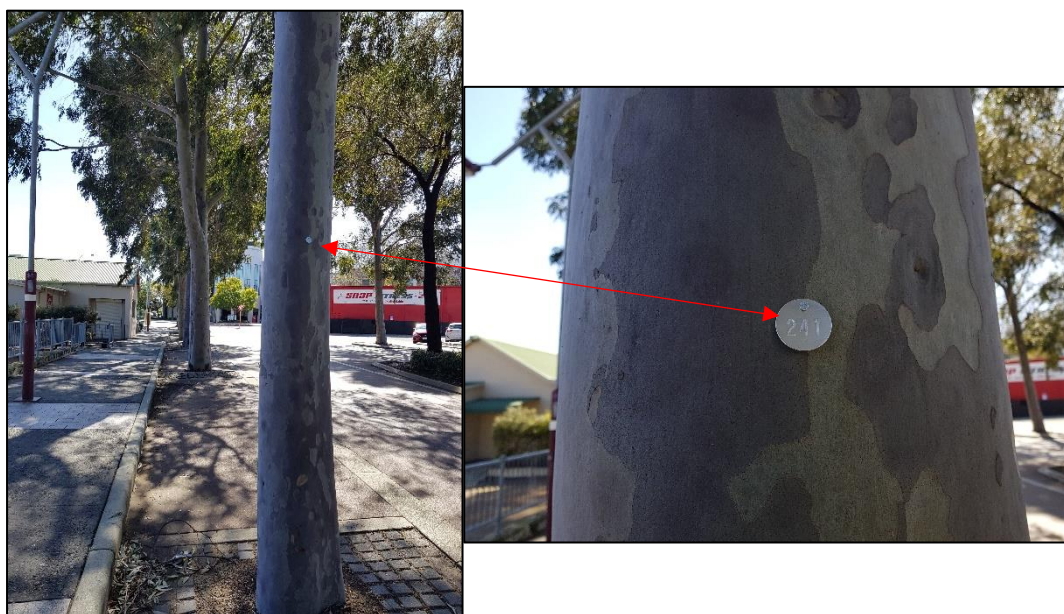
Figure 2. Showing metal tree tag and numbering of the identified trees installed approx. 1.5 meters from ground level

- A total of x 418 trees were assessed as part of the proposed MetroNet Armadale Station Precinct development - refer *Appendix A Tree Location and Numbering Map* & *Appendix B Table of Results* for detail.
- All identified Trees have aluminium number tags installed at approximately 1.5 metres from ground level on main stems – refer figure 2 for example of tags utilised for the project.

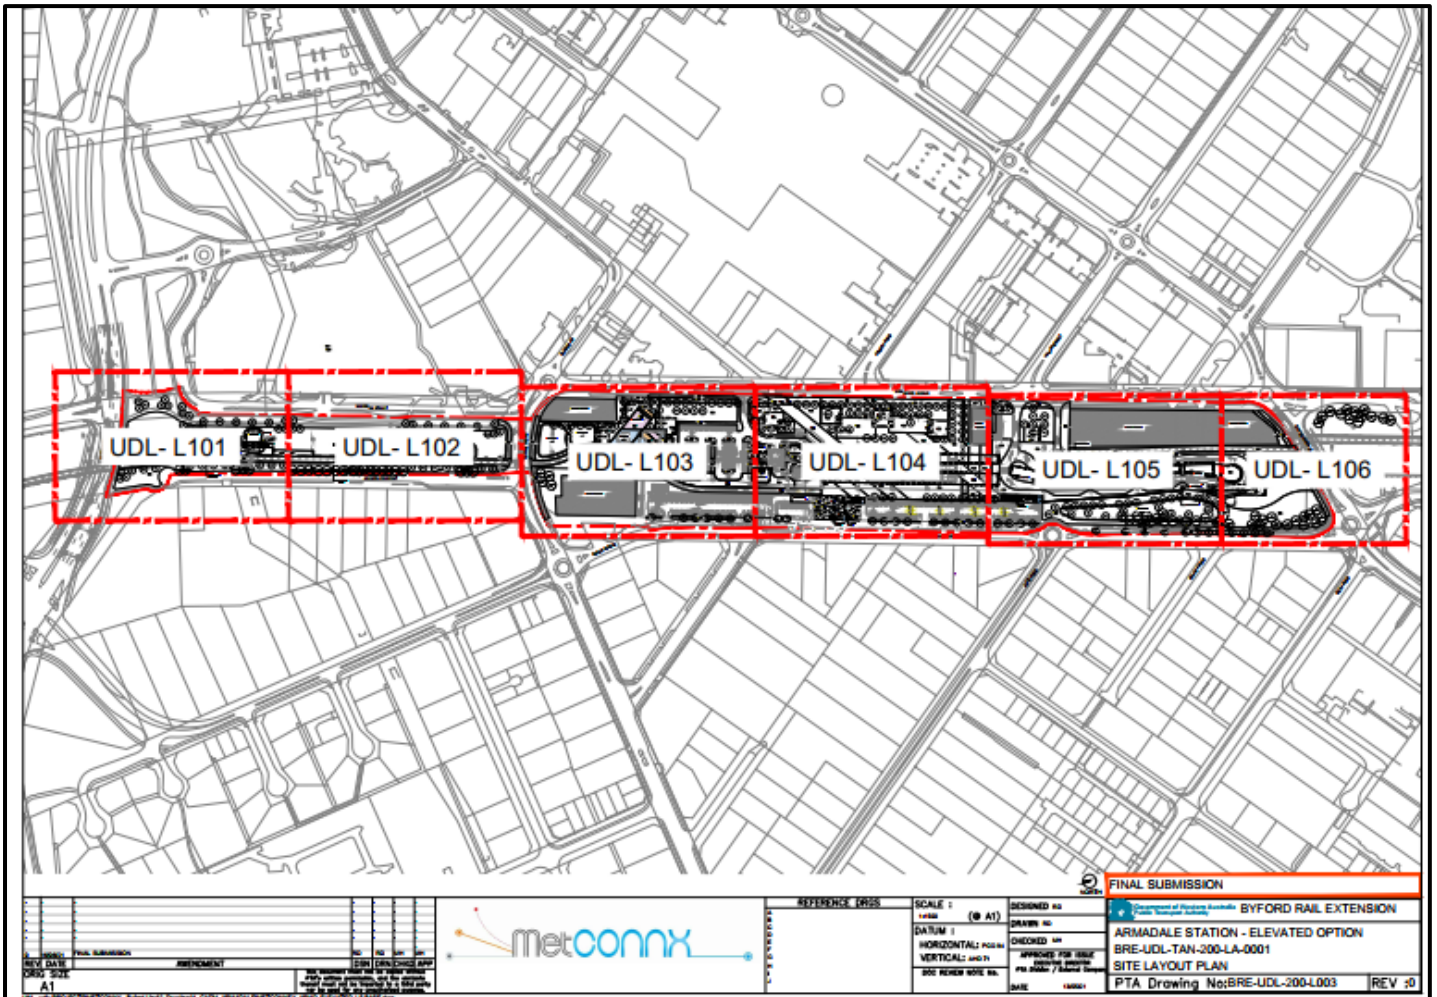
Figure 3. Metconnx Drawings Armadale Station – Elevated Option BRE-UDL-TAN-200-LA-0001 Rev 0
