## Appendix E: Tree Retention Strategy

# APPENDIX A - ARBORICULTURAL SURVEY

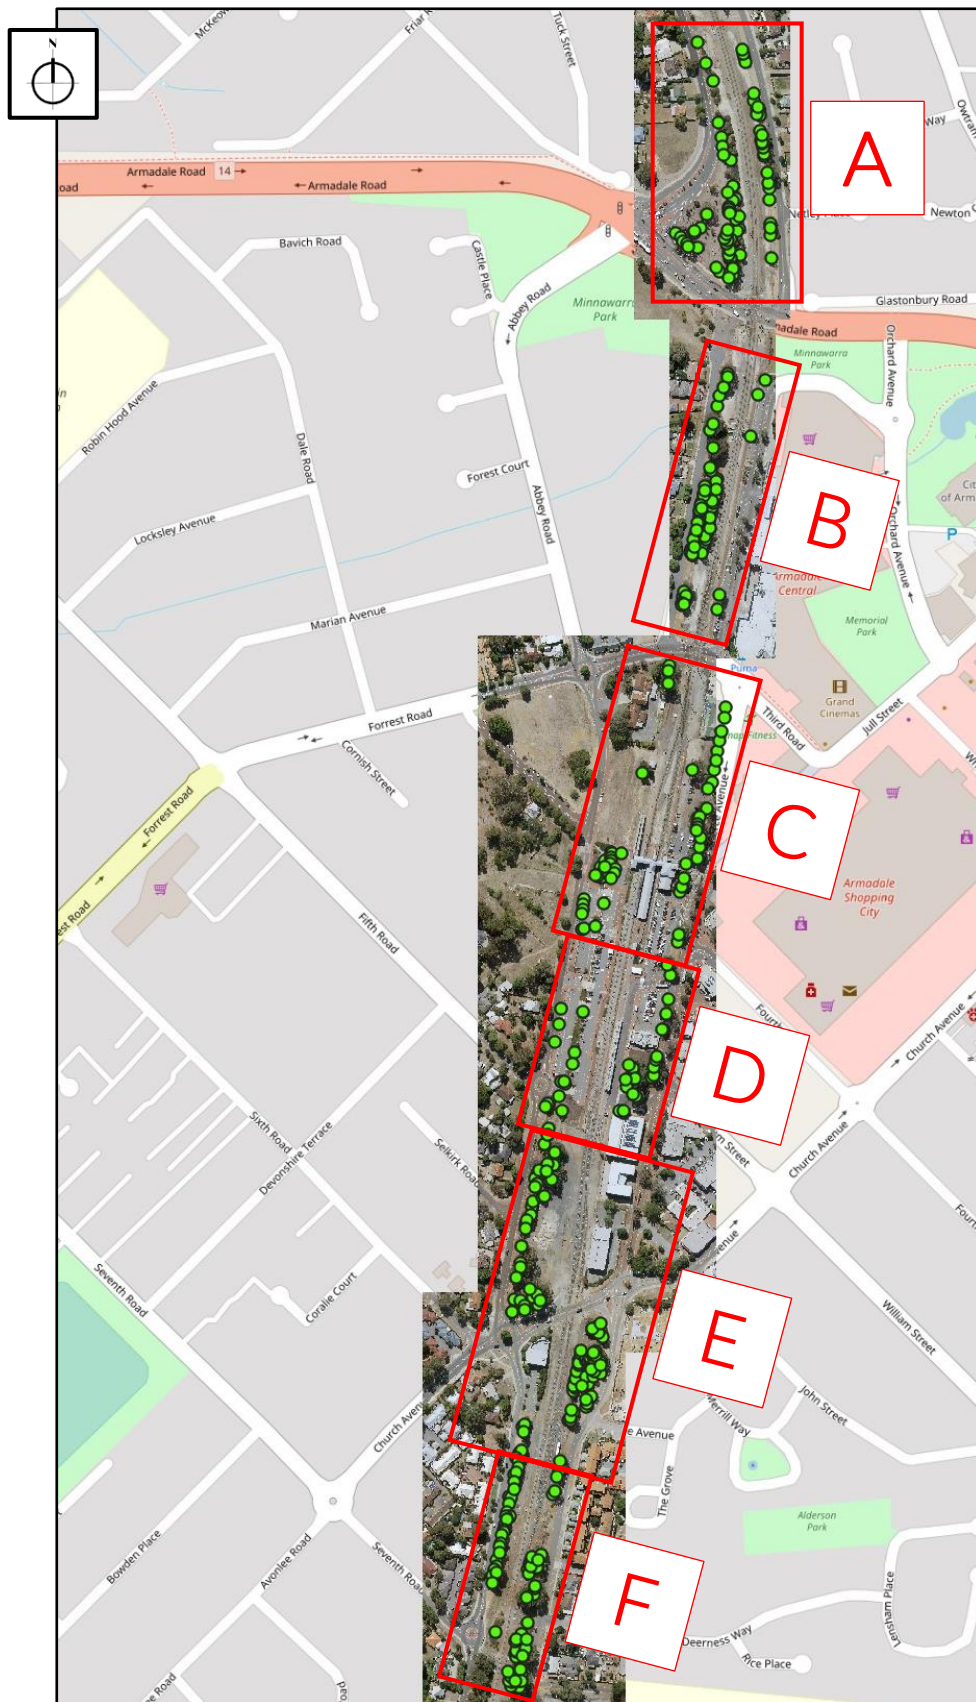
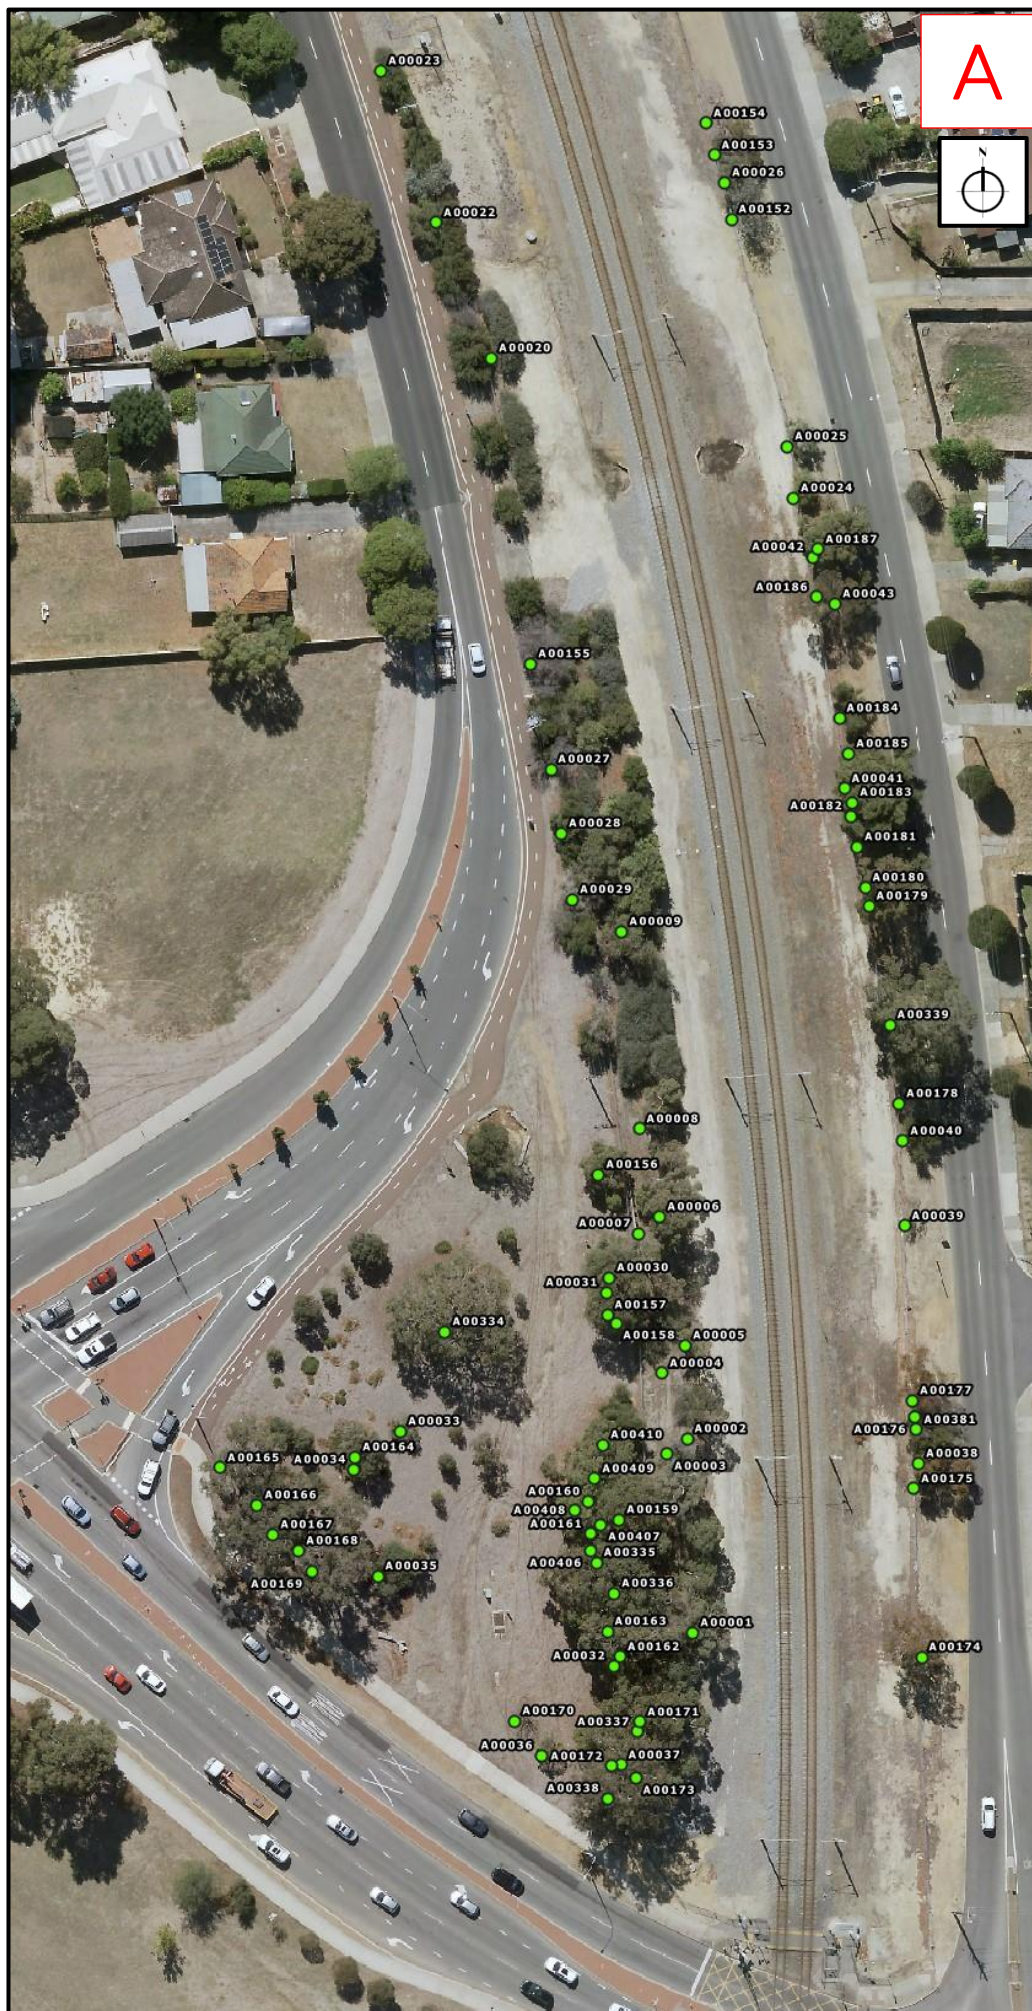
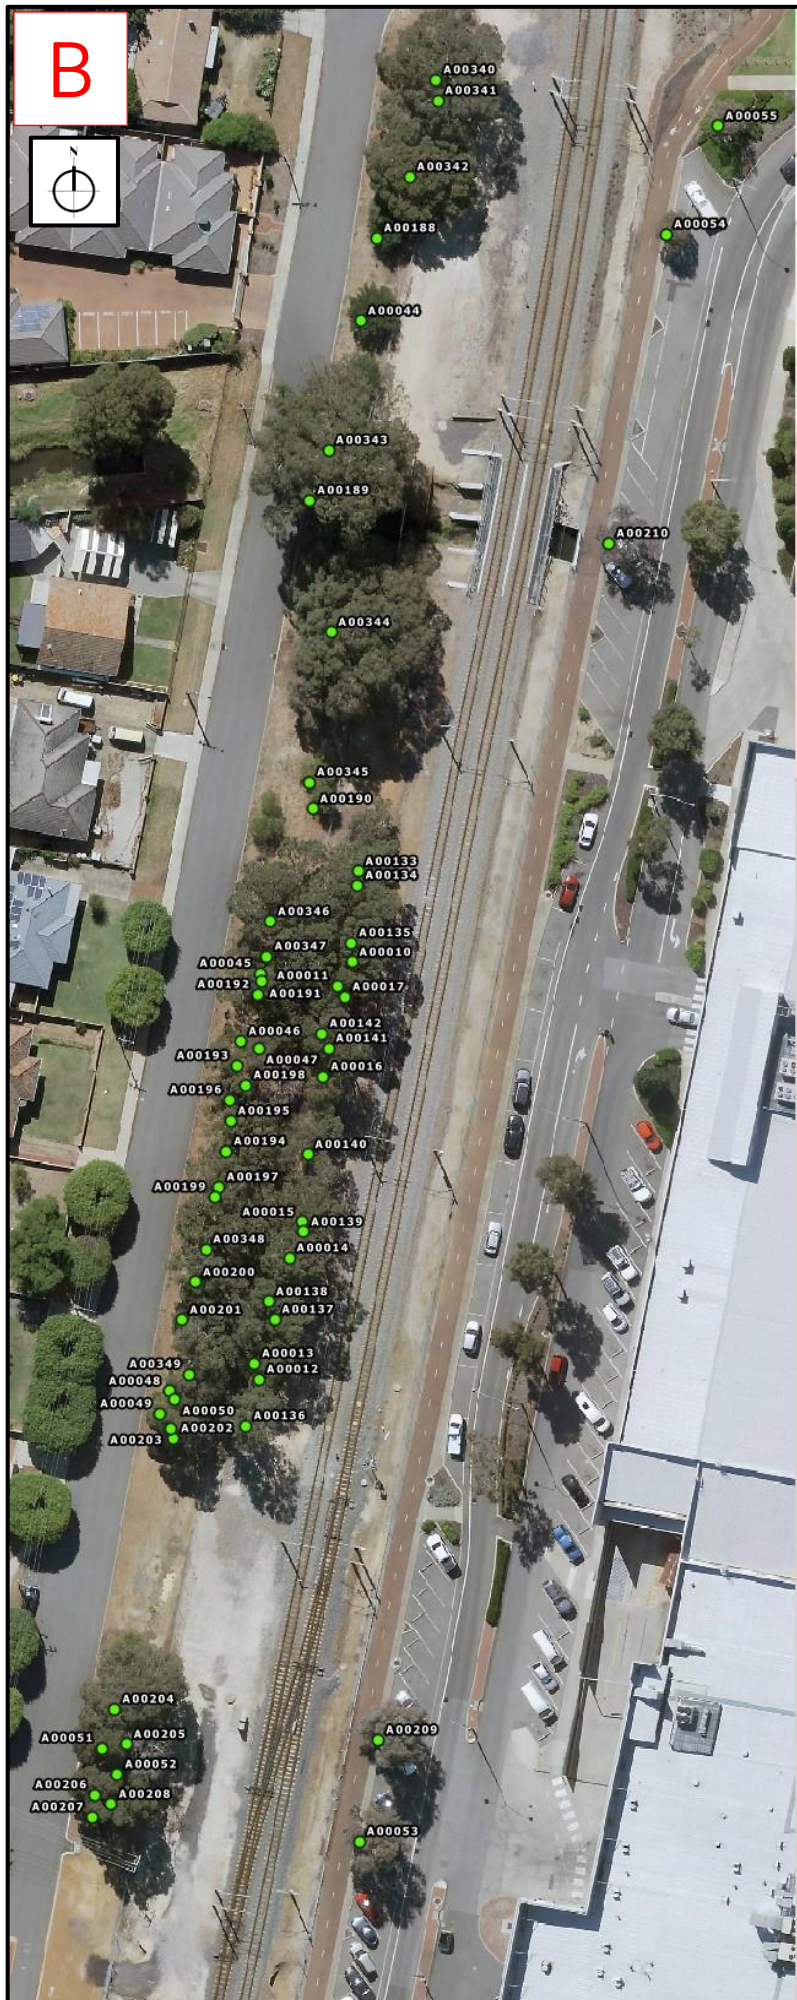
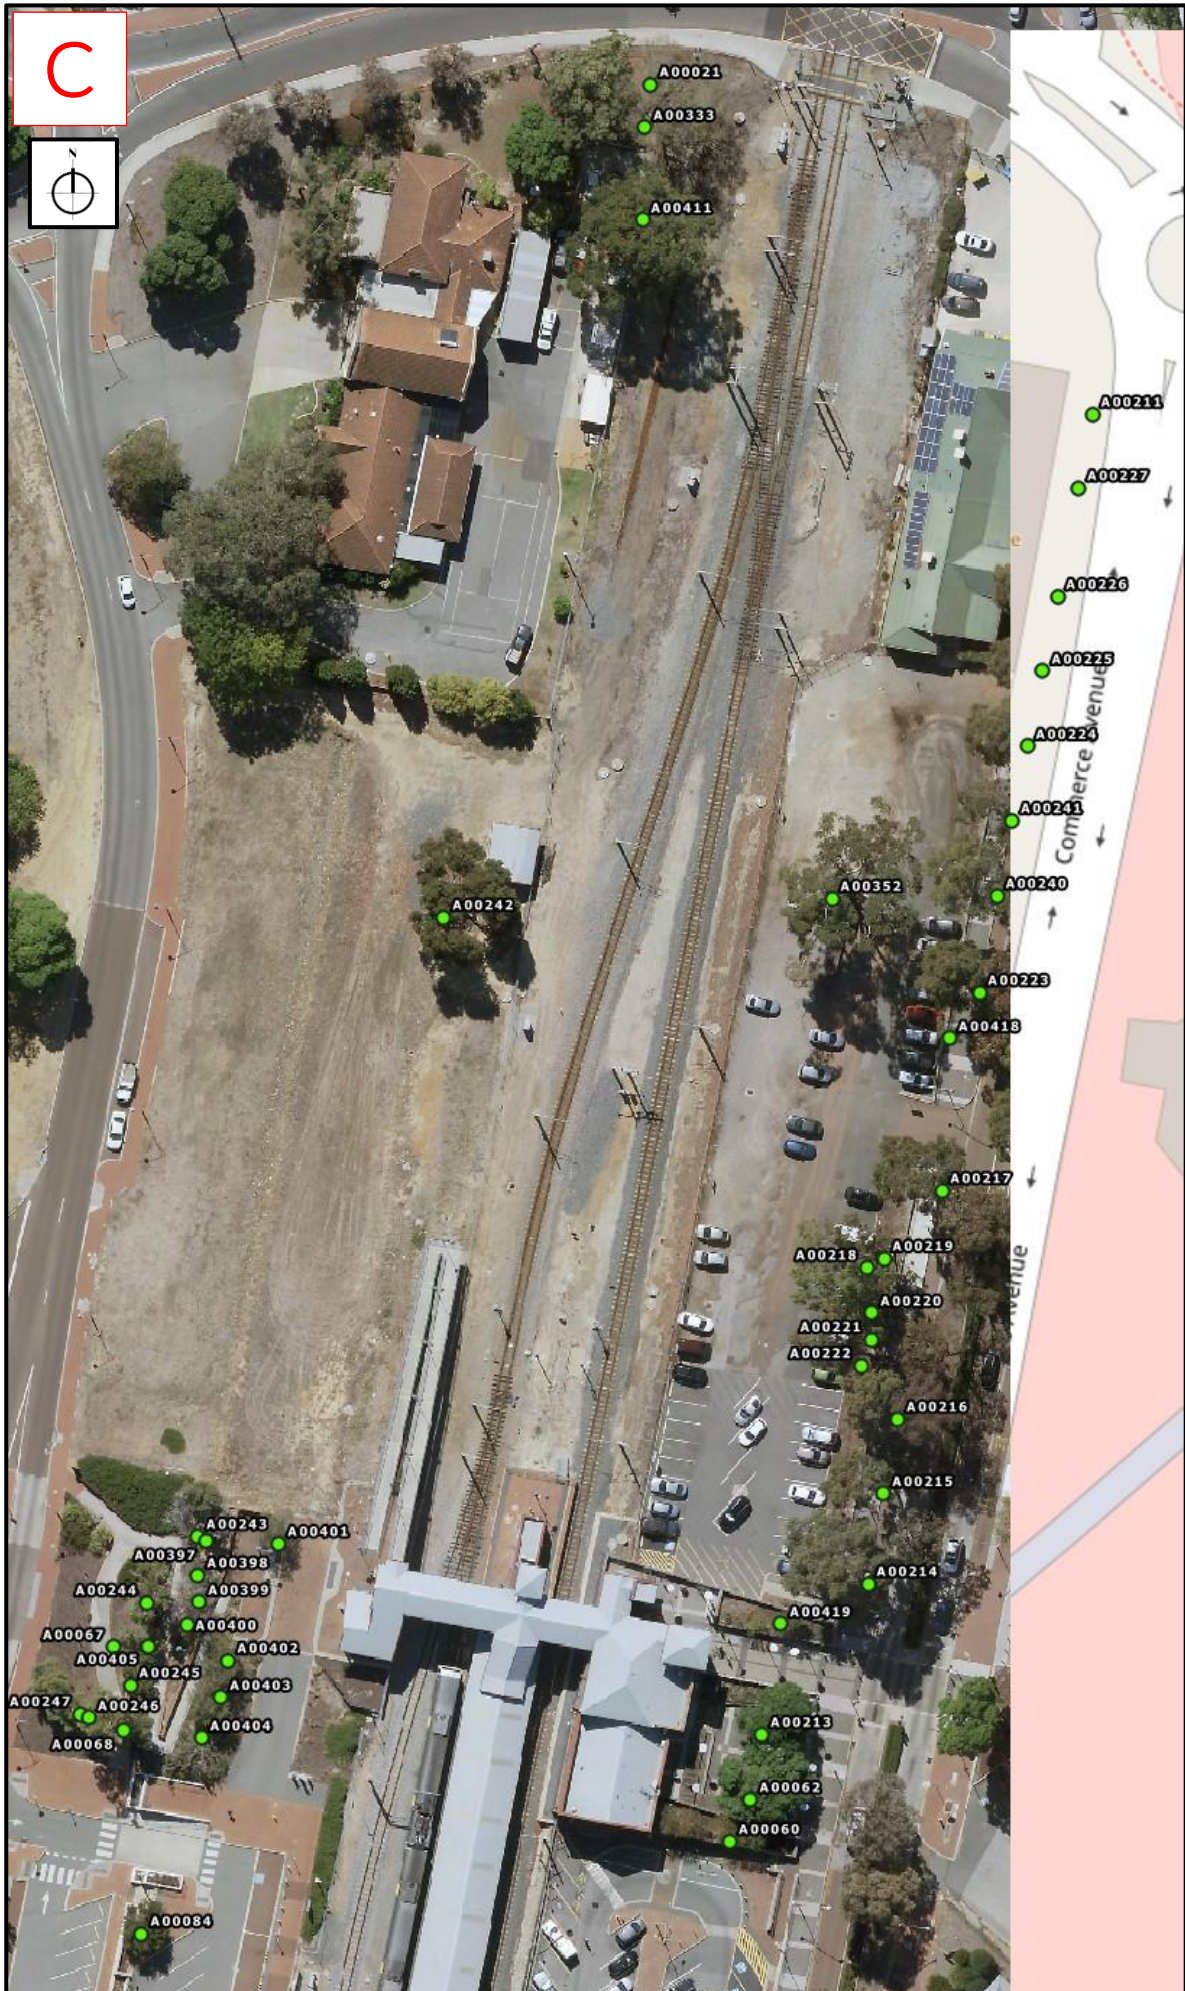
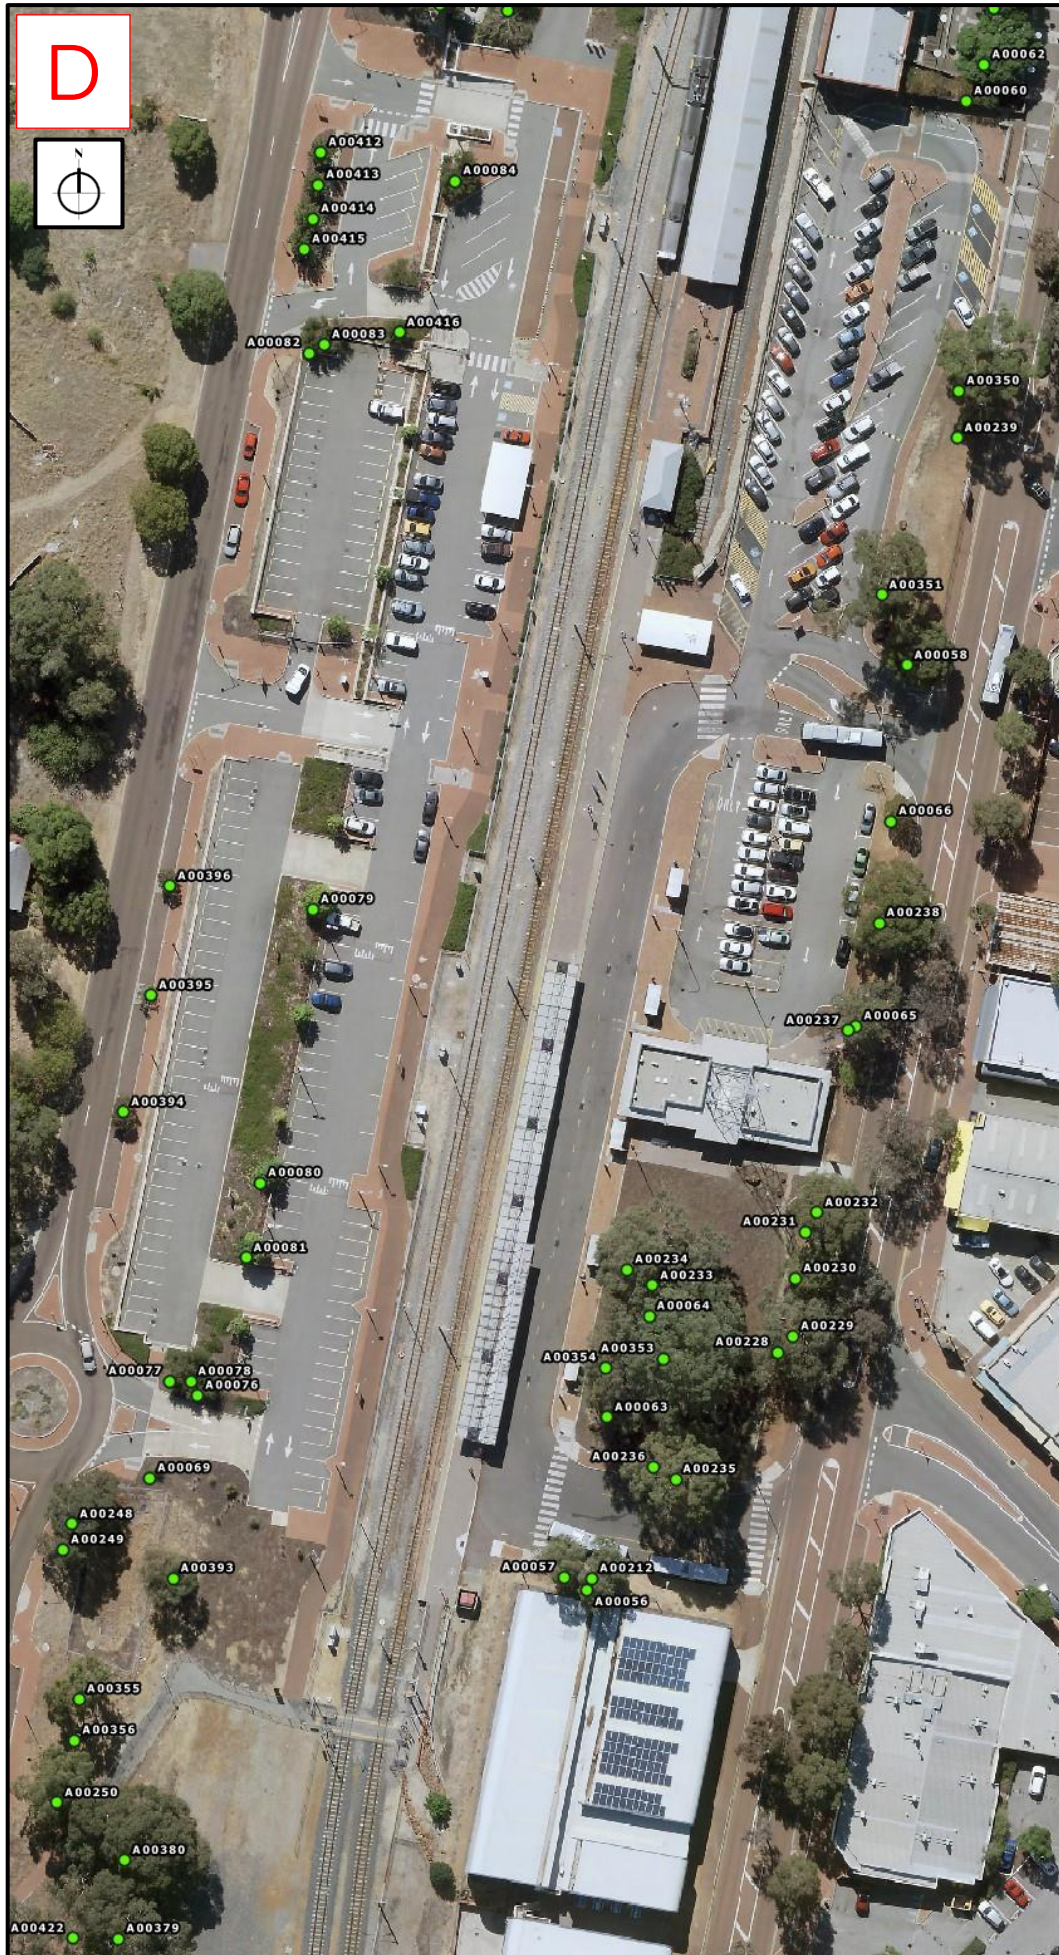
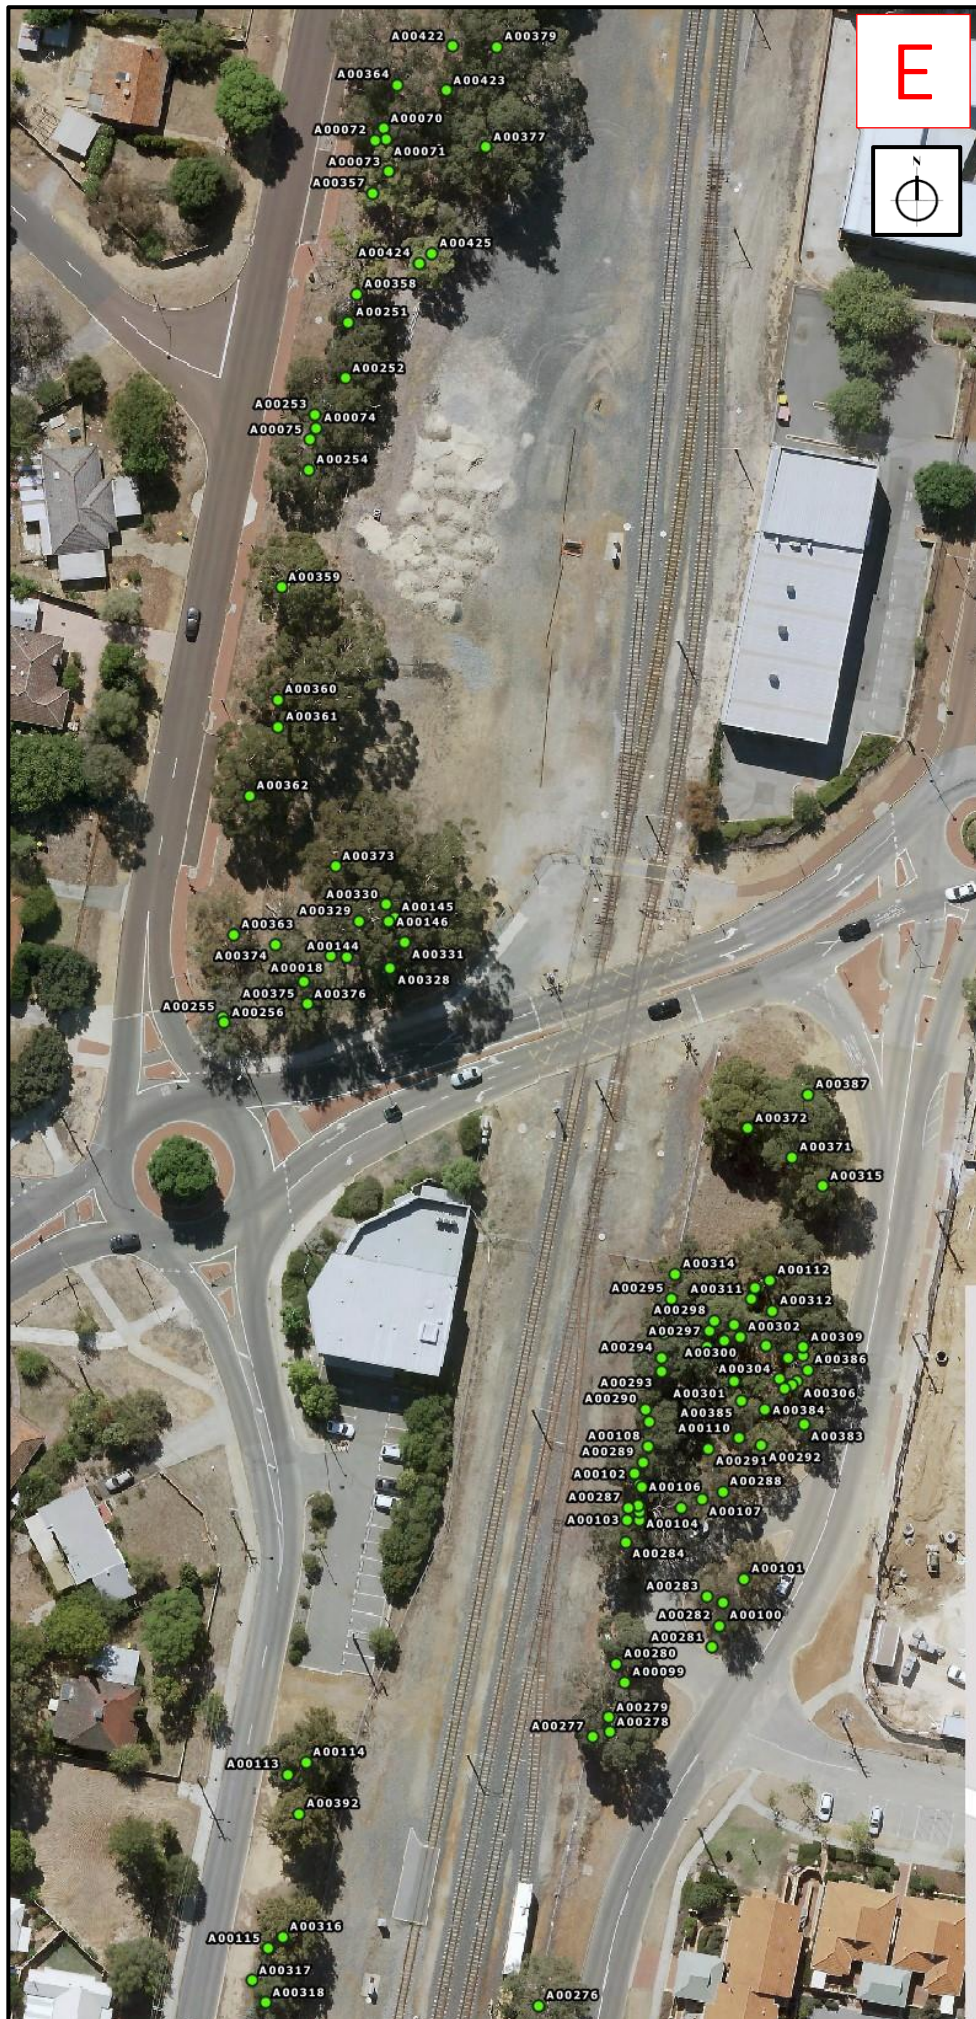
Figures 4 - 10. Tree Location & Individual Tree Tag ID Numbering

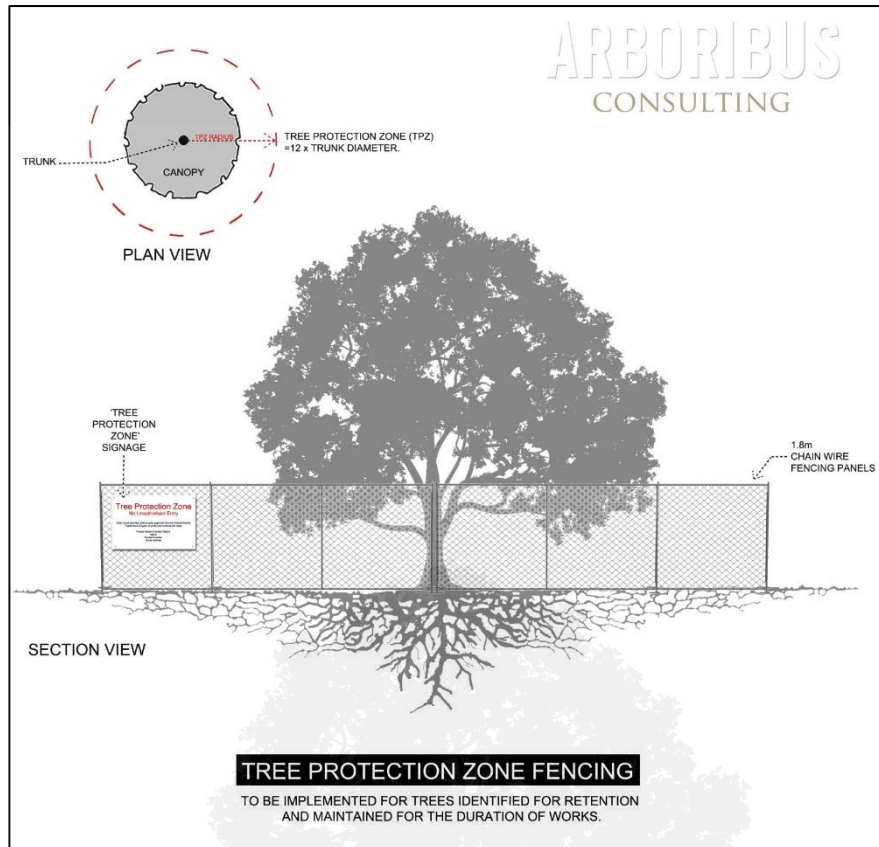
Figure 1. Example of AS4970 TPZ fencing requirements. Image source Arboribus Consulting 2022 as depicted in AS4970 2009

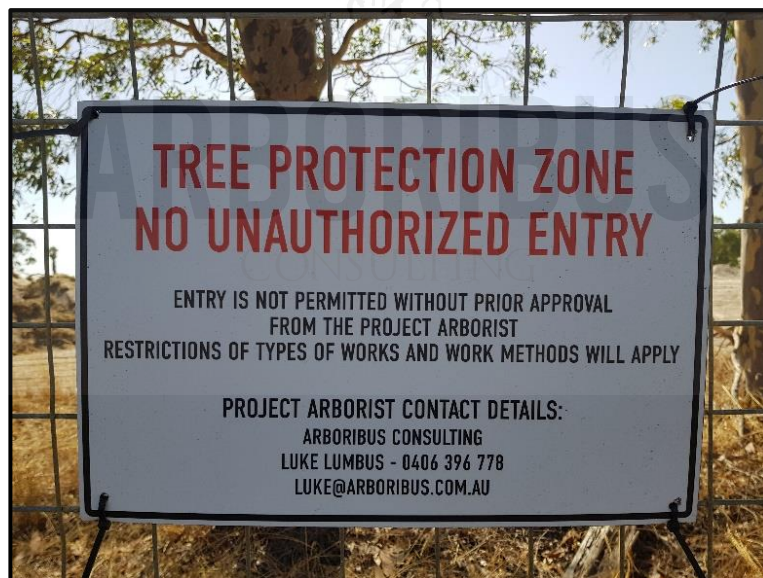
Figure 2. Example of TPZ Signage. Image source Arboribus Consulting 2022

- TPZ Fencing is to have signage installed that identifies the TPZ as a protected area and that no access is permitted without prior approval from the nominated AQF level 5 Arborist. TPZ signs are to clearly display the Nominated AQF level 5 Arborist name, mobile number and email address (refer figure 2 below for example TPZ signage).
