Piara Waters Structure Plan Engineering Servicing Report January 2022

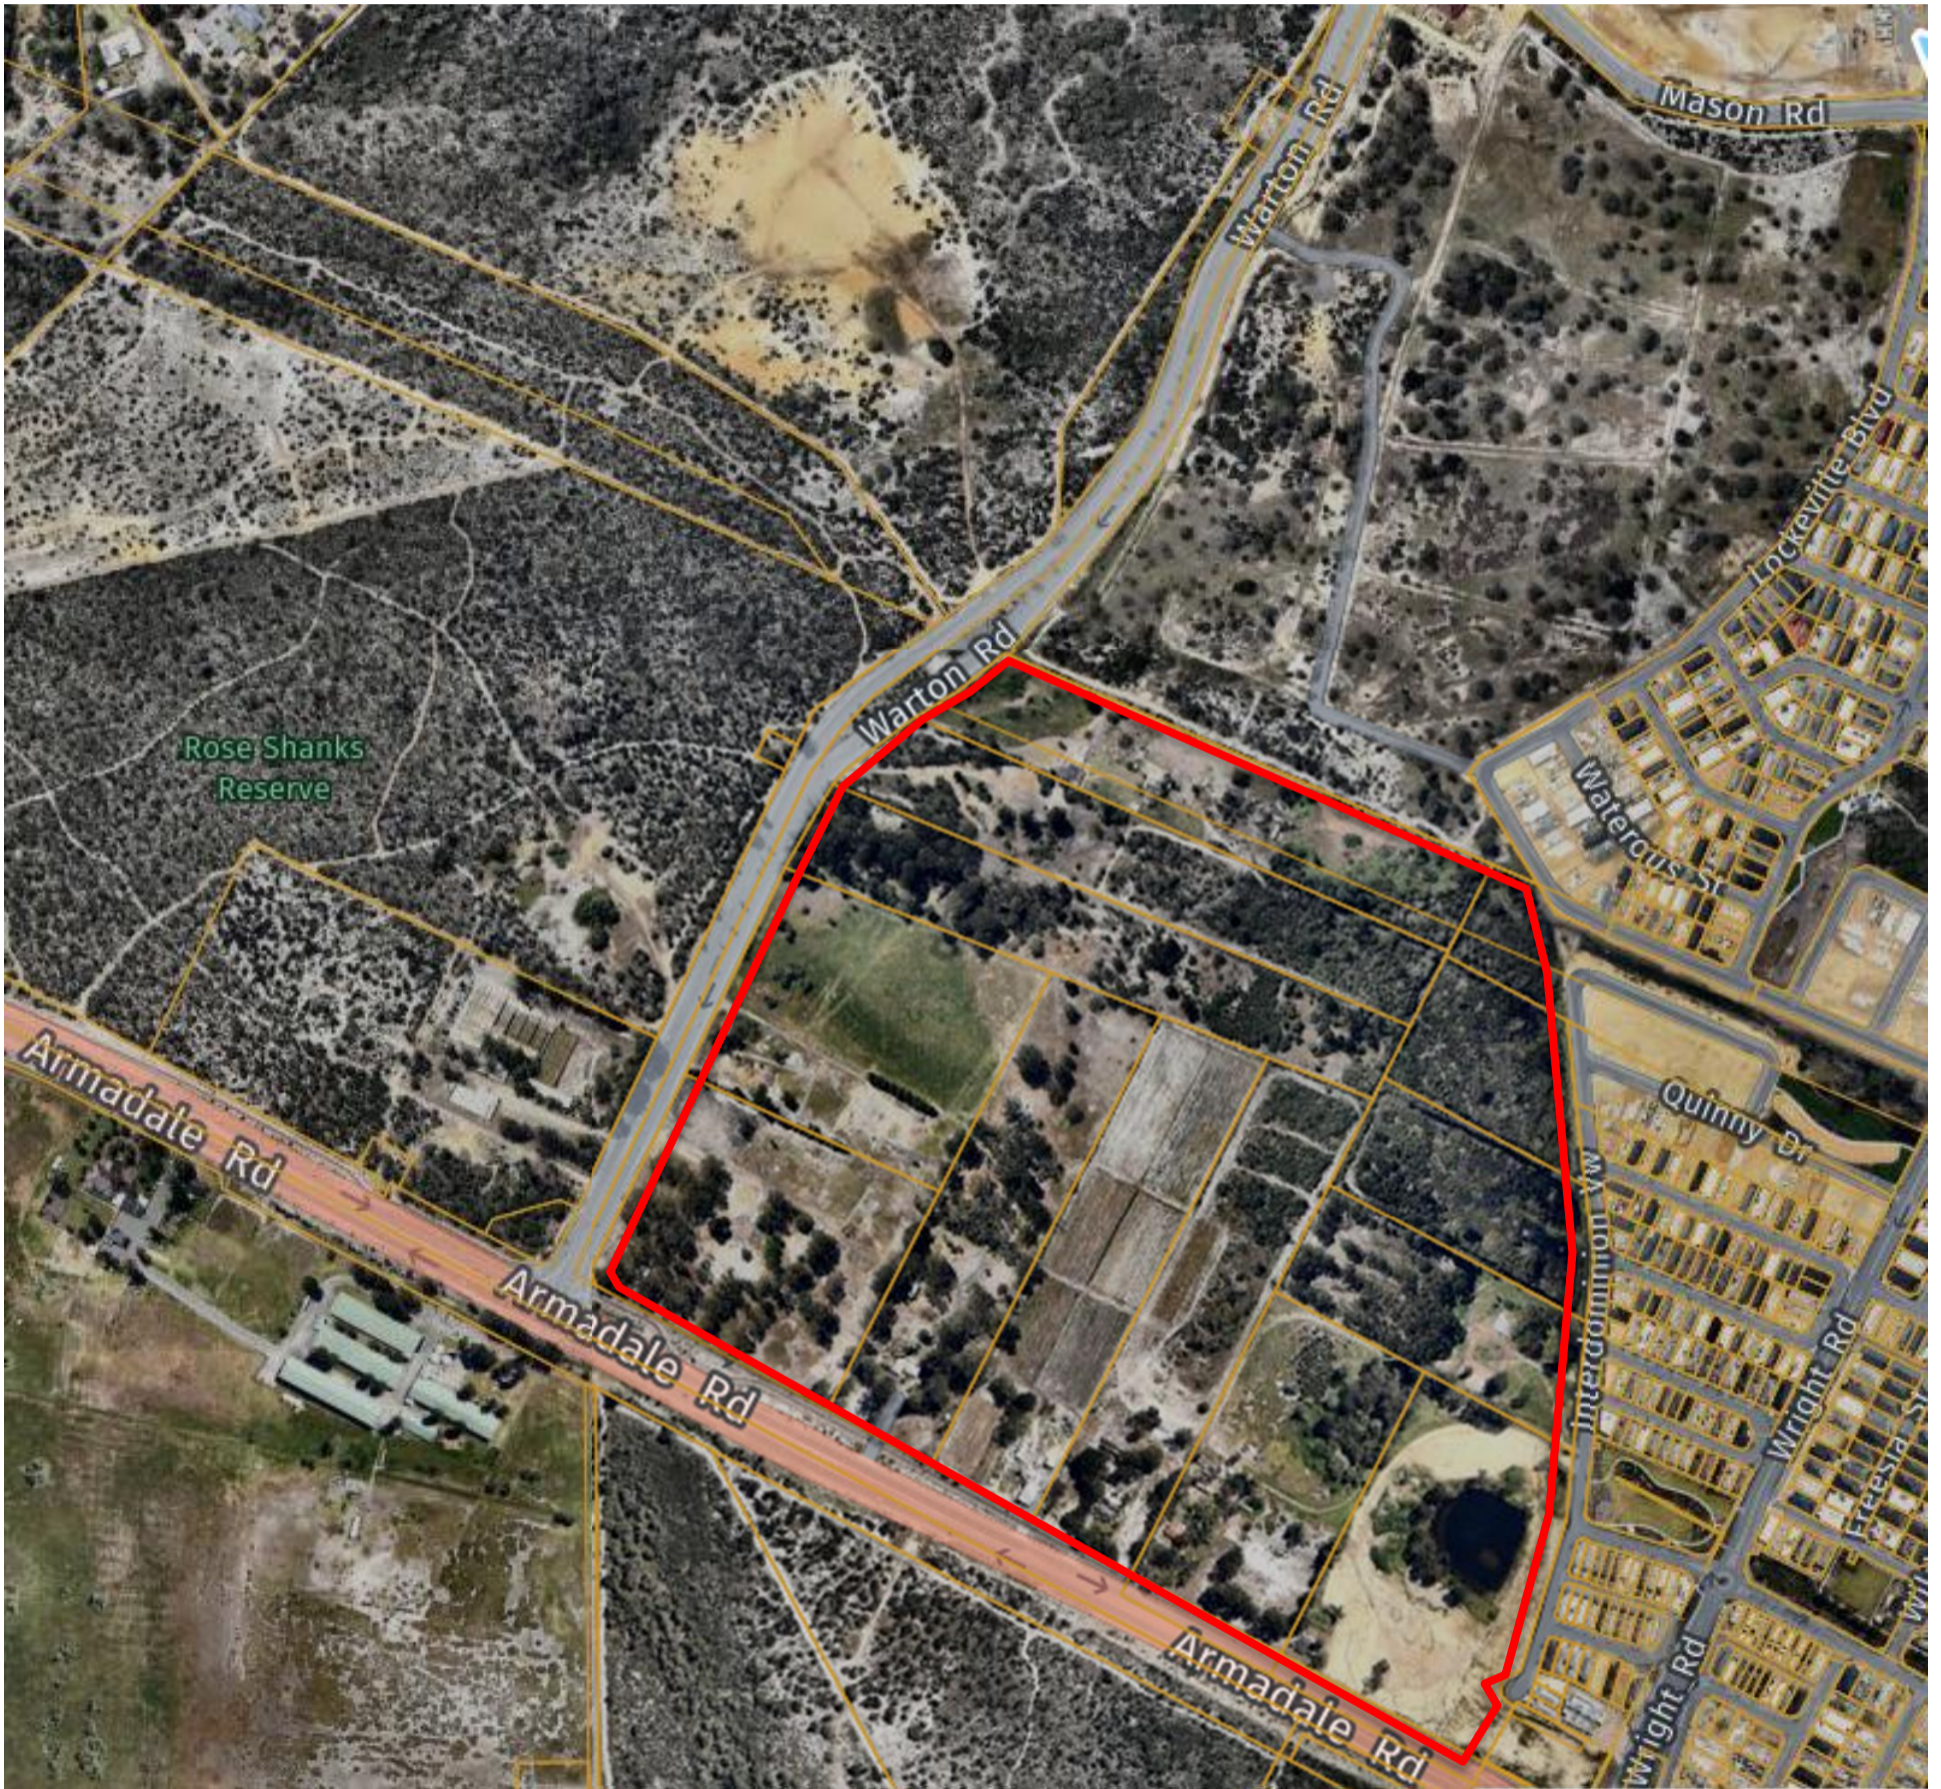
Figure 1 – Structure Plan Area (Nearmap, November 21)

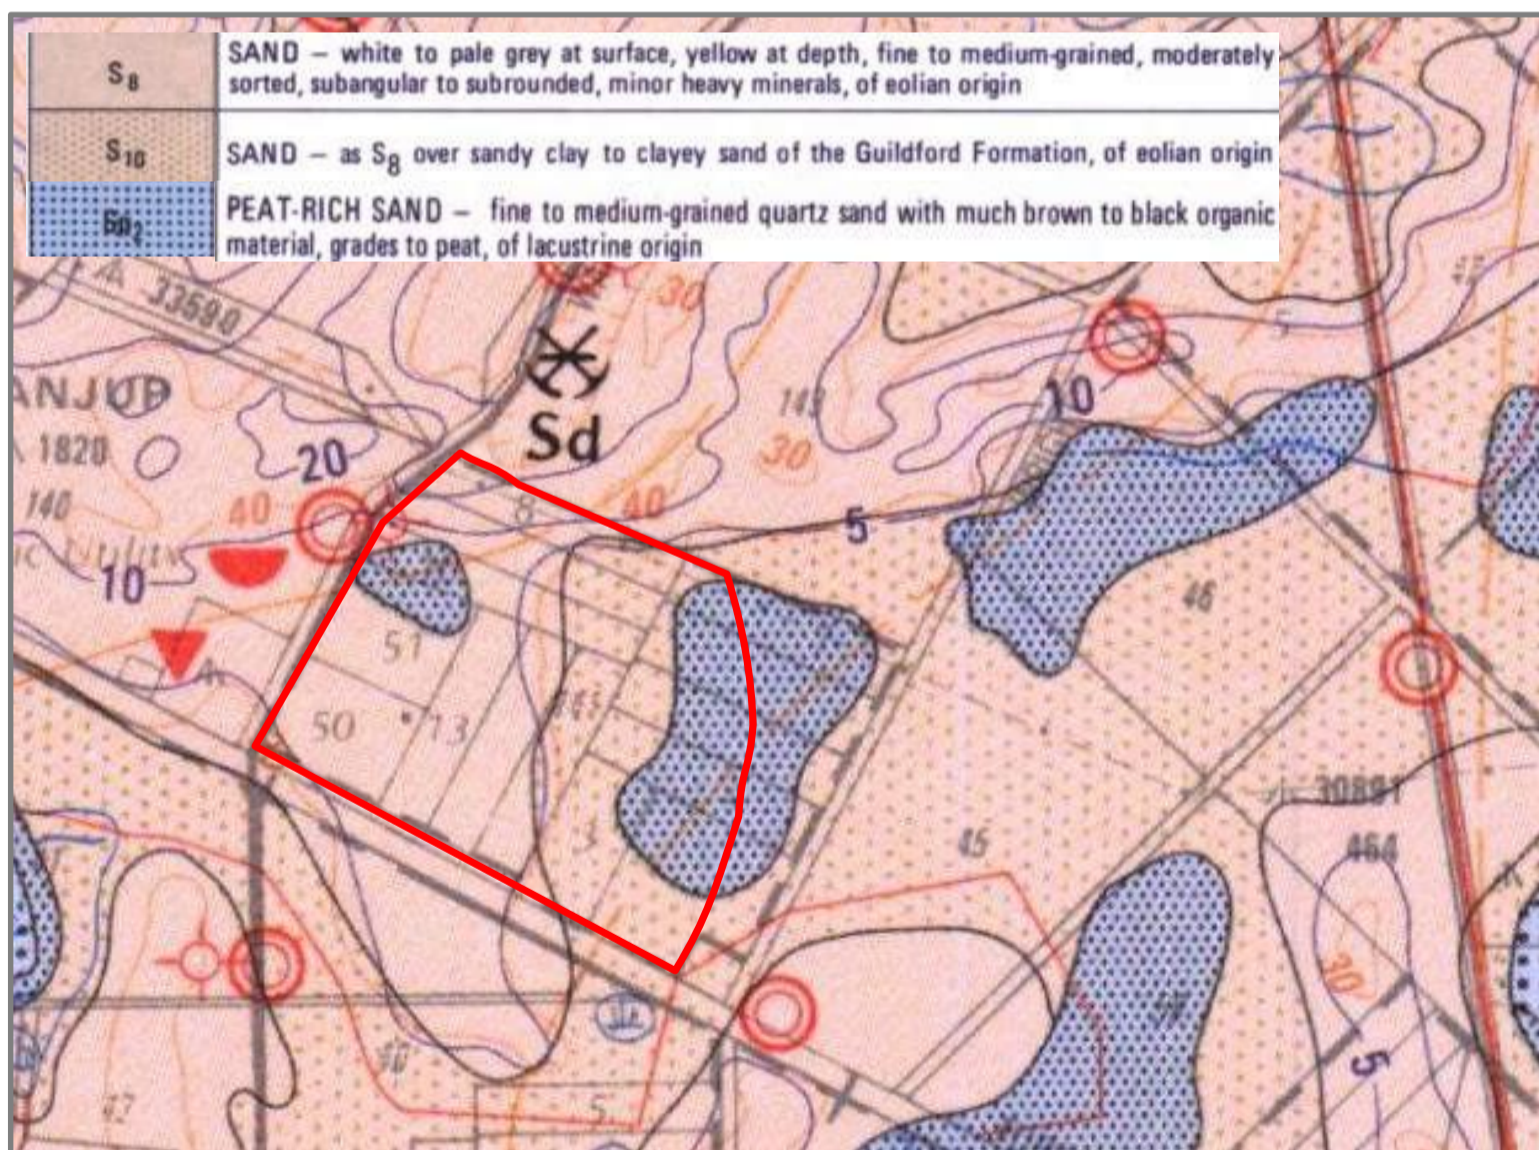
The Armadale Sheet of the 1:50,000 Geological Survey of Western Australia's Perth Metropolitan Region Soils Maps indicates the majority of the Site is generally characterised by Bassendean Sand (S8), with sections of Sandy Clay (S10) and Peat-rich Sand in limited pockets (see Figure 2 below). Areas of Sandy Clay will require a minimum depth of clean fill to provide a Class A Site Classification under AS2876 'Residential Slabs and & Footings'.

Figure 2 – Geotechnical Information (Geological Survey of WA)

A Technical Memorandum was prepared as part of the due diligence for the acquisition of the Site by Galt Geotechnics in February 2021. Galt undertook a series of test pits and dynamic cone penetrometer tests which confirmed the geology of the Site is generally in accordance with the geological mapping.

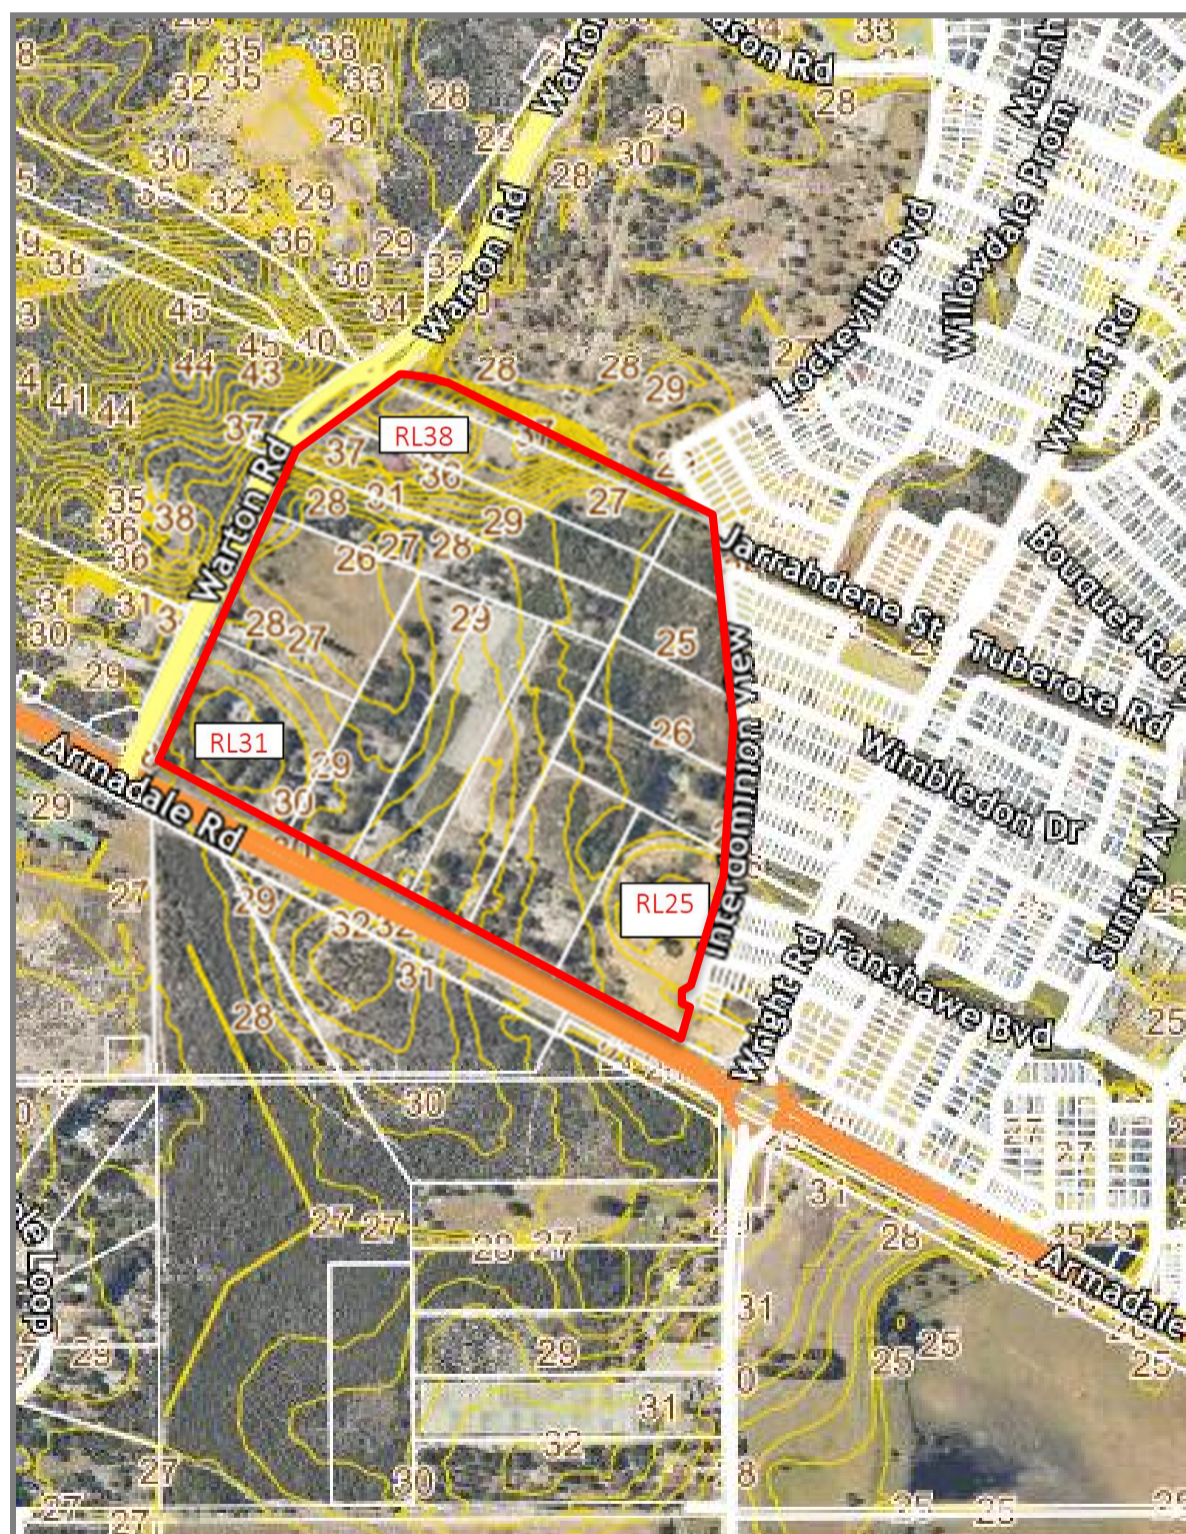
The Site generally grades from a level at RL38m AHD in the north-west near Warton Road, to a low point at RL24m AHD in the south-east as presented below in Figure 3.

Figure 3 – Existing Topography (MNG Access, November 2021)

A large dam has been dug out in the south-eastern corner of the Site, which intersects groundwater at approximately RL 25m AHD.

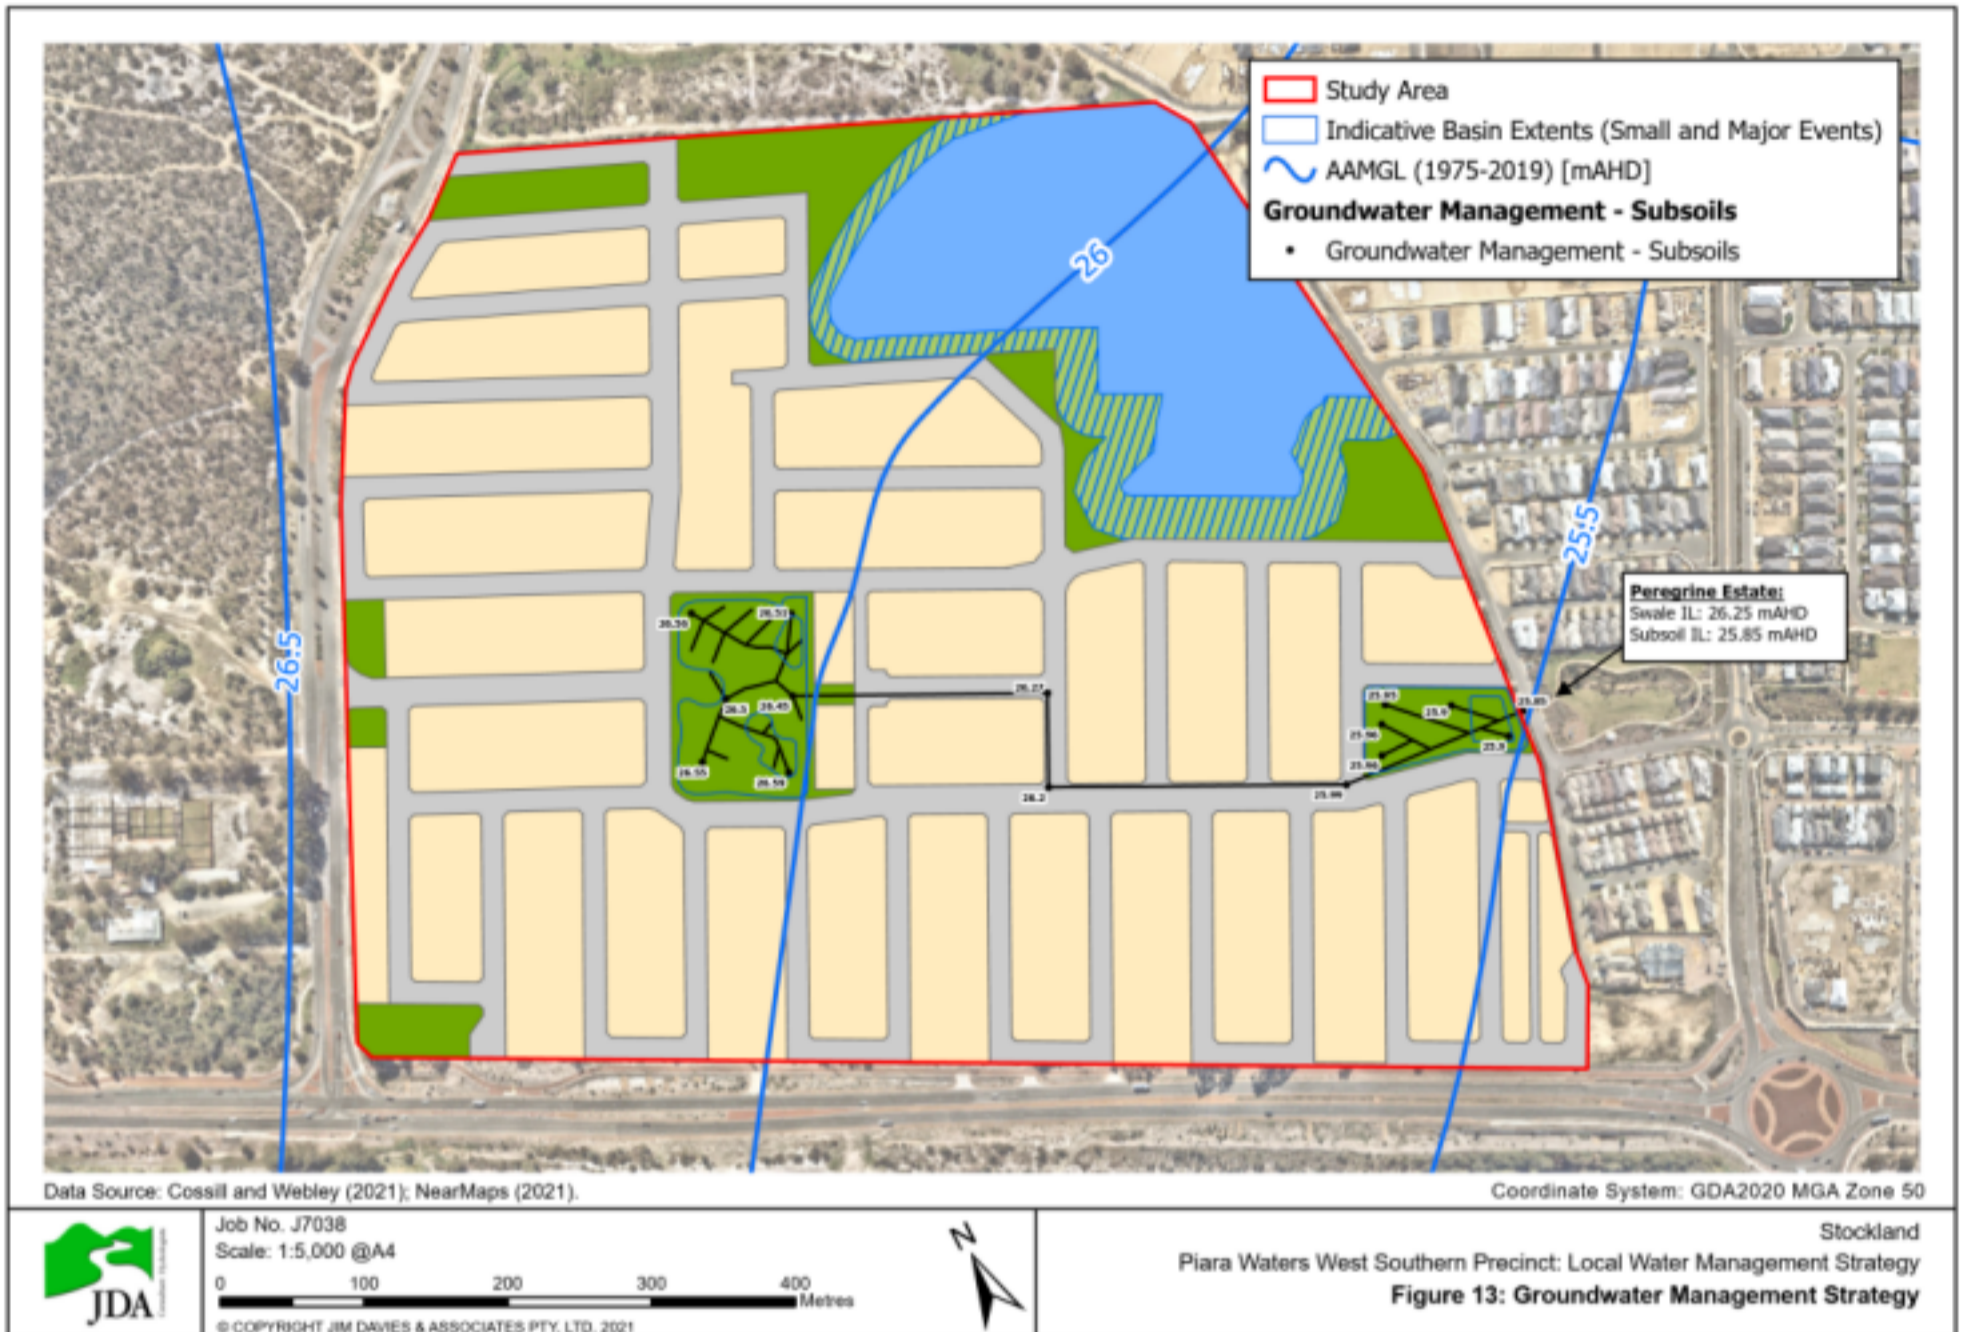
Figure 4 – Average Annual Groundwater Levels (JDA, Dec 2021)

We do not anticipate the existing groundwater levels or the effective disposal of runoff generated from the newly created lots or roads on-site will pose an impediment to development of the Site.

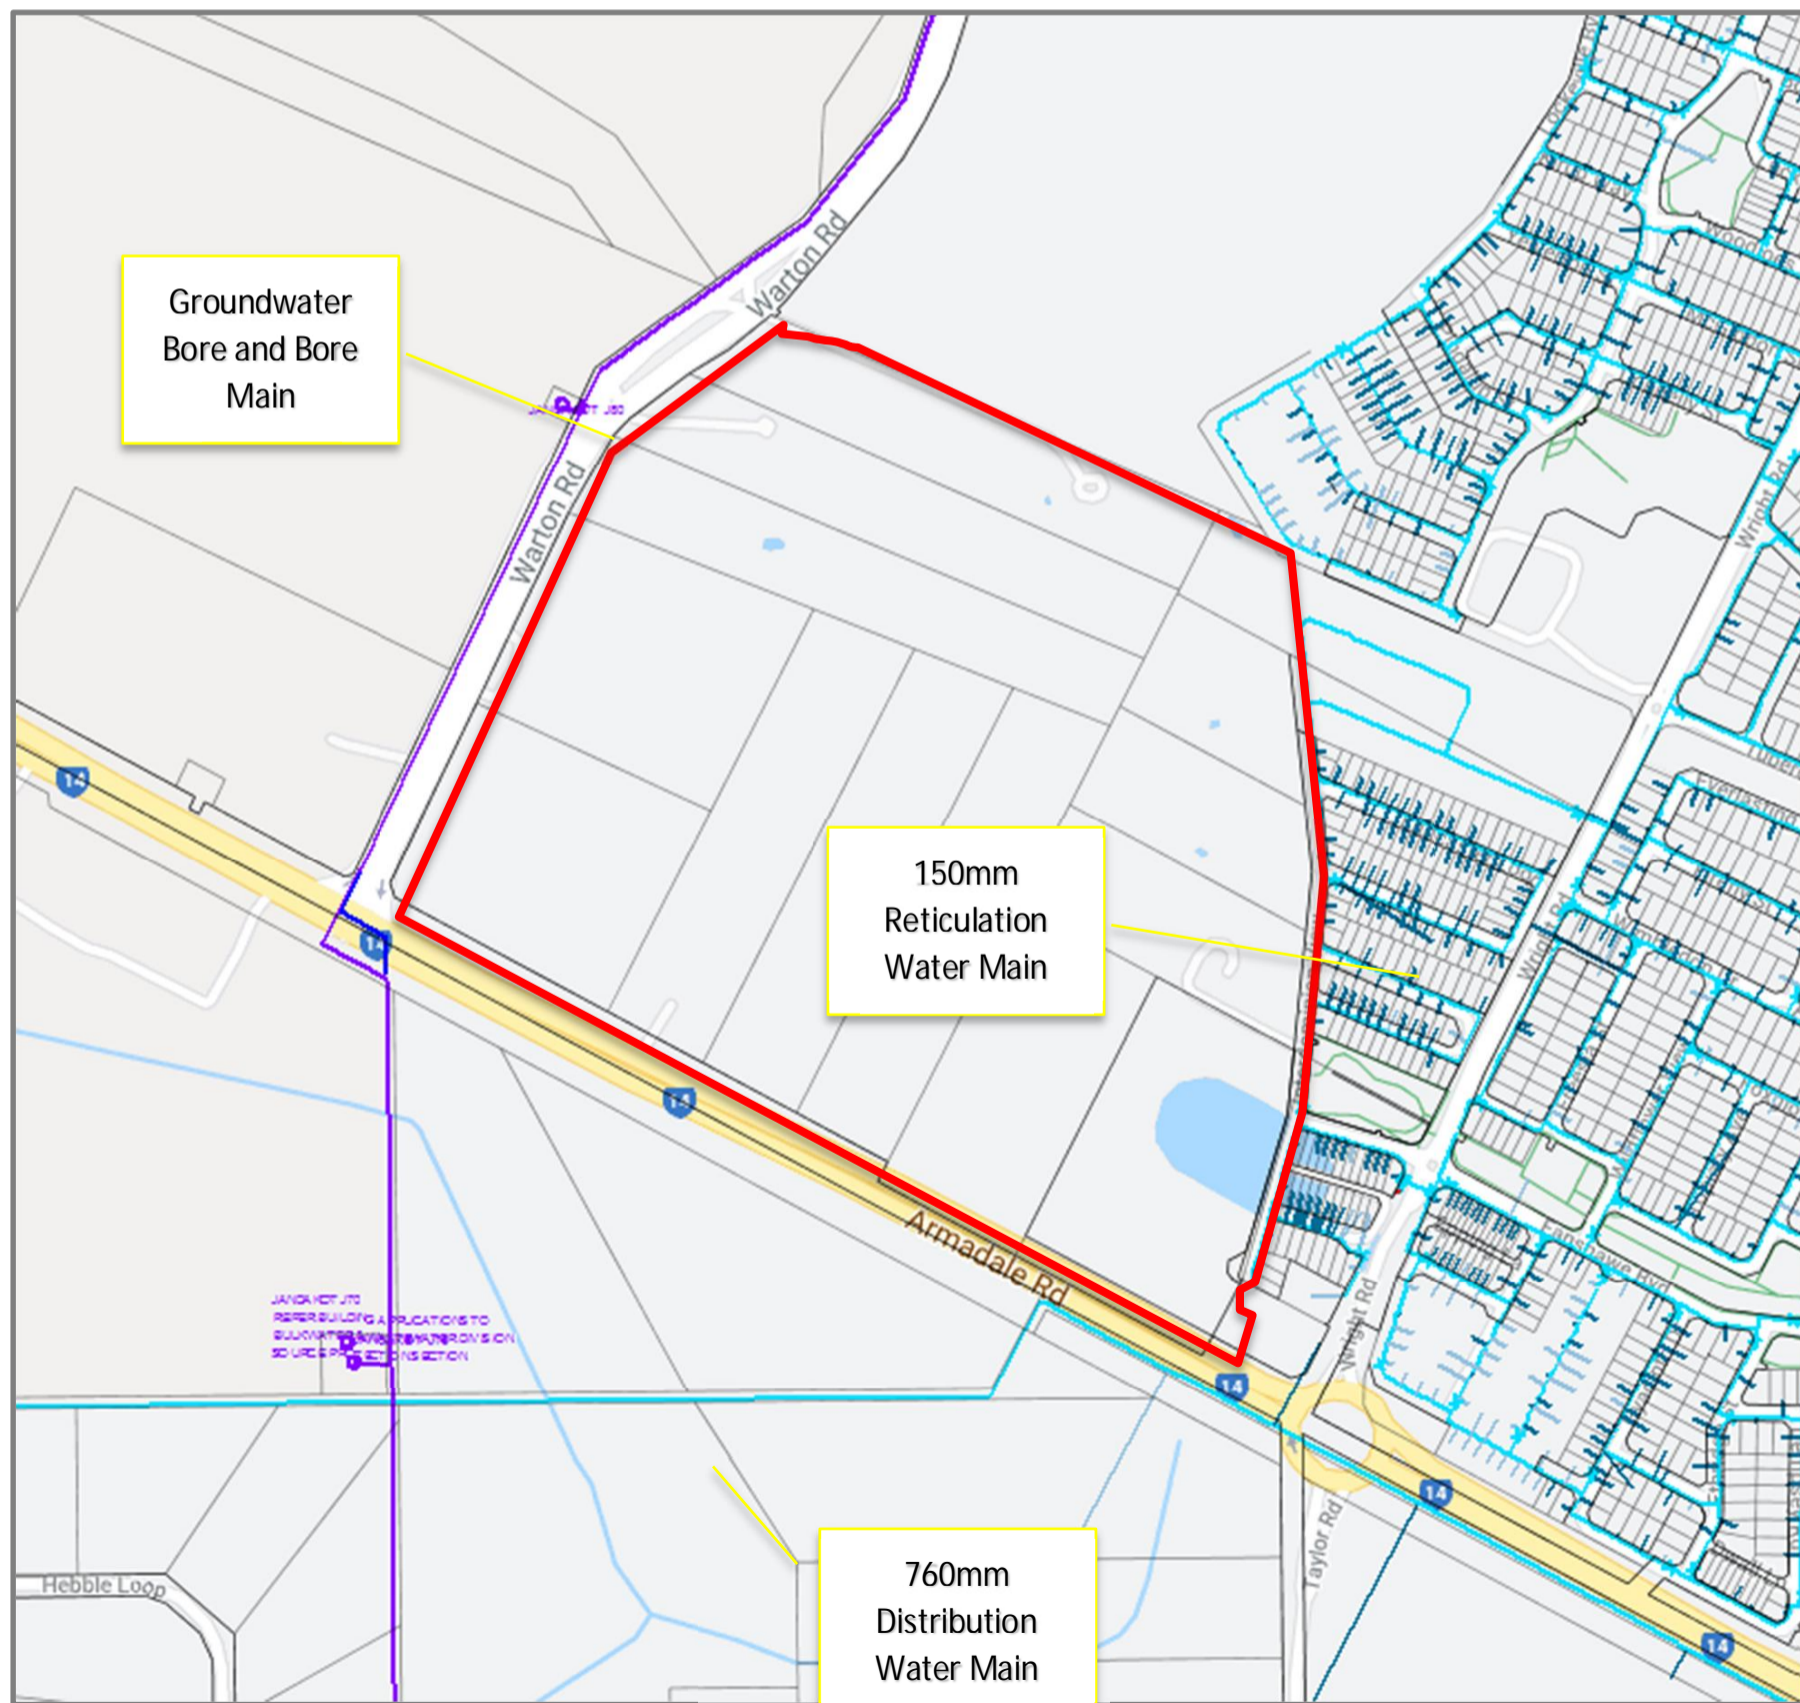
Figure 5 below presents the existing Water Corporation infrastructure that will be extended to service the proposed development.

Figure 5 – Existing Water Reticulation (Water Corporation Esinet November 2021)

The Site is within the Water Corporation's water supply area, and can be serviced off their existing infrastructure to the east.

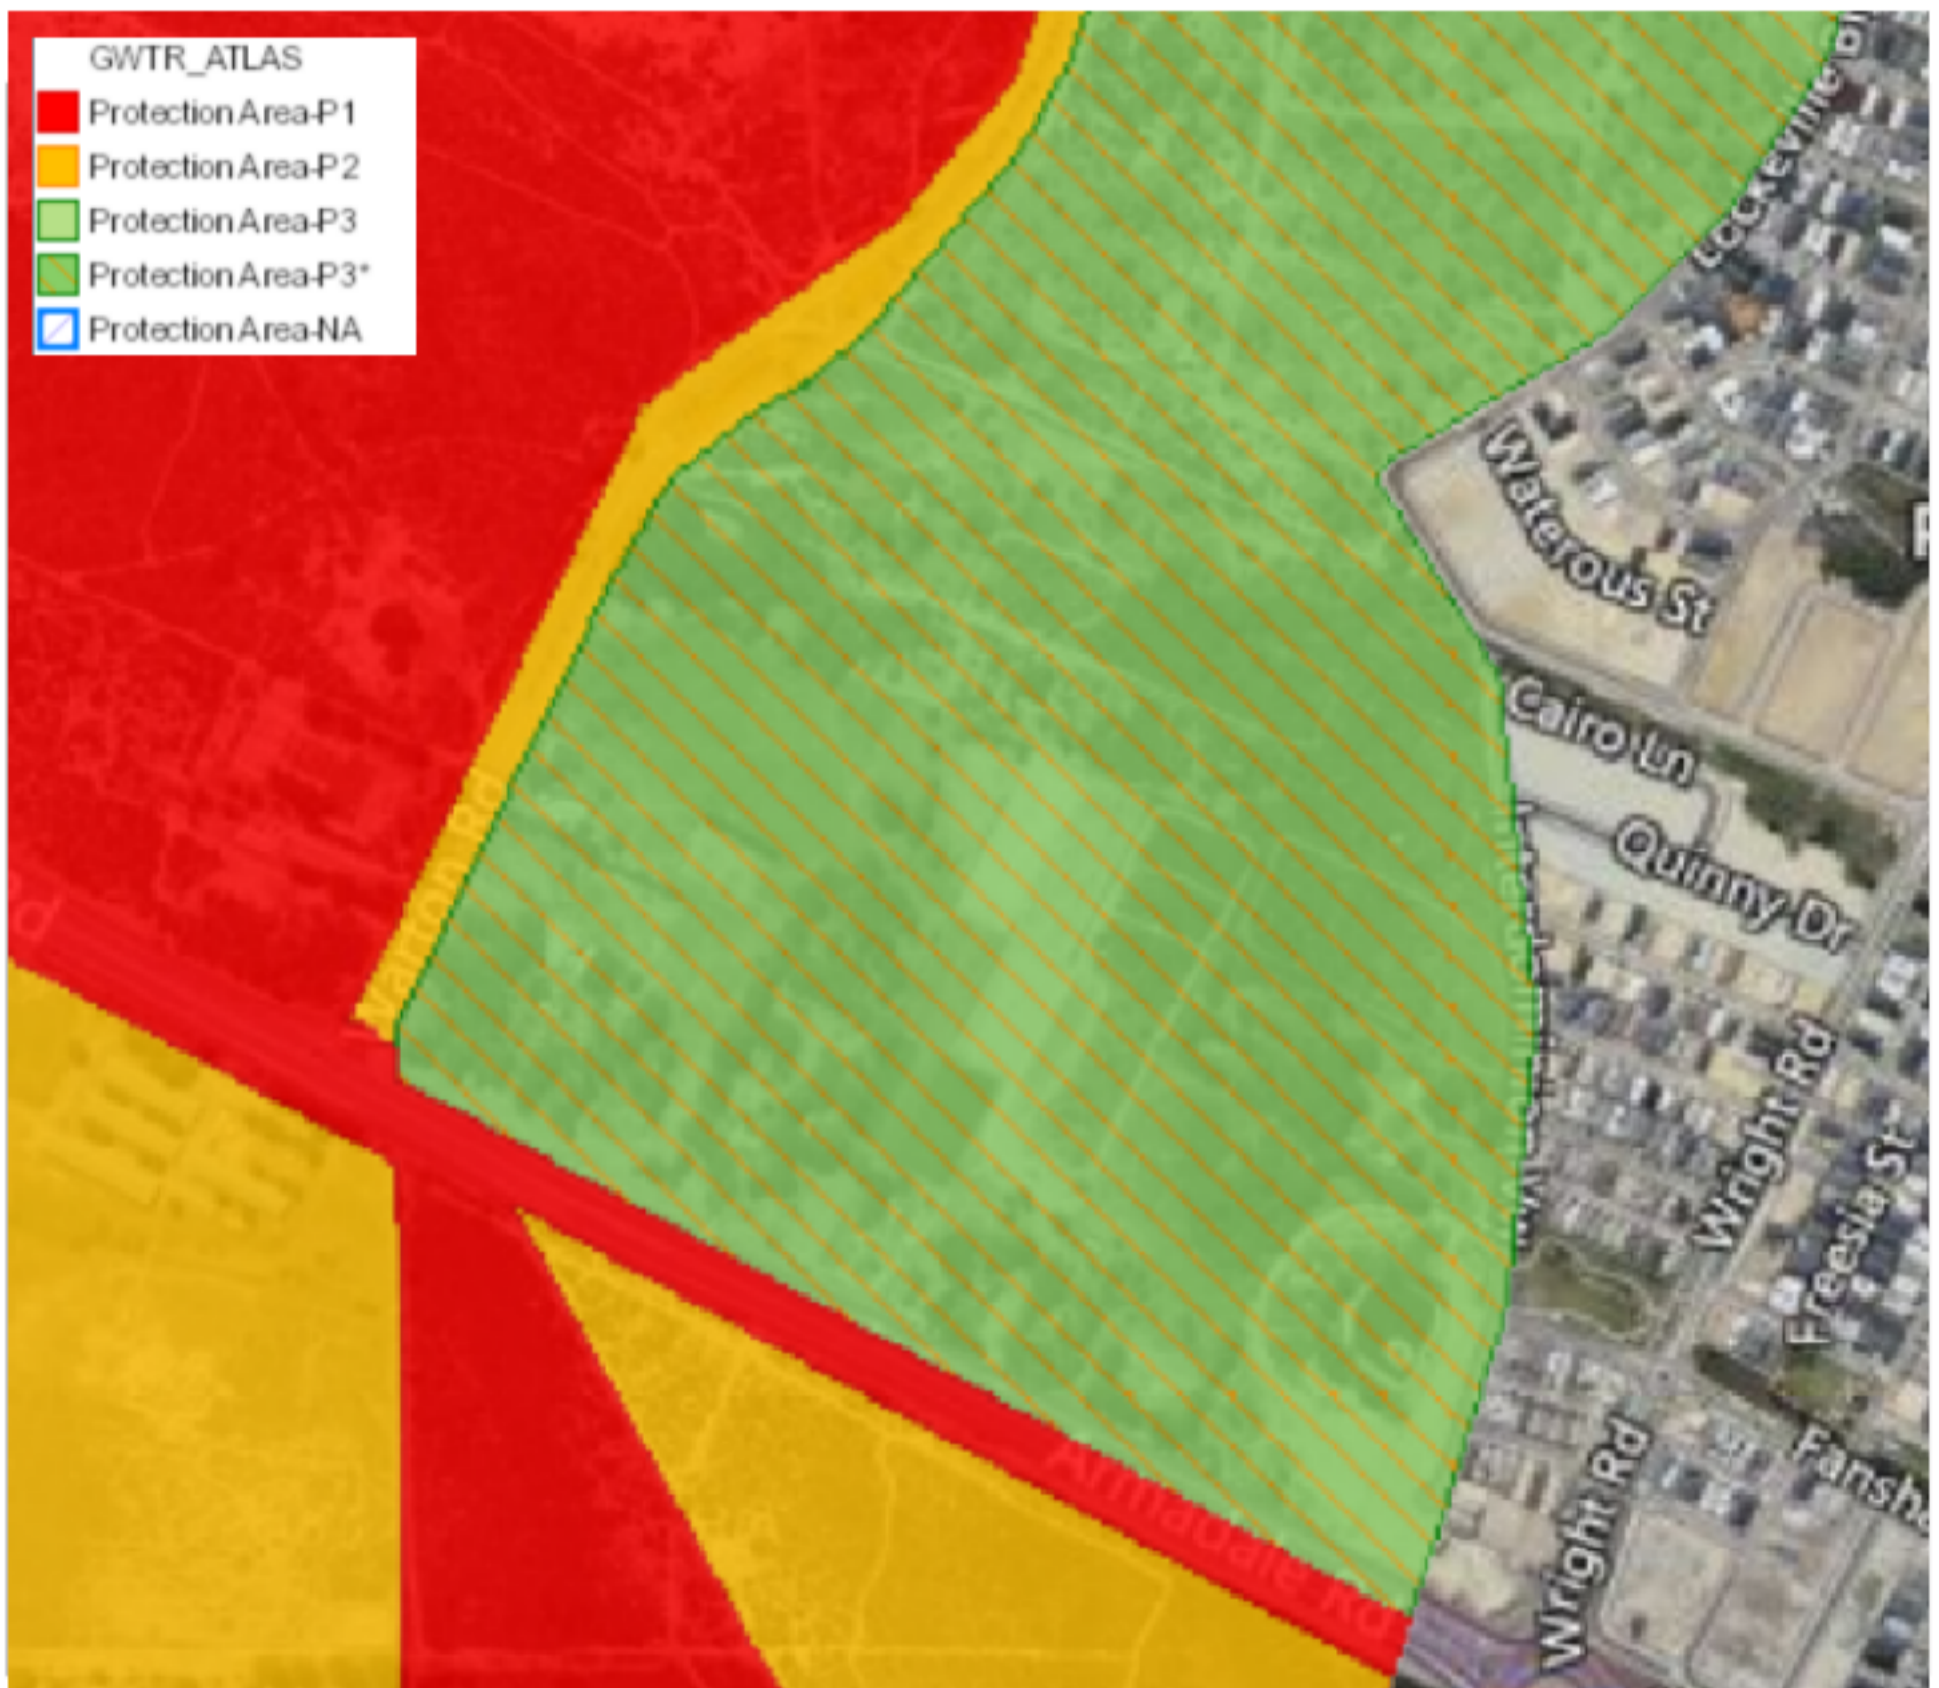
A 300m wellhead protection zone exists to the north and south of the site as depicted below in Figure 6. Potentially contaminating land uses such as petrol stations are precluded within the buffer.

Figure 6 – Priority Drinking Water Protection Zones (DWER ArcGis Maps, November 2021)

The Site is currently within a P2 Public Drinking Water Source Area under State Planning Policy 2.3 for the Jandakot Groundwater Protection Area which allows for residential development.

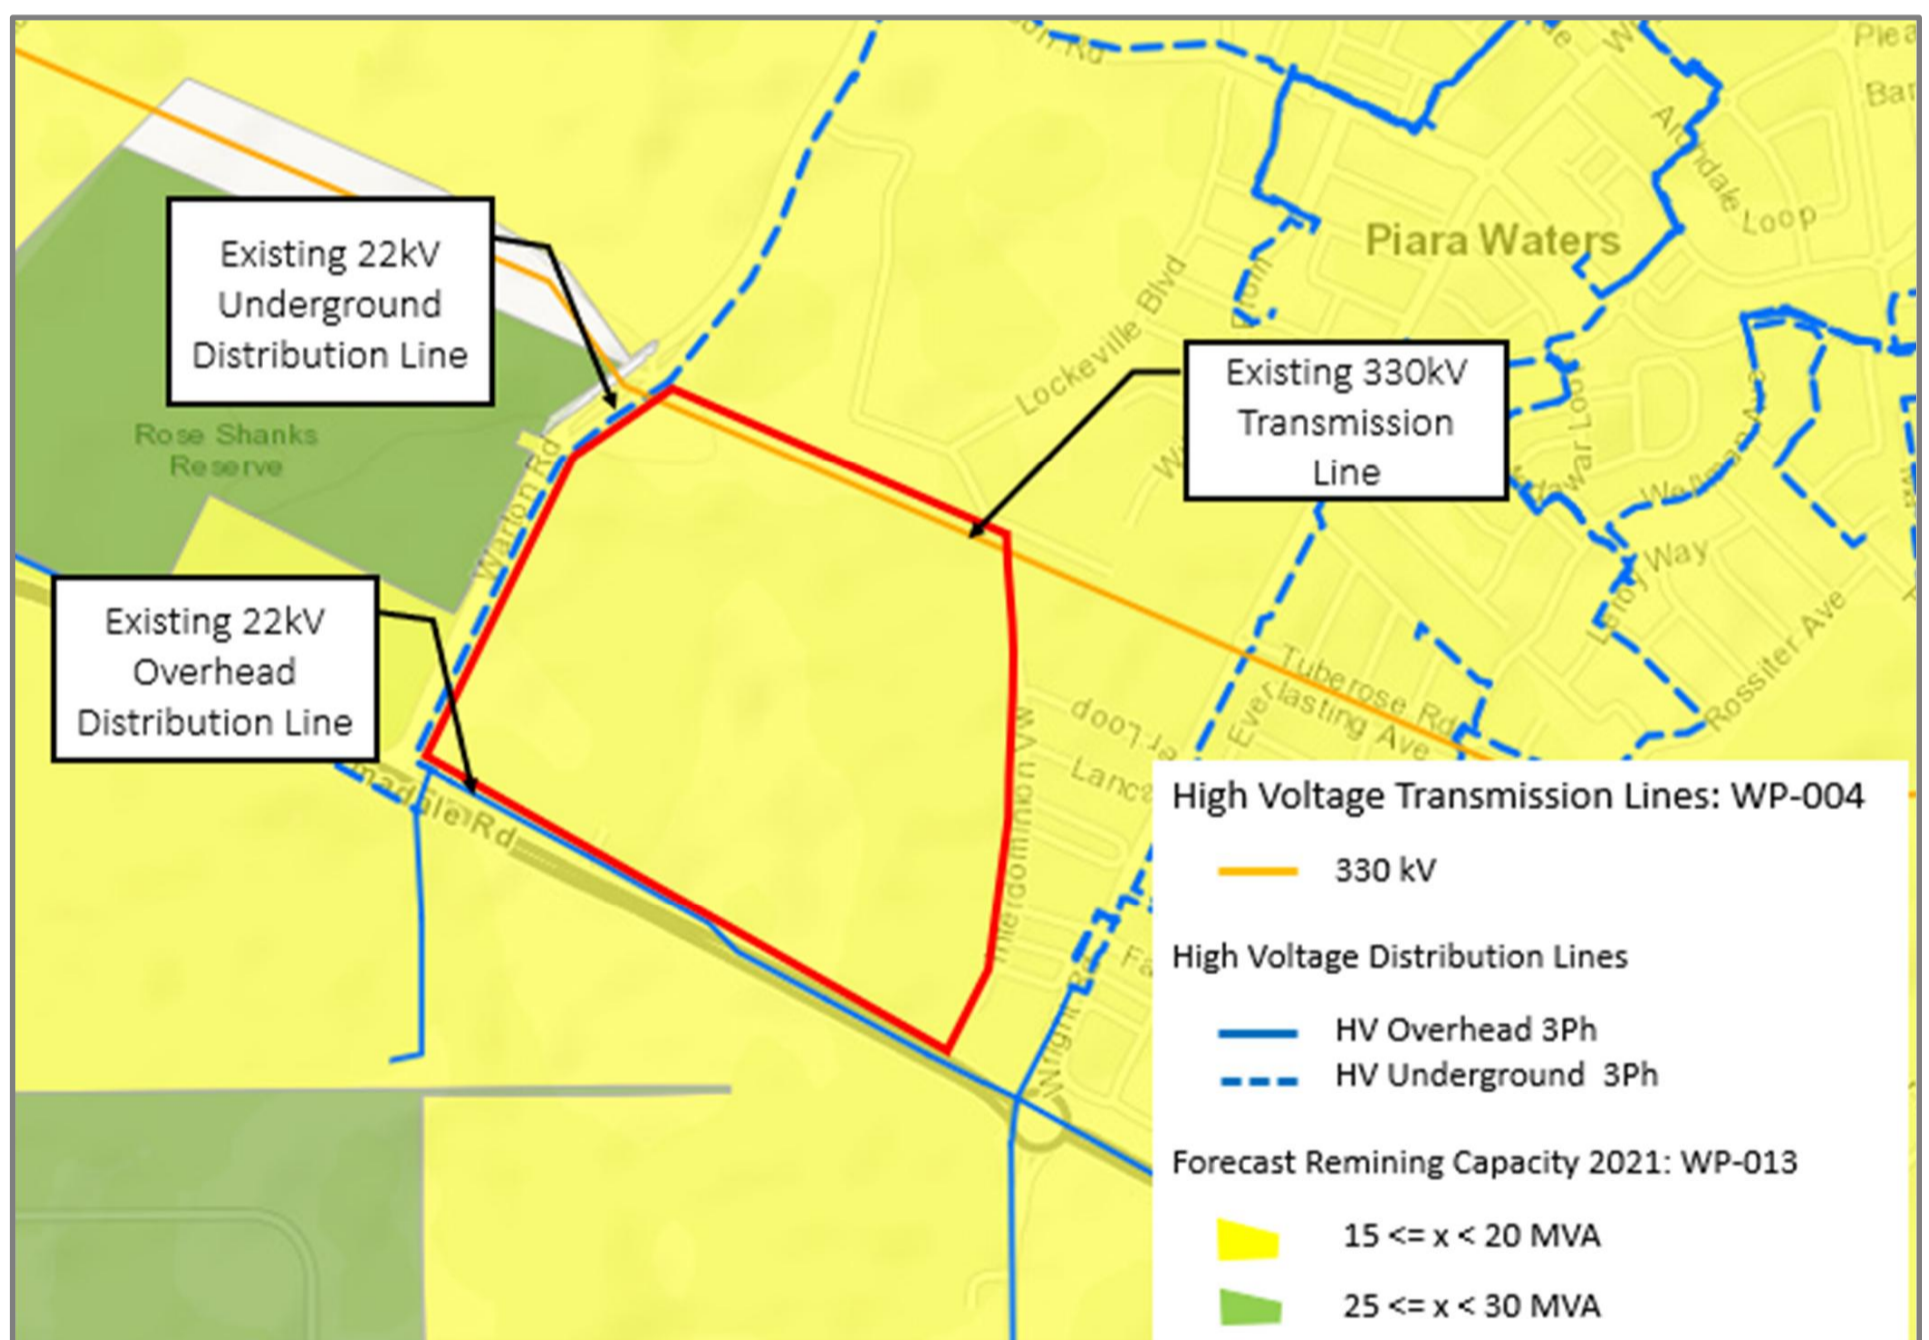
Figure 7 – Western Power Network Mapping Capacity Tool (Western Power, 2021)

The Site is surrounded by existing power infrastructure to the east, overhead power lines to the south on Armadale Road, a mix of overhead, underground feeder cables and transformers on Warton Road, and overhead 330 kV transmission lines through the northern portion of the Structure Plan area.

Western Power's Network Mapping Tool confirms there is 15-20 MVA capacity remaining in the surrounding network and based on the power demand of 4.7kVa per dwelling, the estimated total power requirement for residential development of the Site is approximately 3MVA, well within the available remaining capacity.

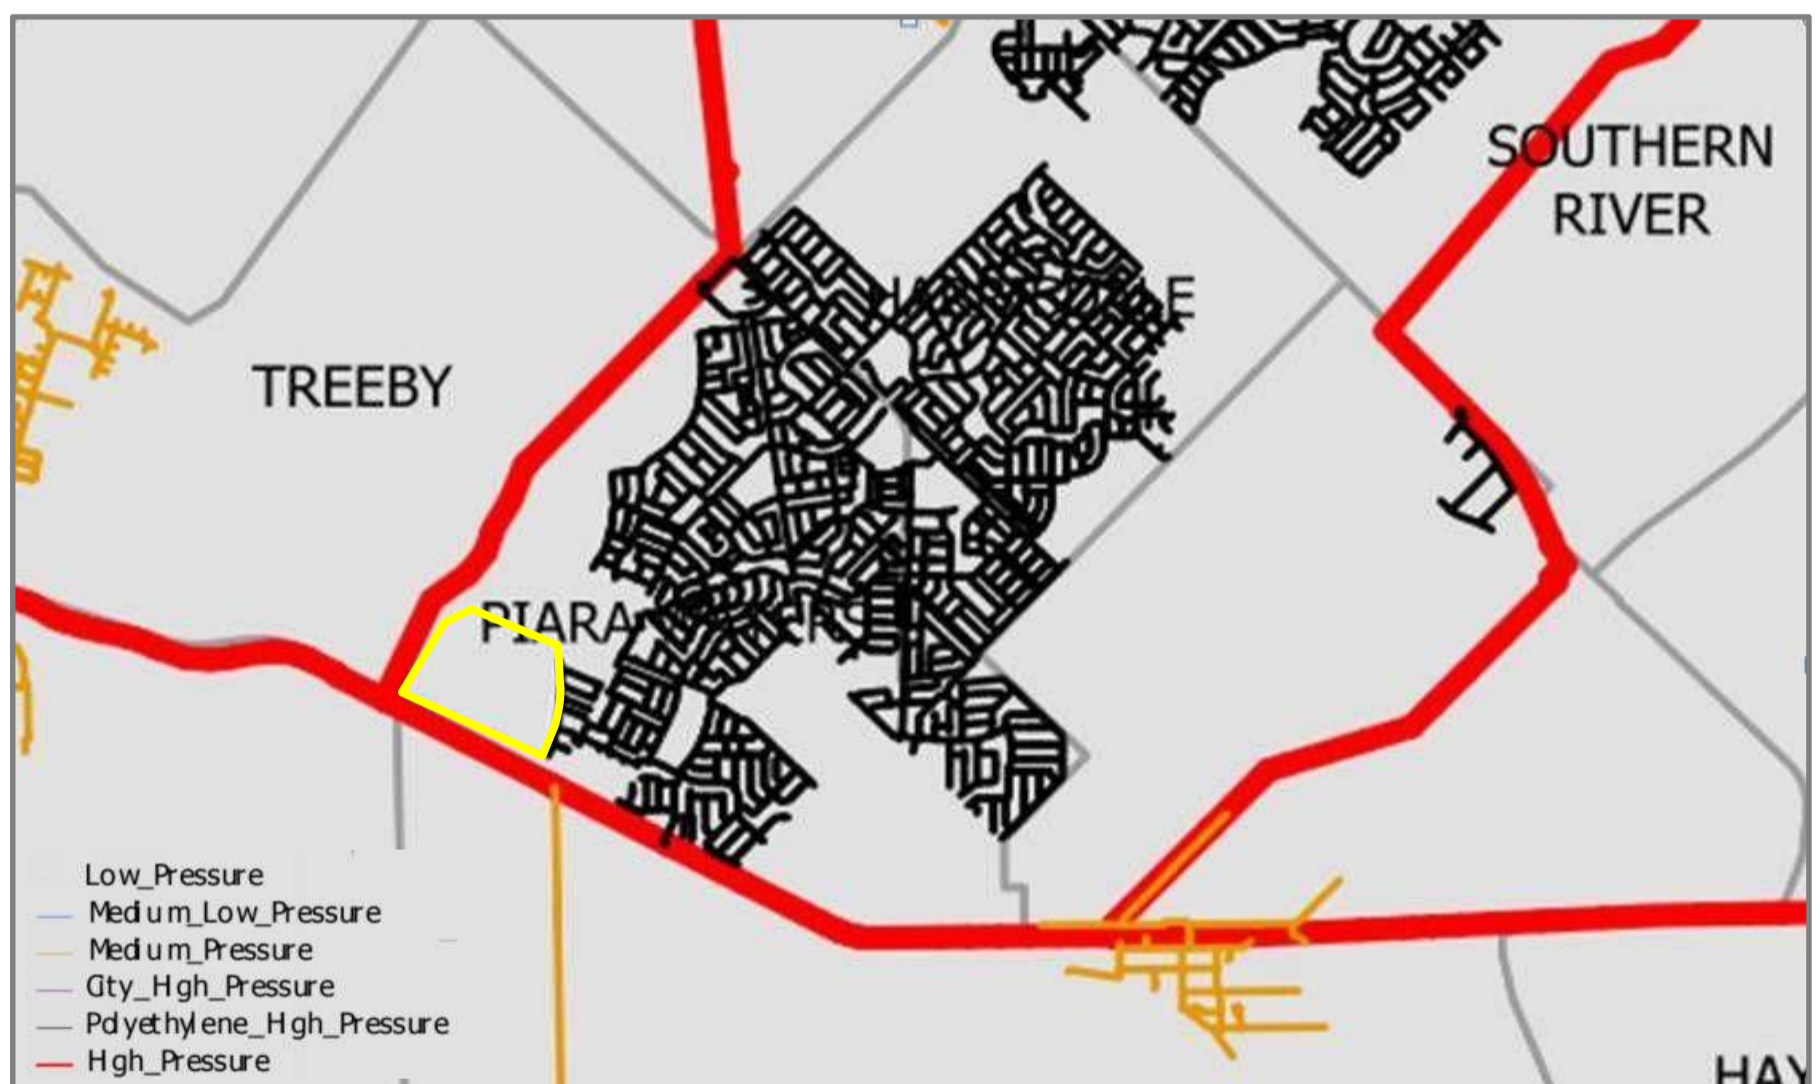
High-Pressure gas mains exist around the Site as depicted below in Figure 8. The mains east of the Site within the existing development generally consist of 110mm diameter polyethene reticulation mains. Larger 200mm diameter High-Pressure gas mains exist in the western verge of Warton Road which can be extended to service the proposed development.

Figure 8 – Location of Existing Gas Infrastructure (ATCO Gas, 2020)

Figure 8 above indicates the presence of High-pressure gas infrastructure in the western and southern road reserves of Warton and Armadale Road respectively. In reviewing the mapping, excerpt in Figure 9, it is apparent that the western and southern portion of the subject site falls within the trigger distance set out in Development Control policy 43. "Section 3.2 Exceptions" and in particular Section 3.2.1 of the Policy suggests that there are no policy requirements for subdivision and development on land that is not intersected by a pipeline, and not zoned for a "Sensitive", "Industrial", "Heavy Industrial" or "Common Infrastructure Corridor" purpose.
