Piara Waters Structure Plan Engineering Servicing Report January 2022

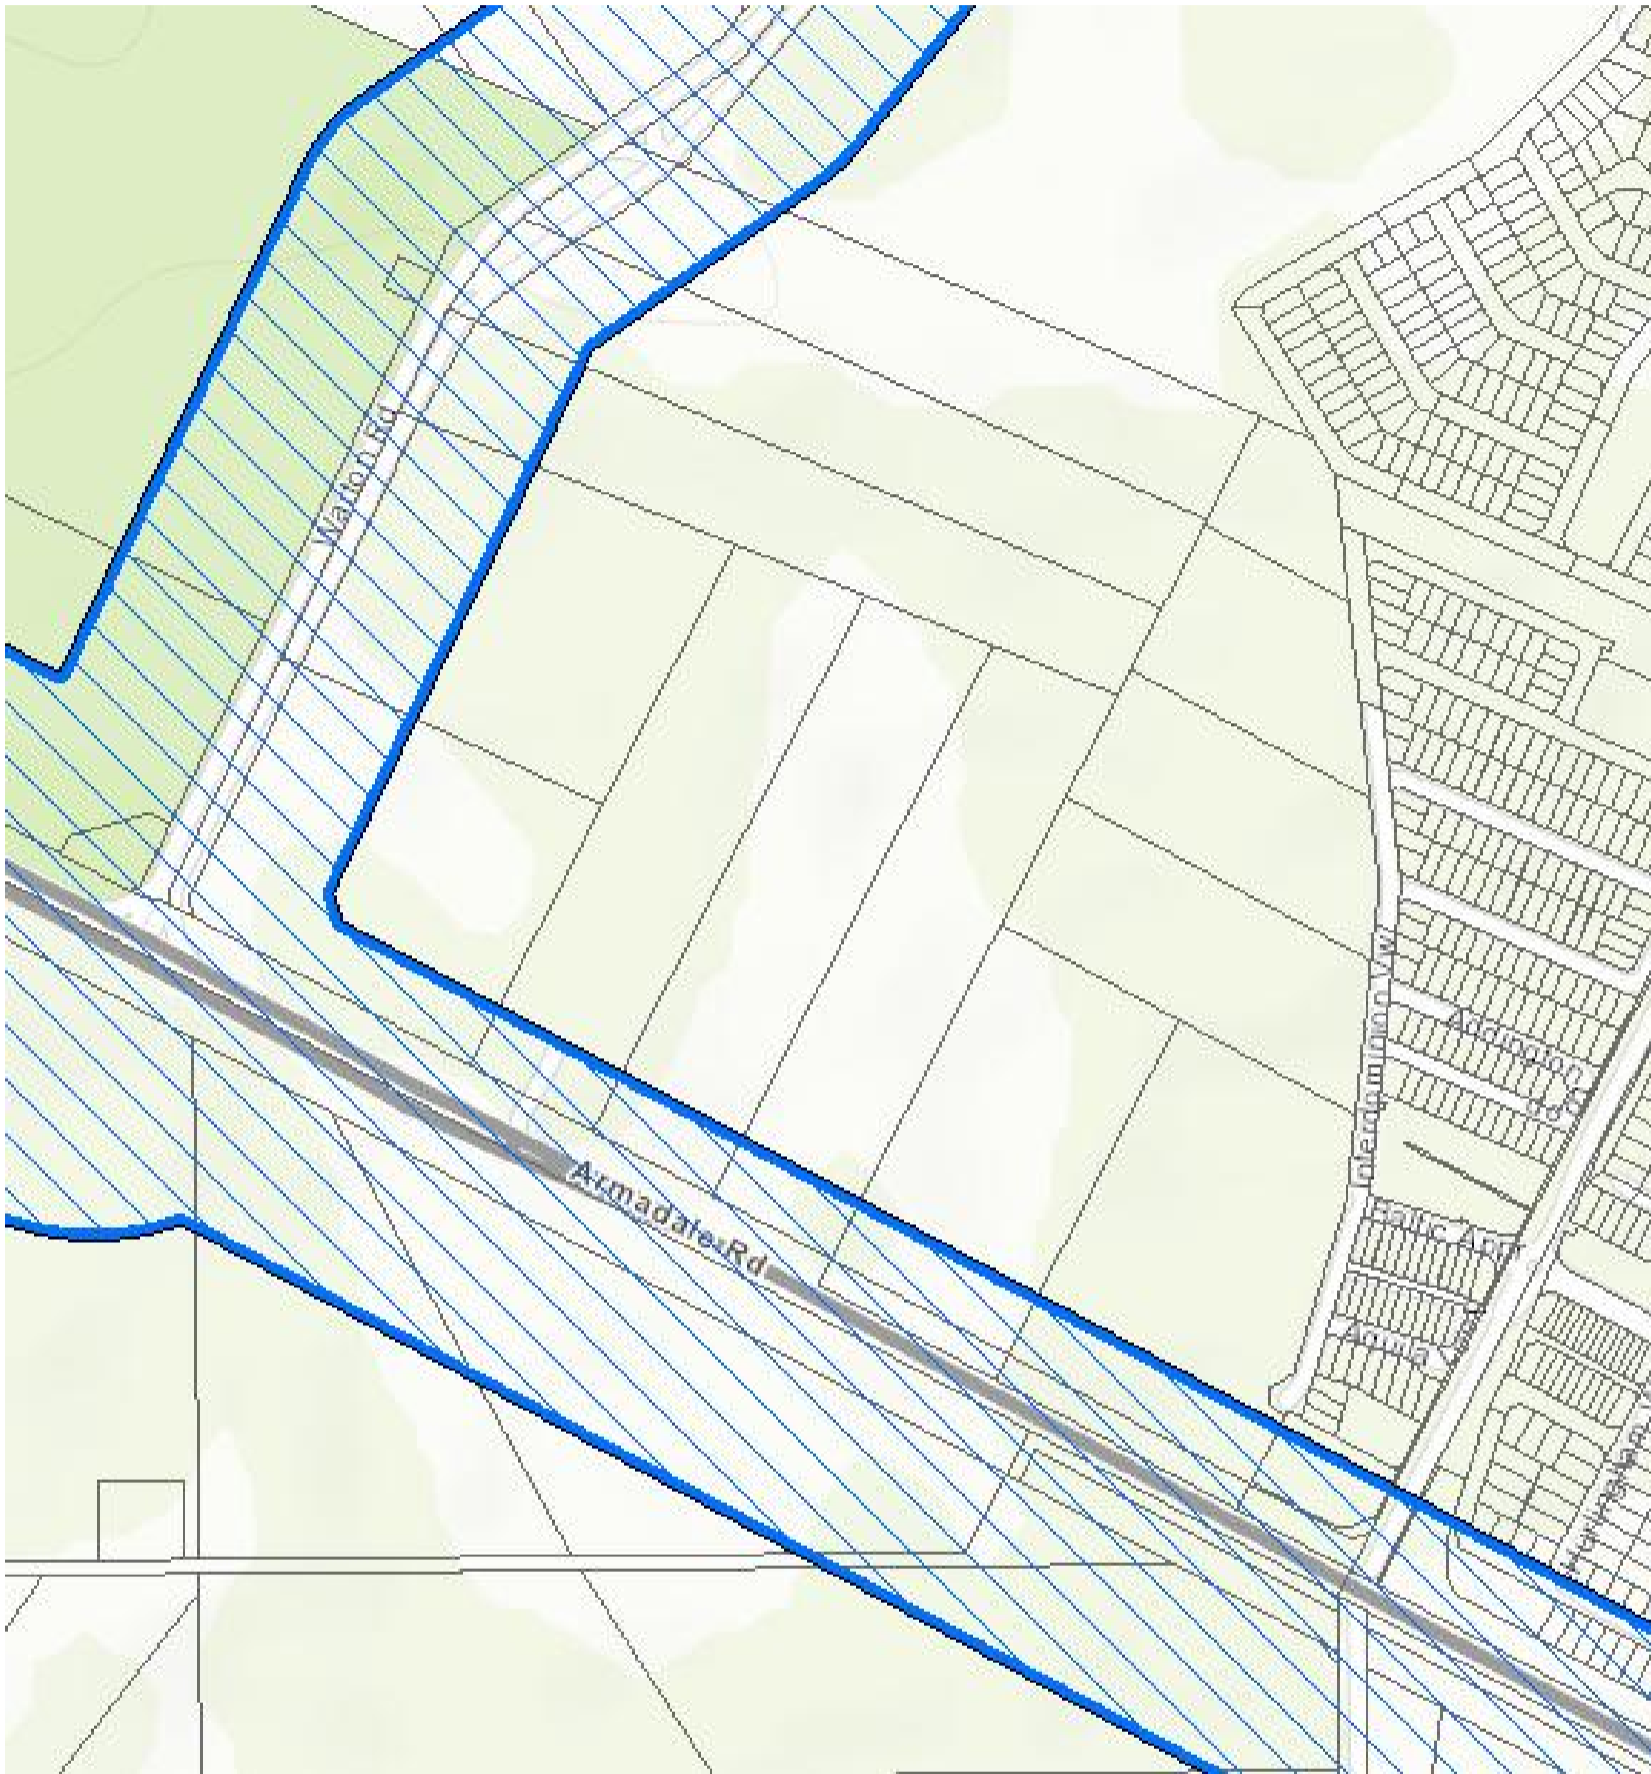
Figure 9 – ATCO gas trigger distance mapping (DPLH, 2022)

The HP Gas pipeline in this instance does not intersect the subject site and because the proposed development is wholly residential without any portion zoned Industrial, Heavy Industrial or Common Infrastructure and considering a "sensitive land use" is defined as schools, hospitals, aged-care facilities or prisons, the proposed residential subdivision of the site is considered exempt in accordance with the Development Control Policy 43.

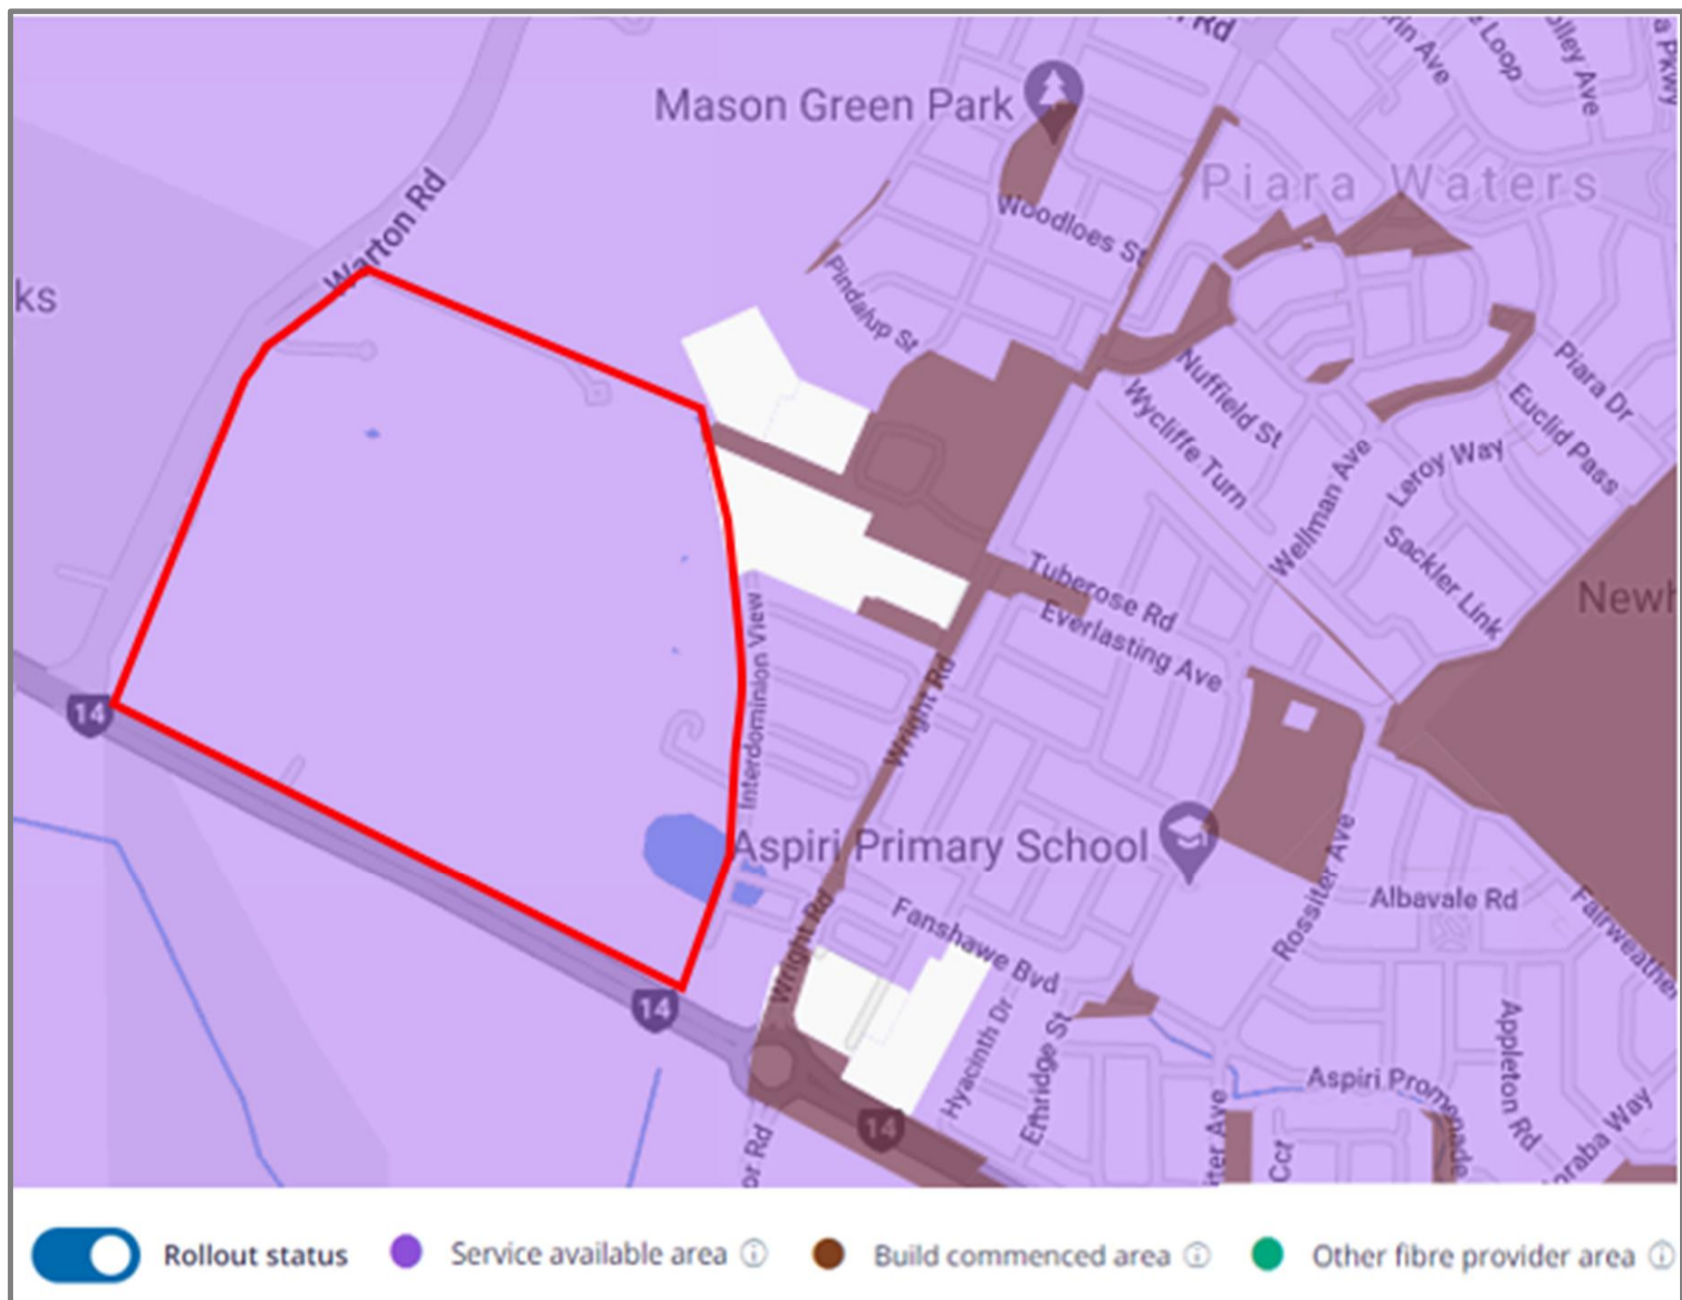
Figure 9 – NBN Fibre Footprint (NBN, 2021)

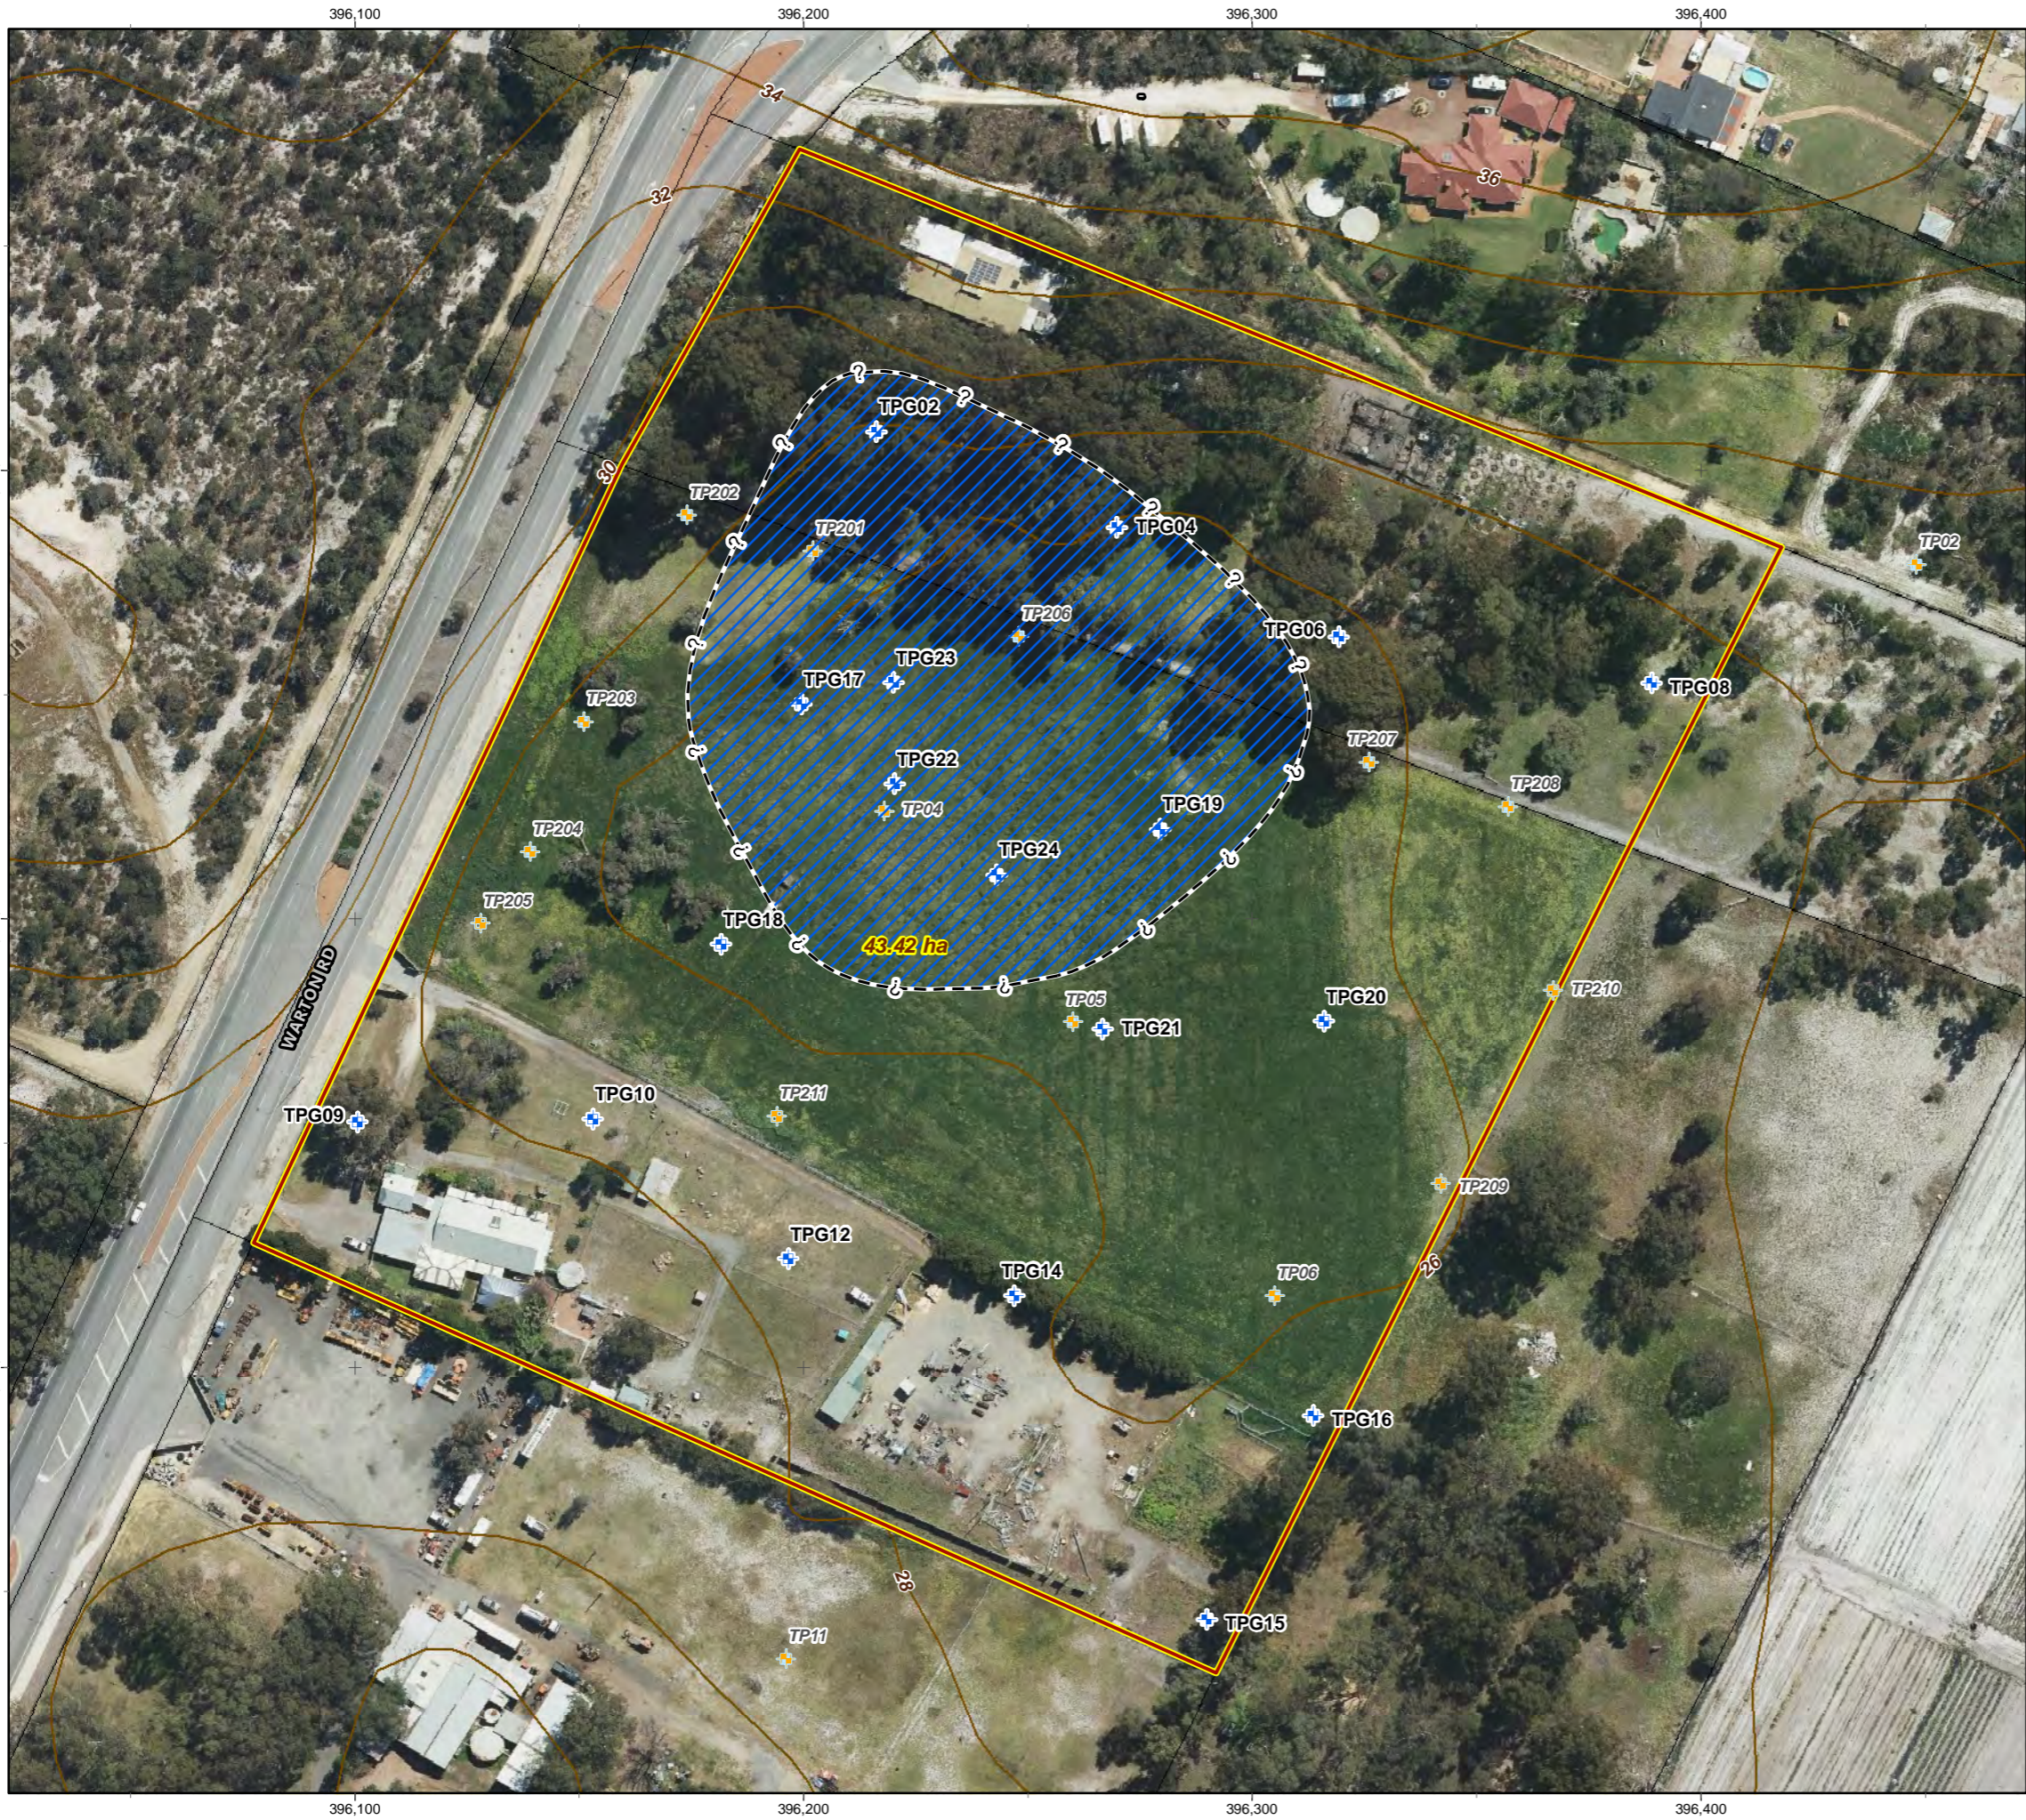
FIGURE 1

Site and Location Plan

Approximate area of site where topsoil is underlain by silty and organic sand materials, which will need to be removed and replaced with structural fill

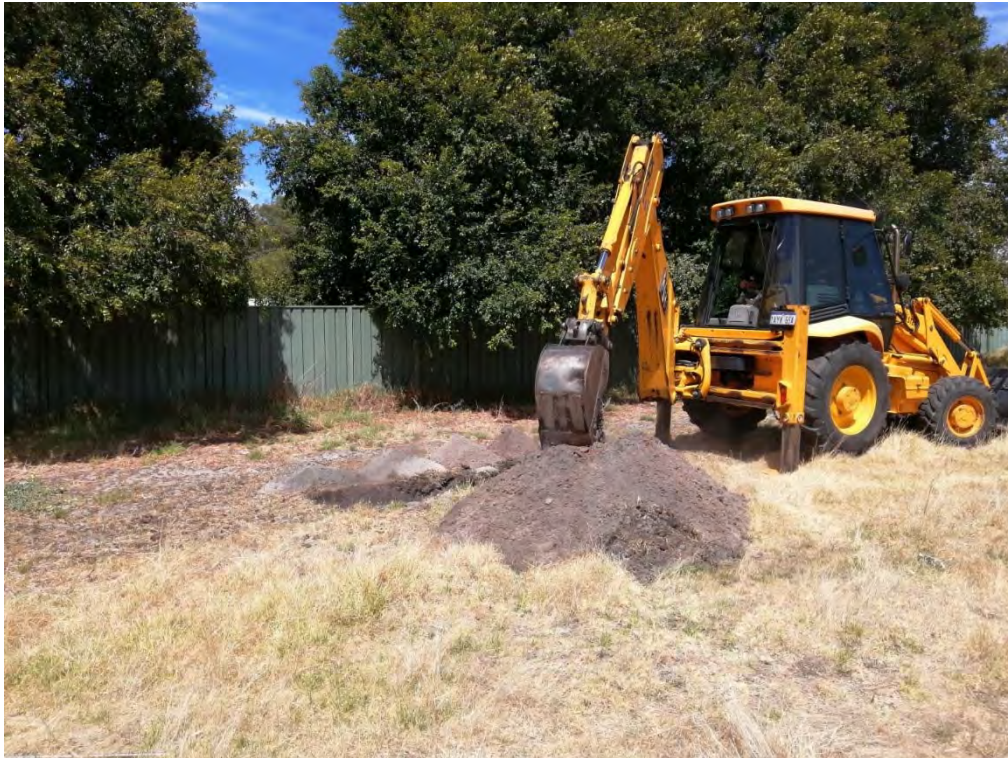
Photograph 1: Test pitting underway at the site

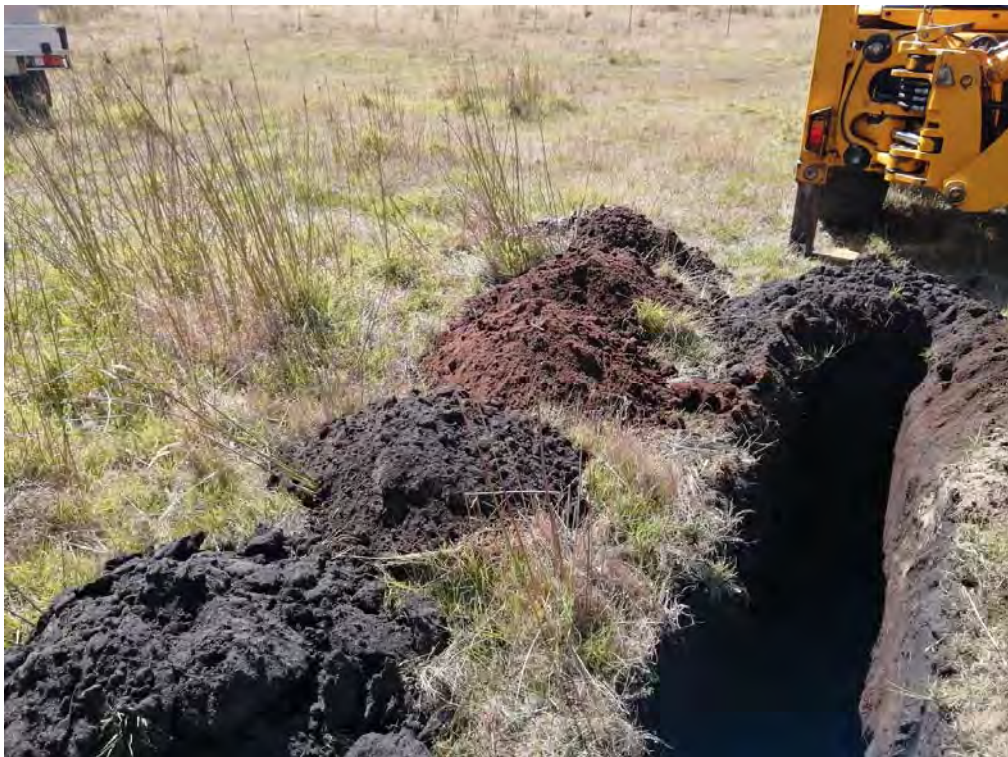
Photograph 2: Typical thick topsoil/organic soil test pit
