Kelmscott District Centre Precinct Plan

Place Audit Report (including Public Open Space Audit)

Taylor Burrell Barnett
Town Planning and Design

Revision	Reviewer	Date Issued
20/053	SB	13 May 2021

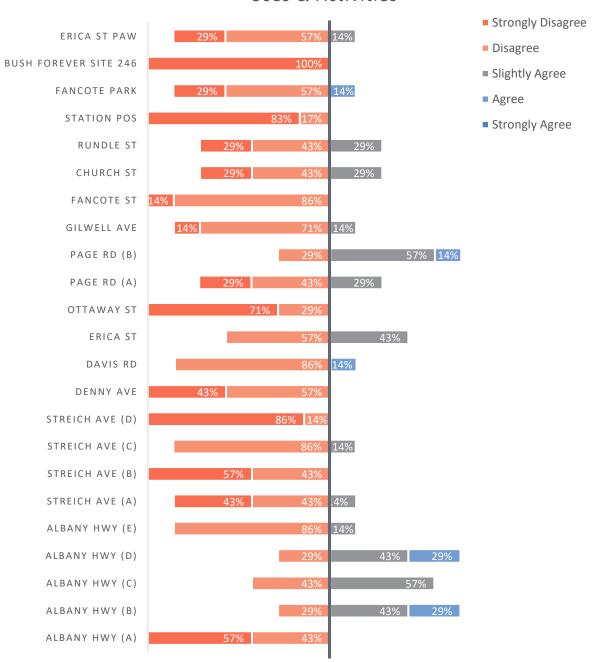
Uses & Activities

The results indicate that uses and activities are a key concern for the Kelmscott Activity Centre with regards to the overall quality of place and should be a key consideration when considering place creation strategies going forward.

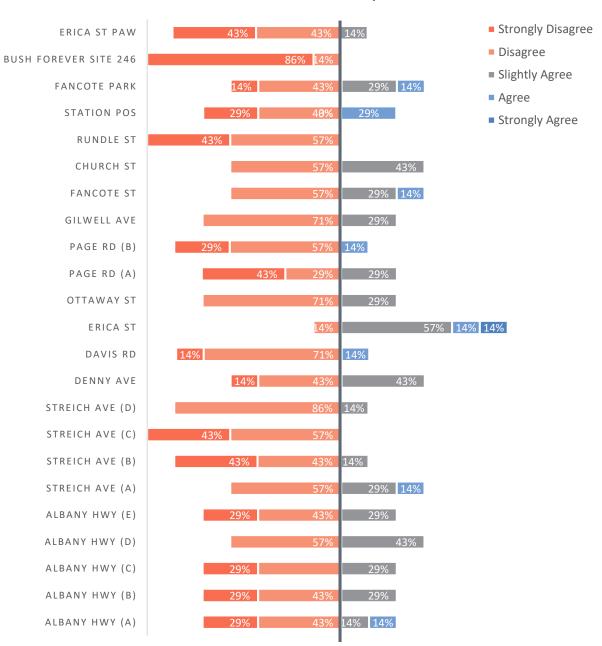
Sociability

The audit results indicate that majority of the streets are not very well placed in the sociability category.

The results indicate that sociability factors such as pedestrian amenity and places to gather should be a key focus of any place improvements.

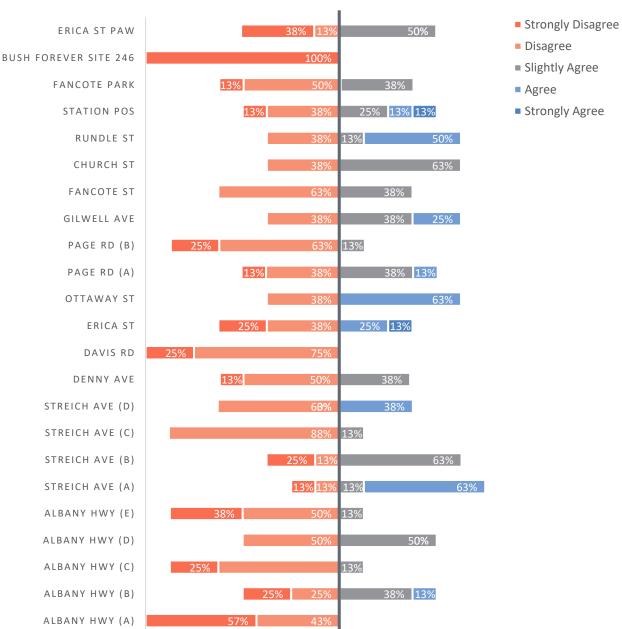
Access & Linkages

Results were mixed for the 'Access & Linkages' category.

The results indicate that access and linkage improvements such as provision for active transport, signage and wayfinding should be considered across the study area, with particular attention paid to underperforming areas.

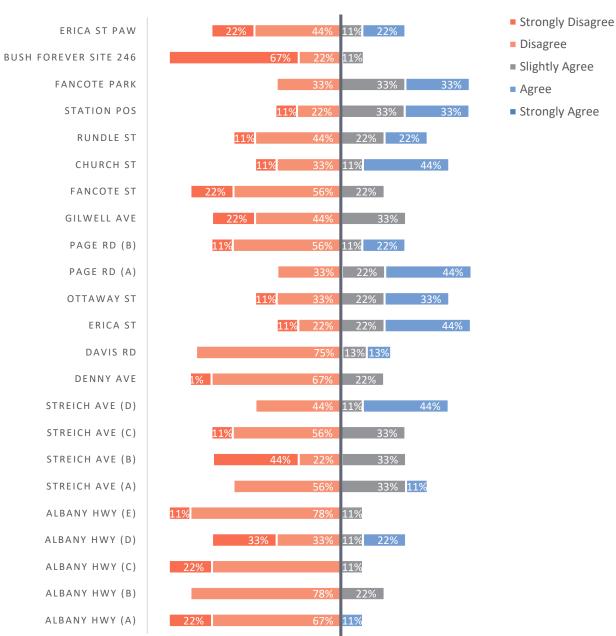
Comfort & Image

The 'Comfort & Image' category was relatively low scoring across all areas,

As with access and linkages category, the findings indicate some improvements will be required to all areas within the study area, such as the attractiveness of landscaping and building presentation, night time safety and provision of places to sit.
